The Forces that Destroy Historic Structures

The SC Historic Preservation Conference

Craig M. Bennett, Jr., PE

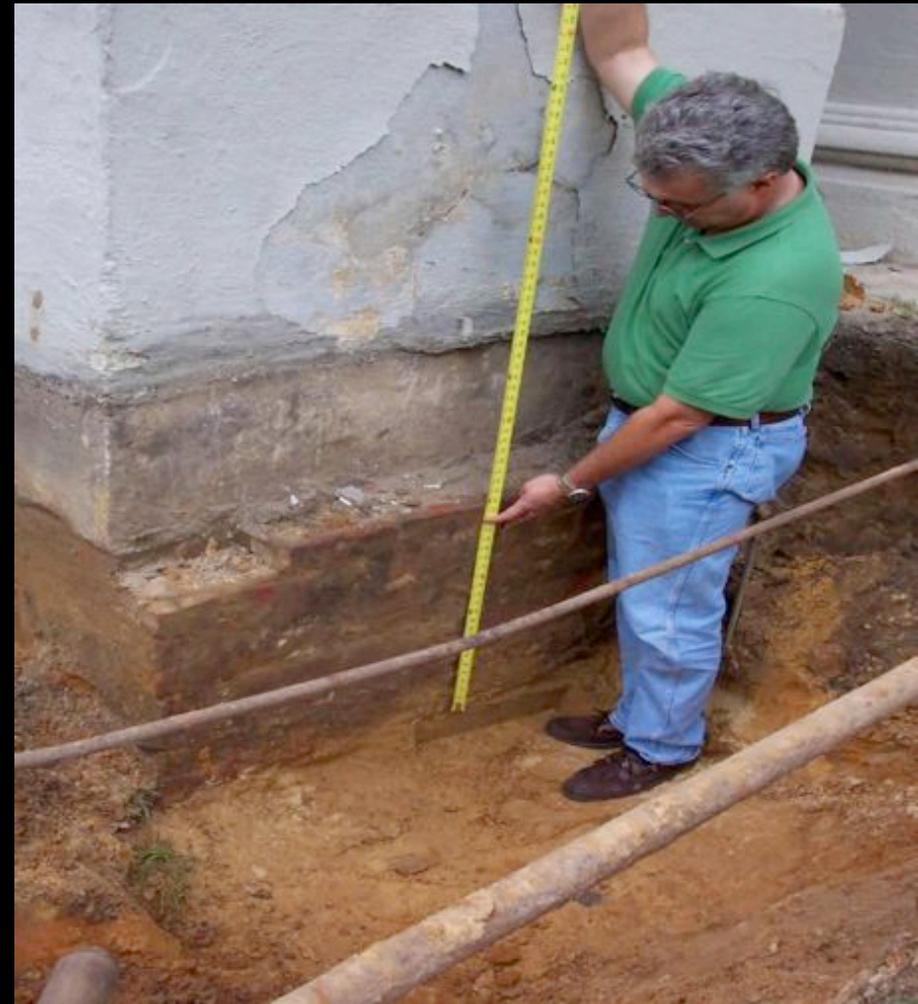
- And foundations are rarely adequate:
 - Grace Church, Charleston

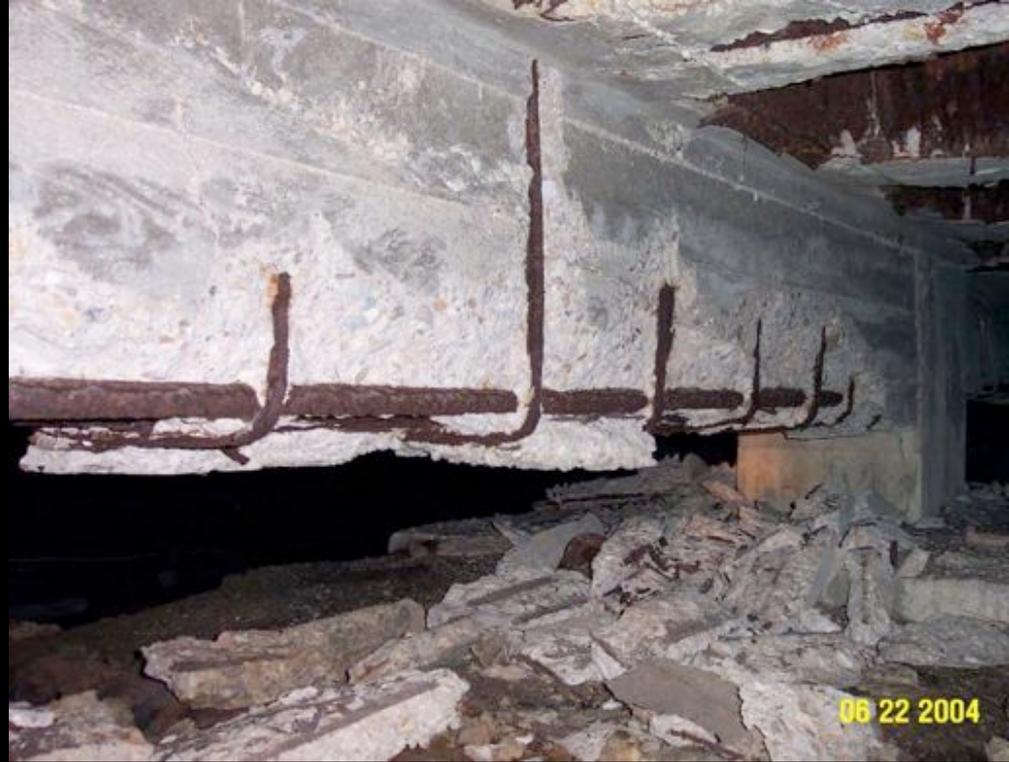
- Deterioration then superb repairs to concrete:
 - The Fort Sumter House, Charleston

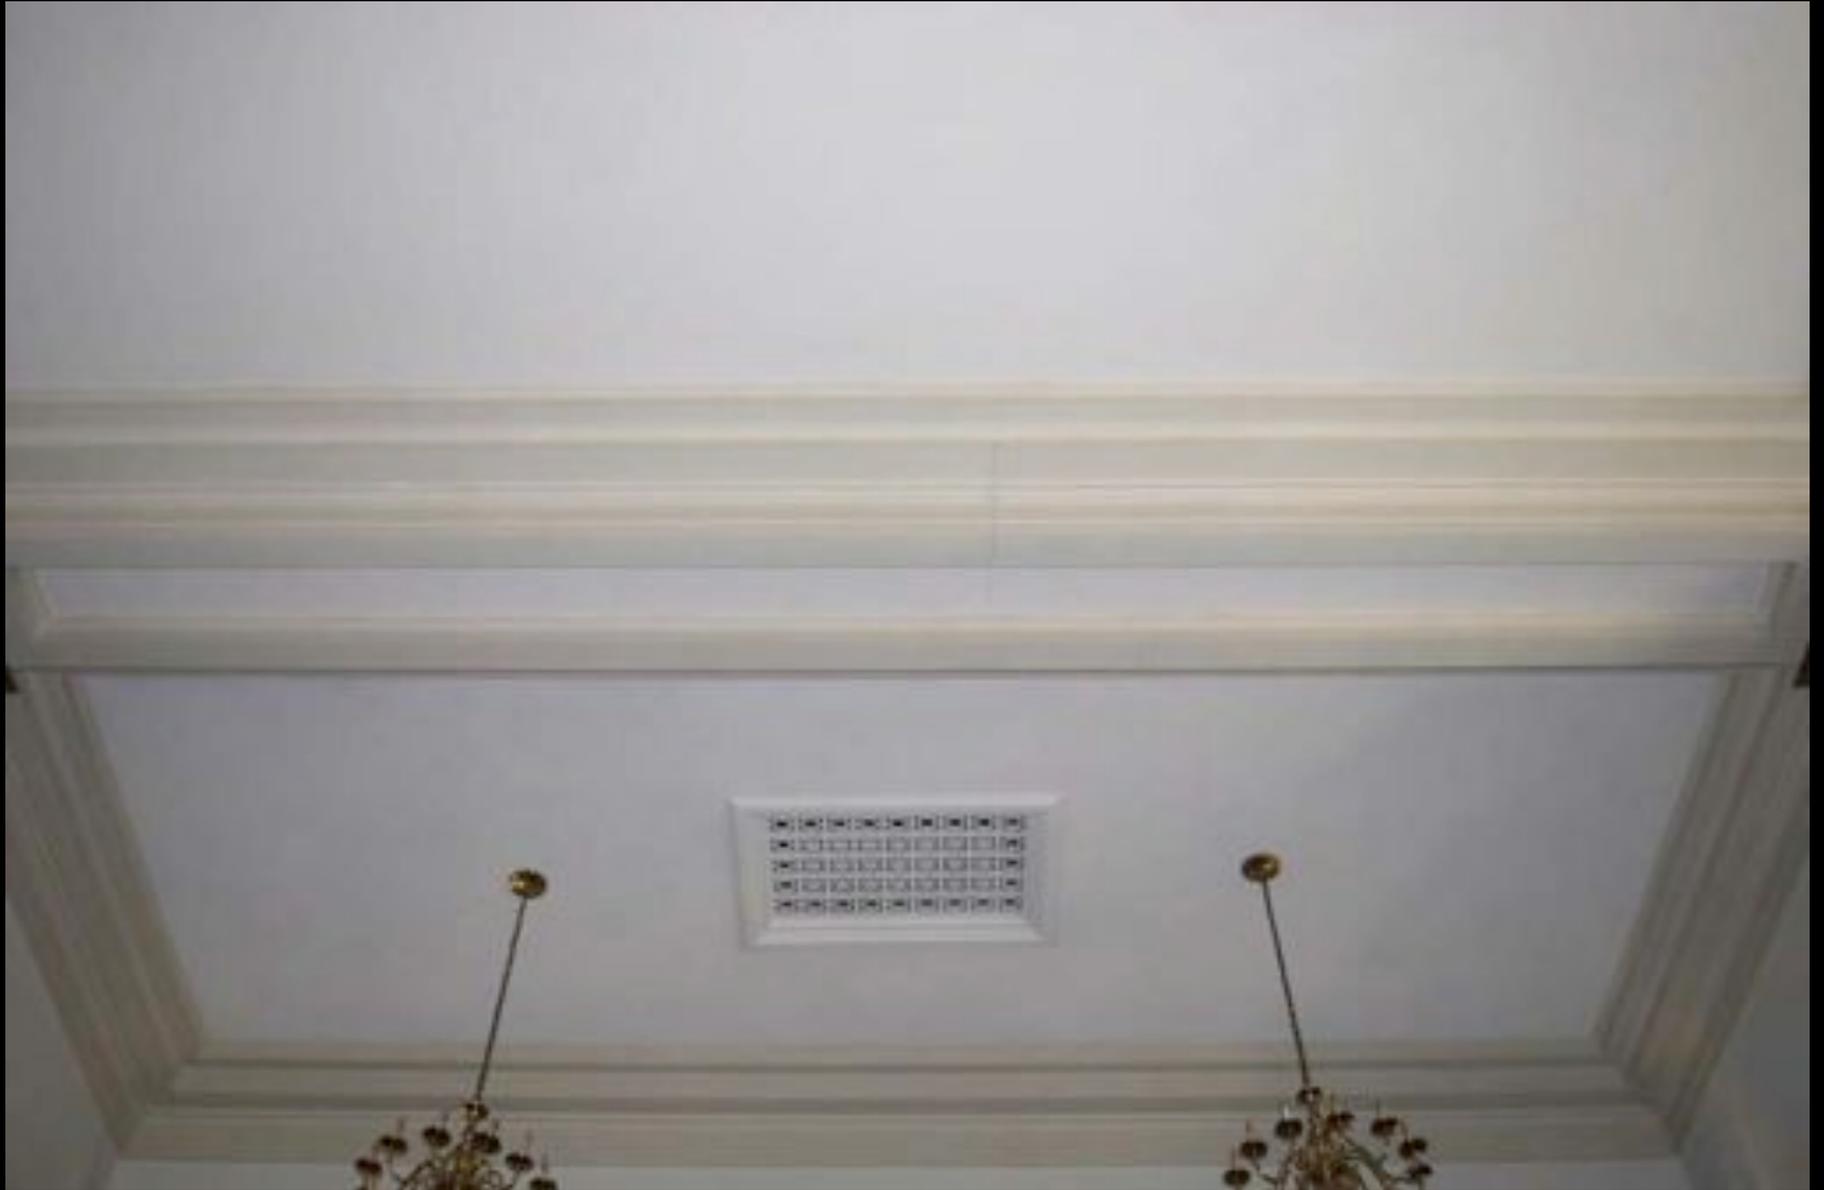
Ceiling Deflection: Soffit Over the Balcony Rail

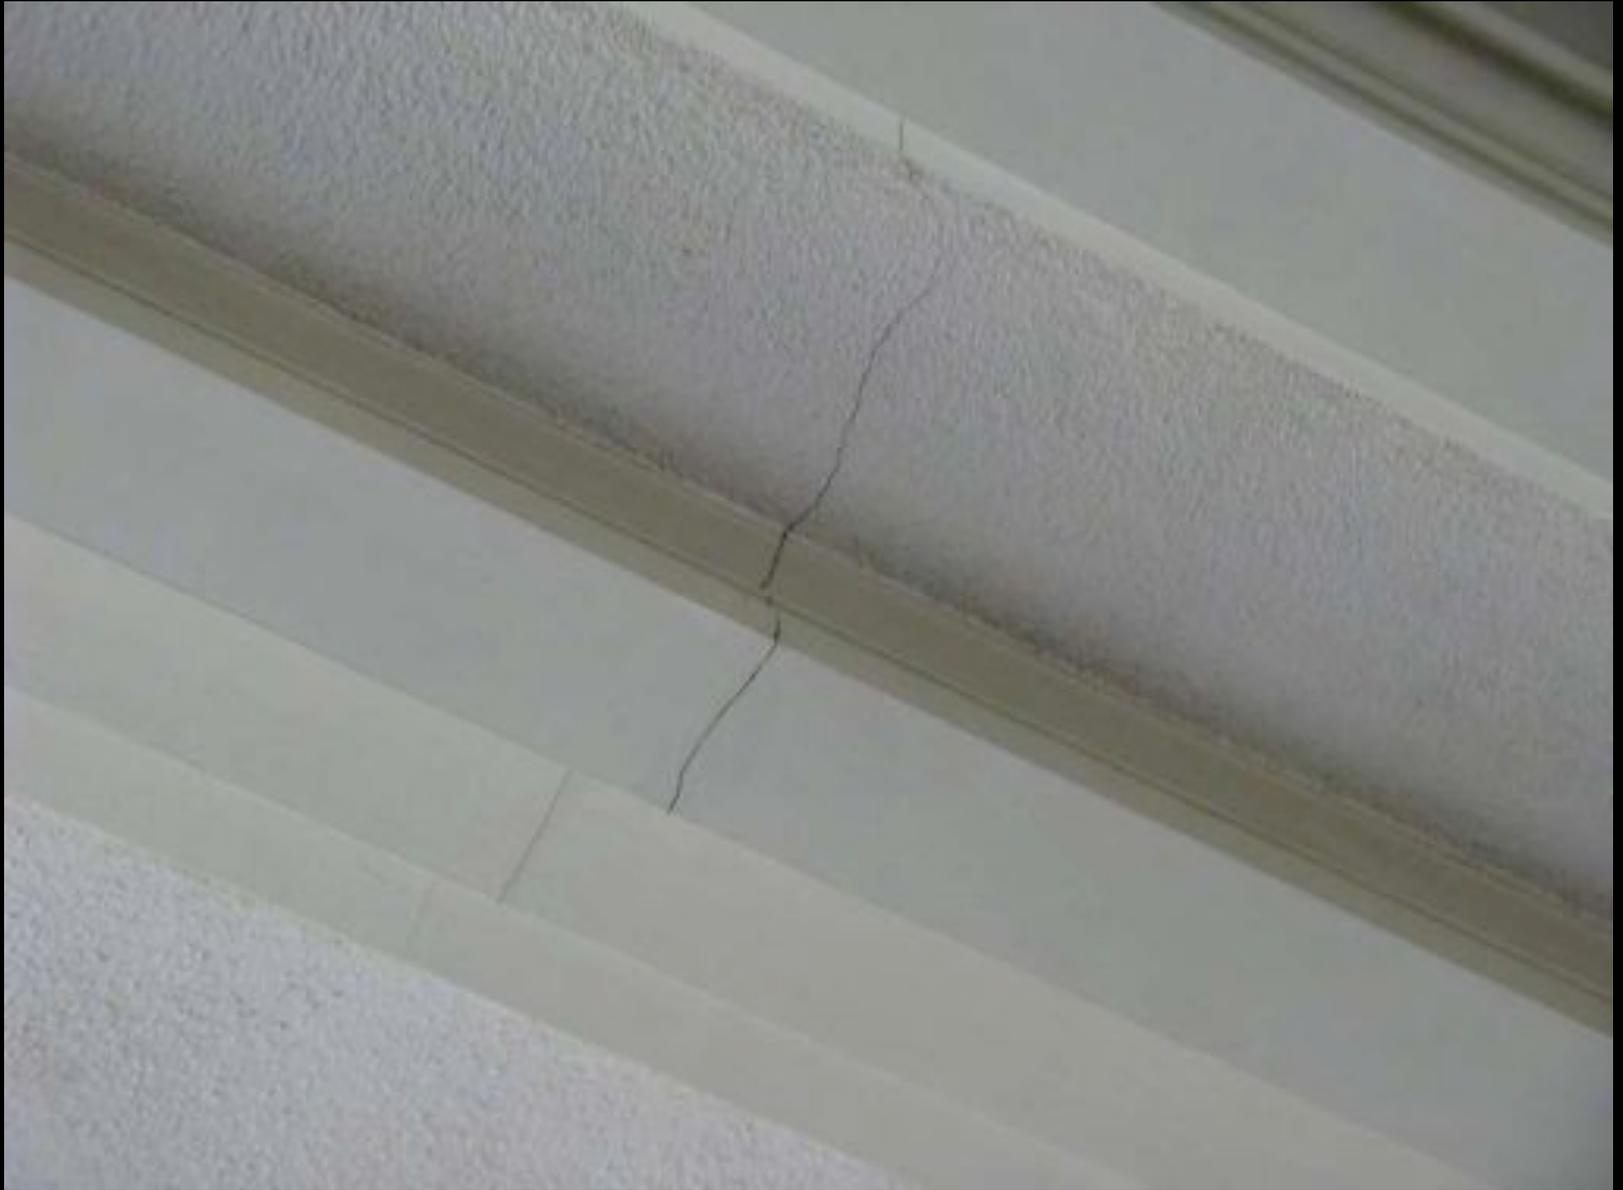
Plaster Cracking

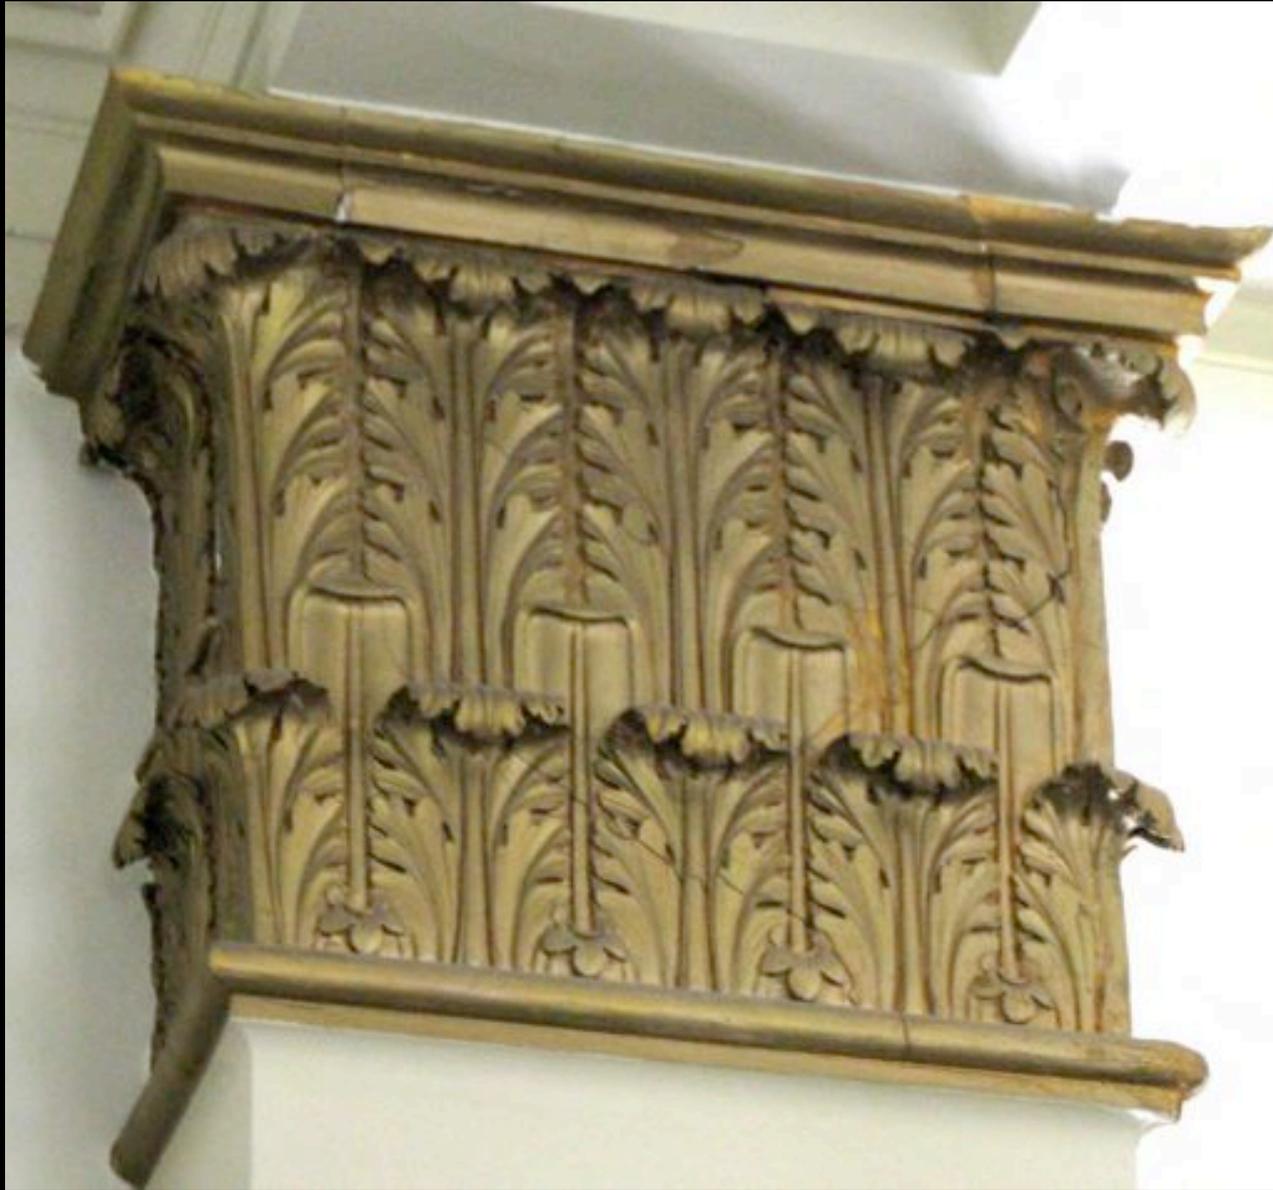
Cracking of the Pilasters

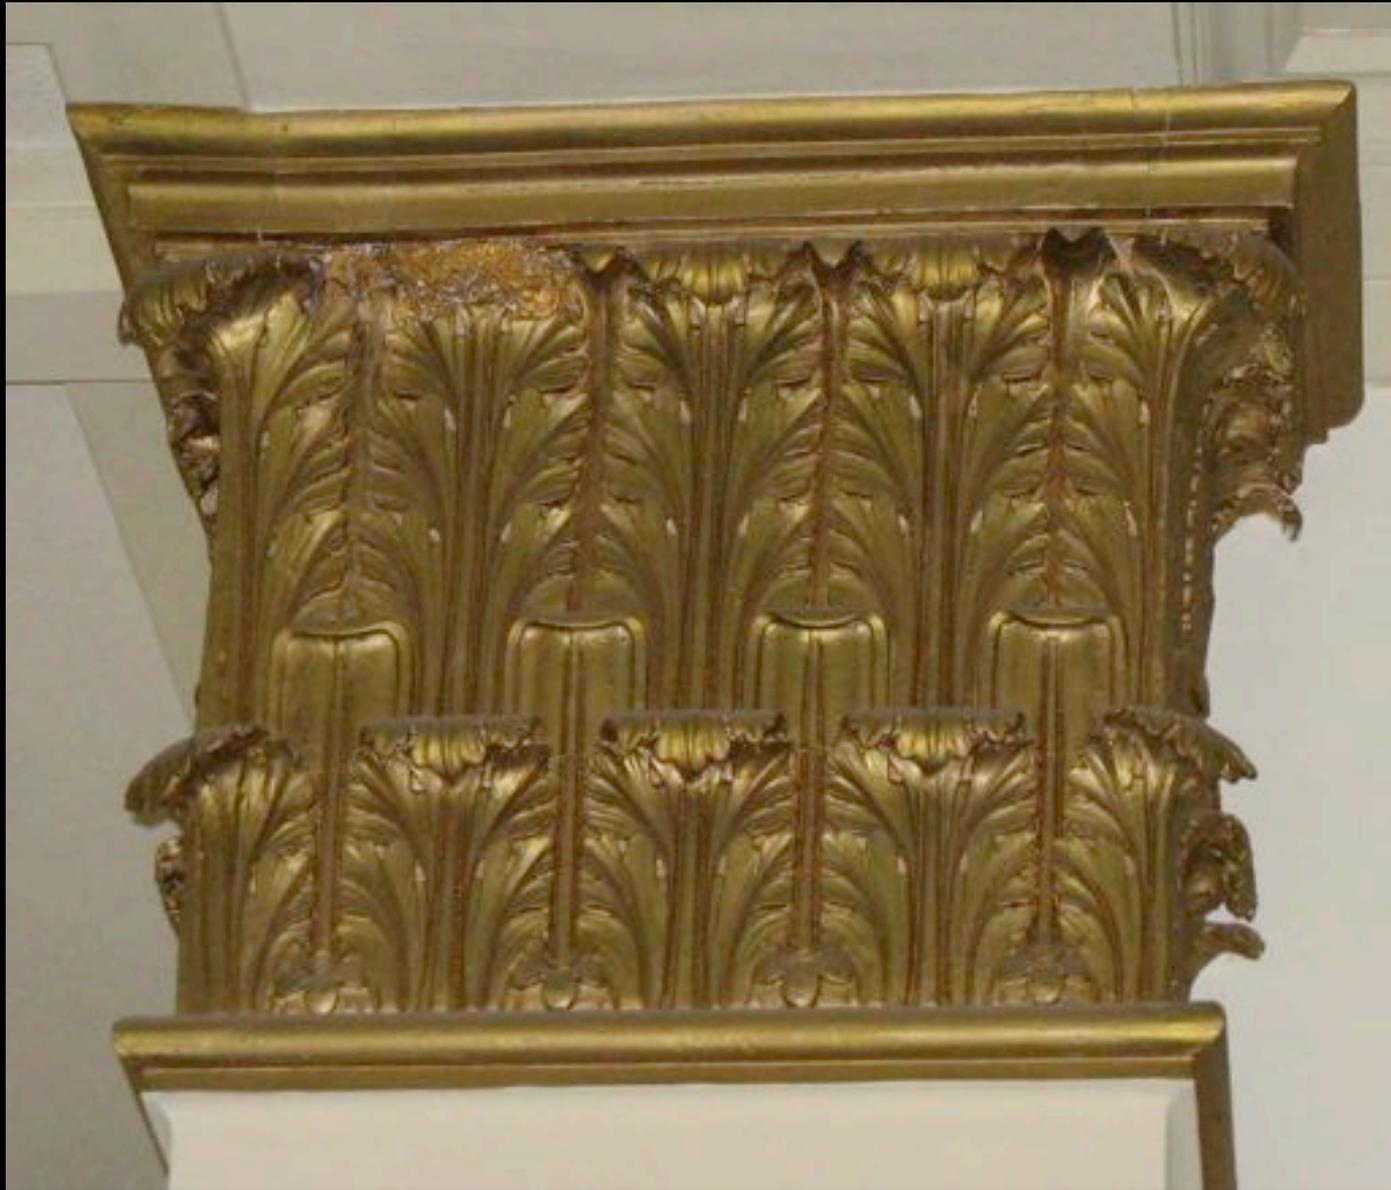
Cracking of the Pilasters

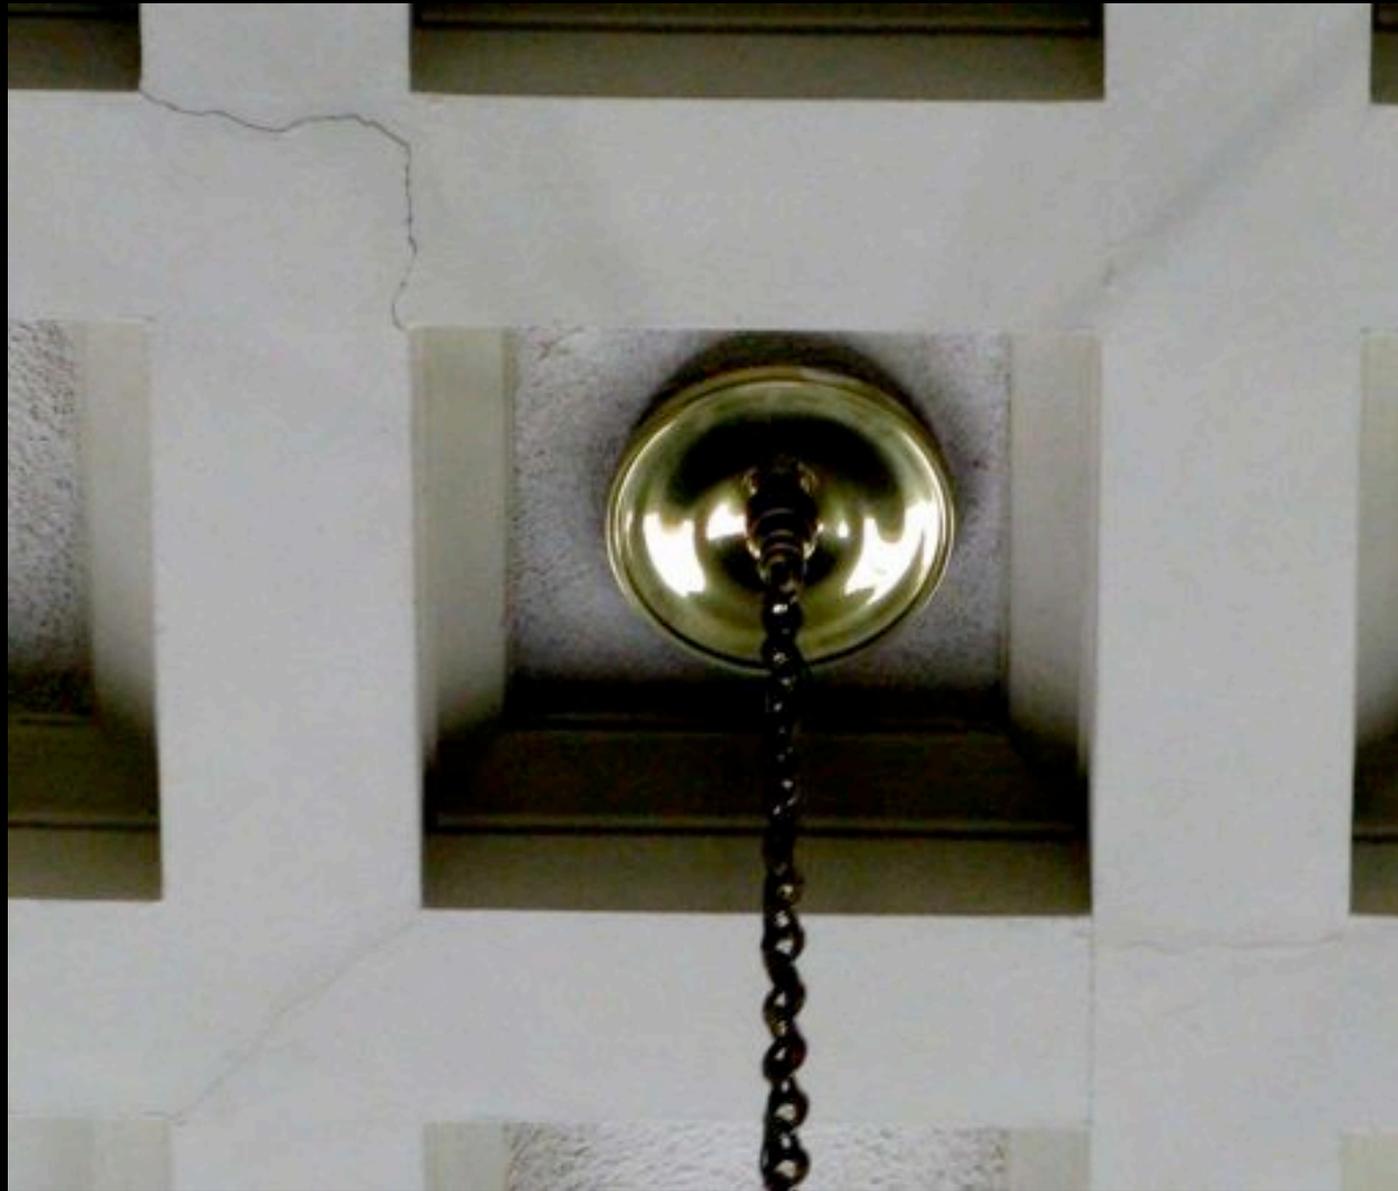
Plaster Cracking

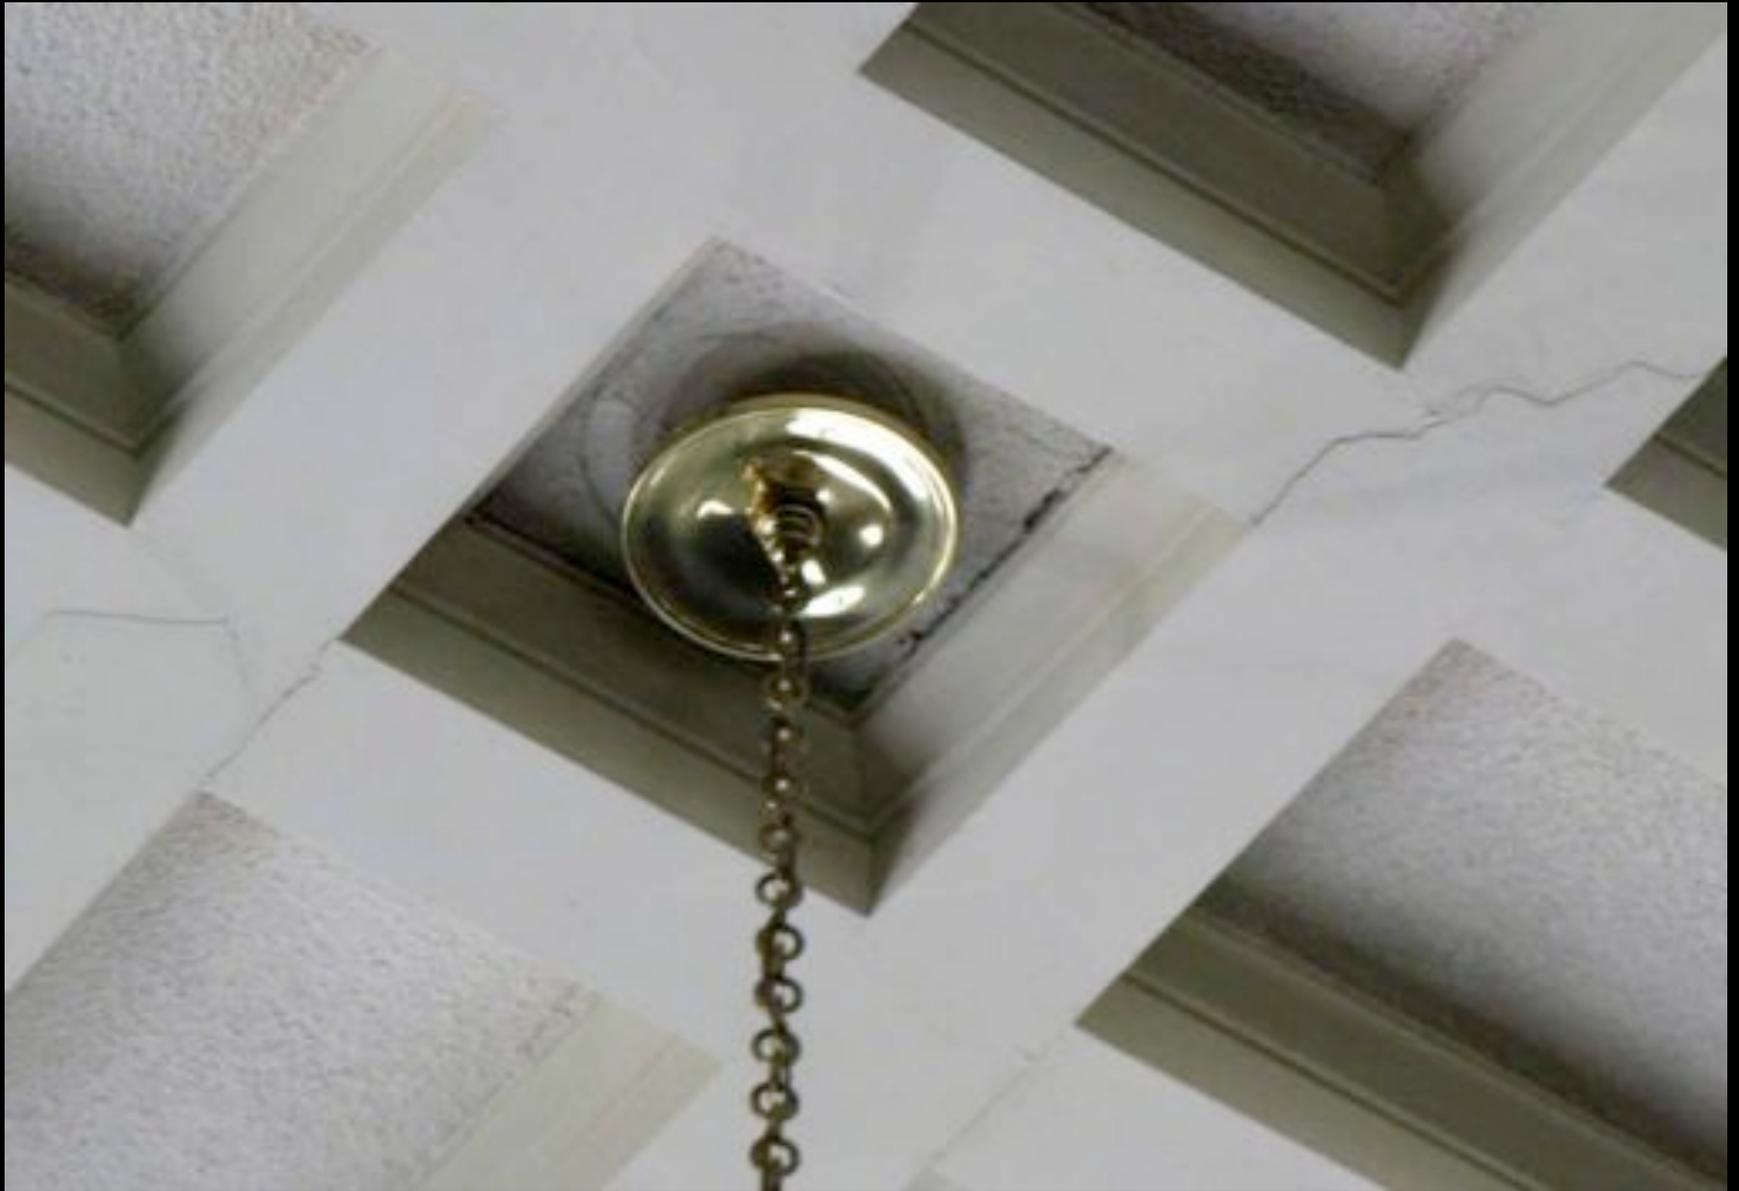
Plaster Cracking

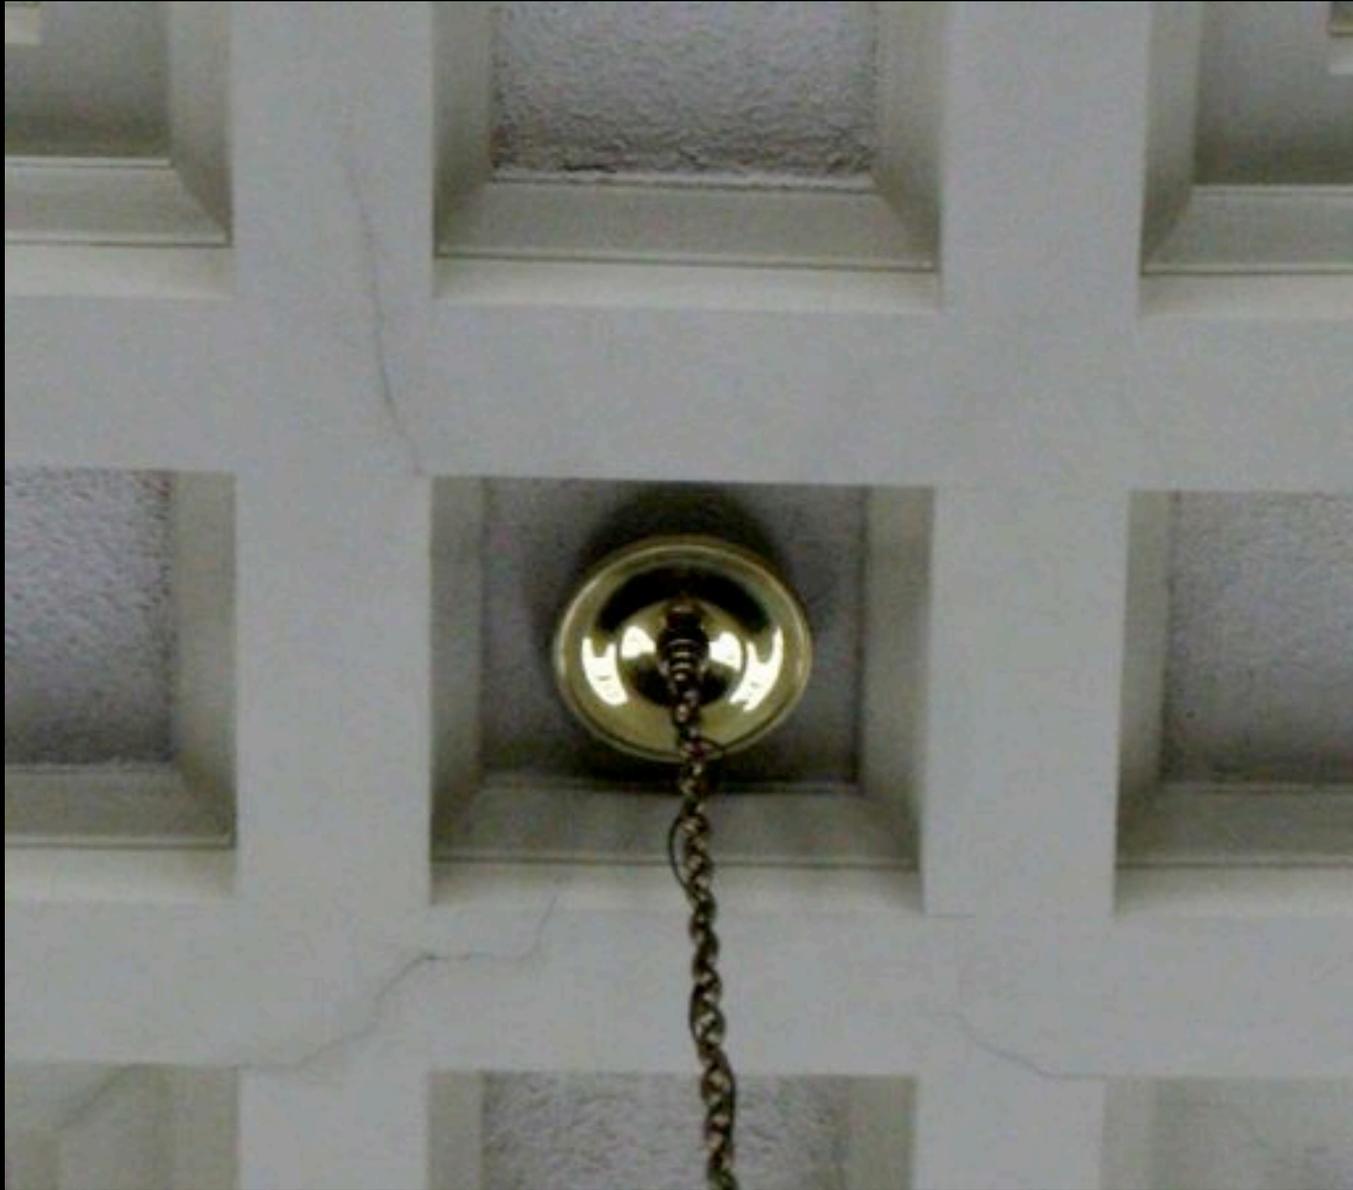
Plaster Cracking

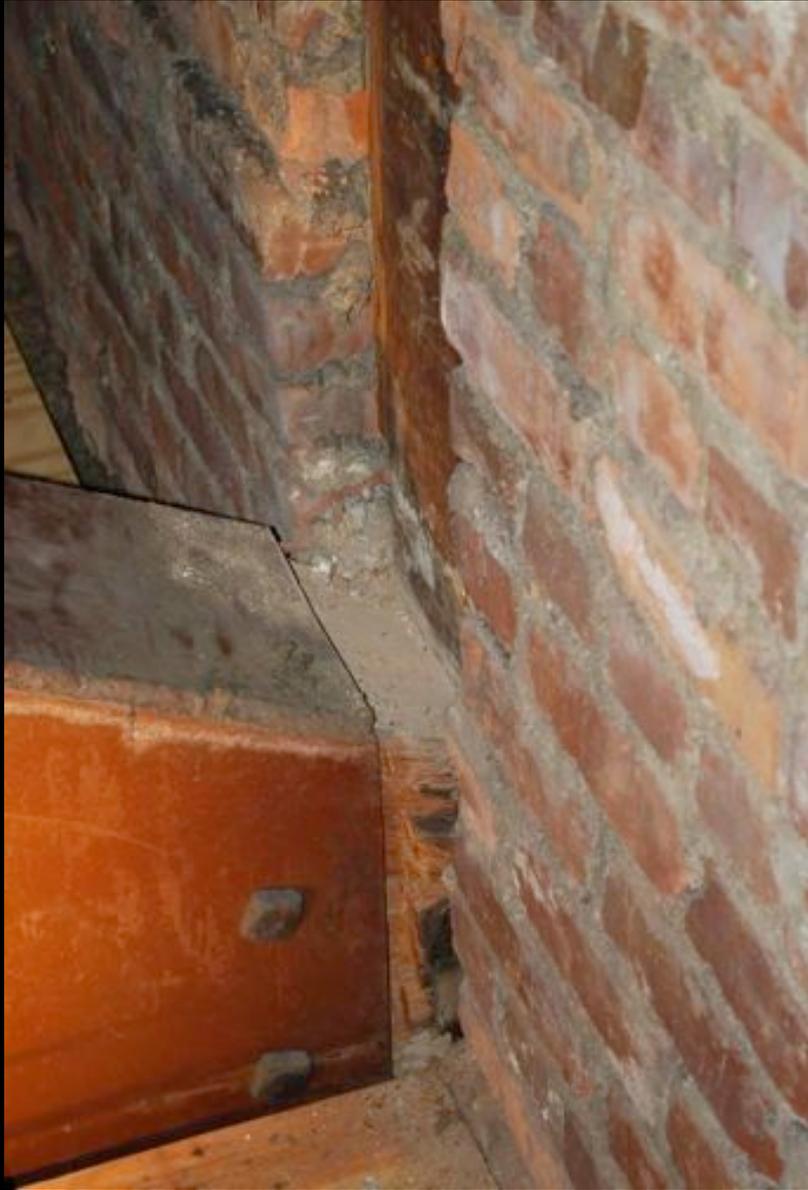
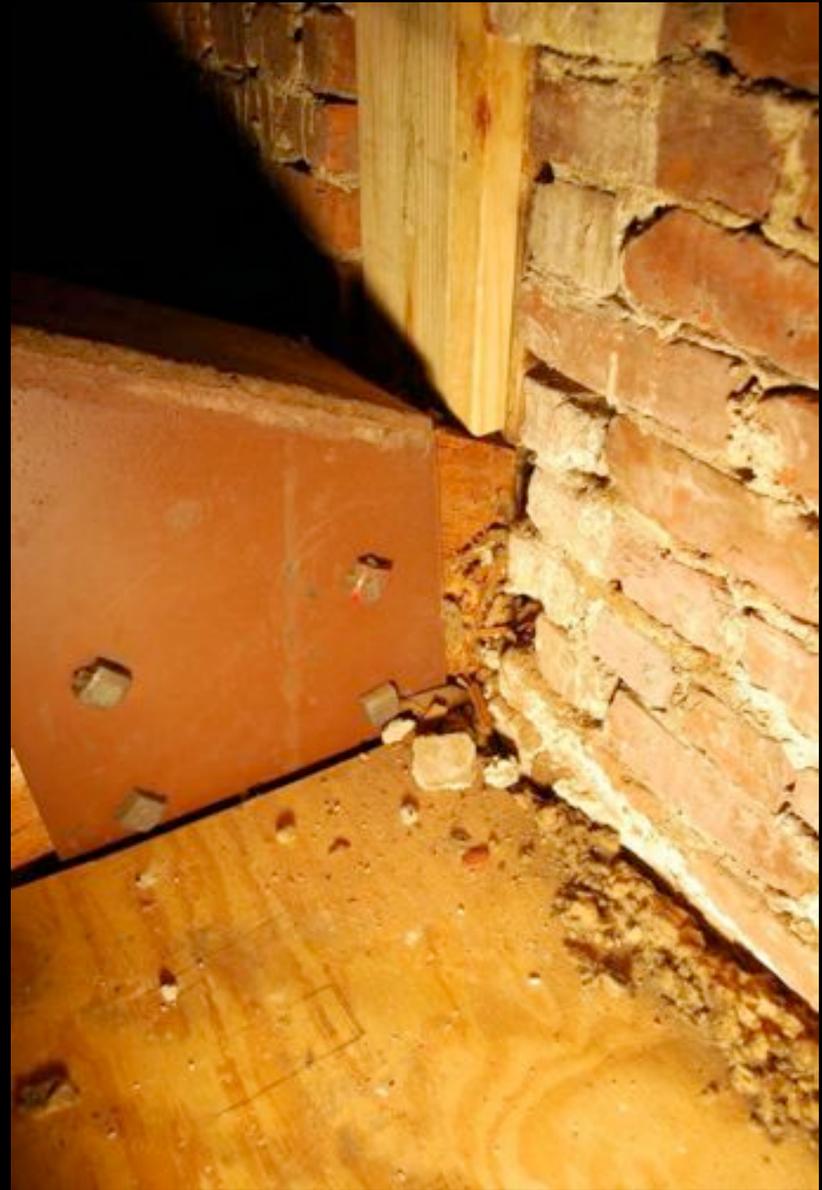
Sealed Truss Ends

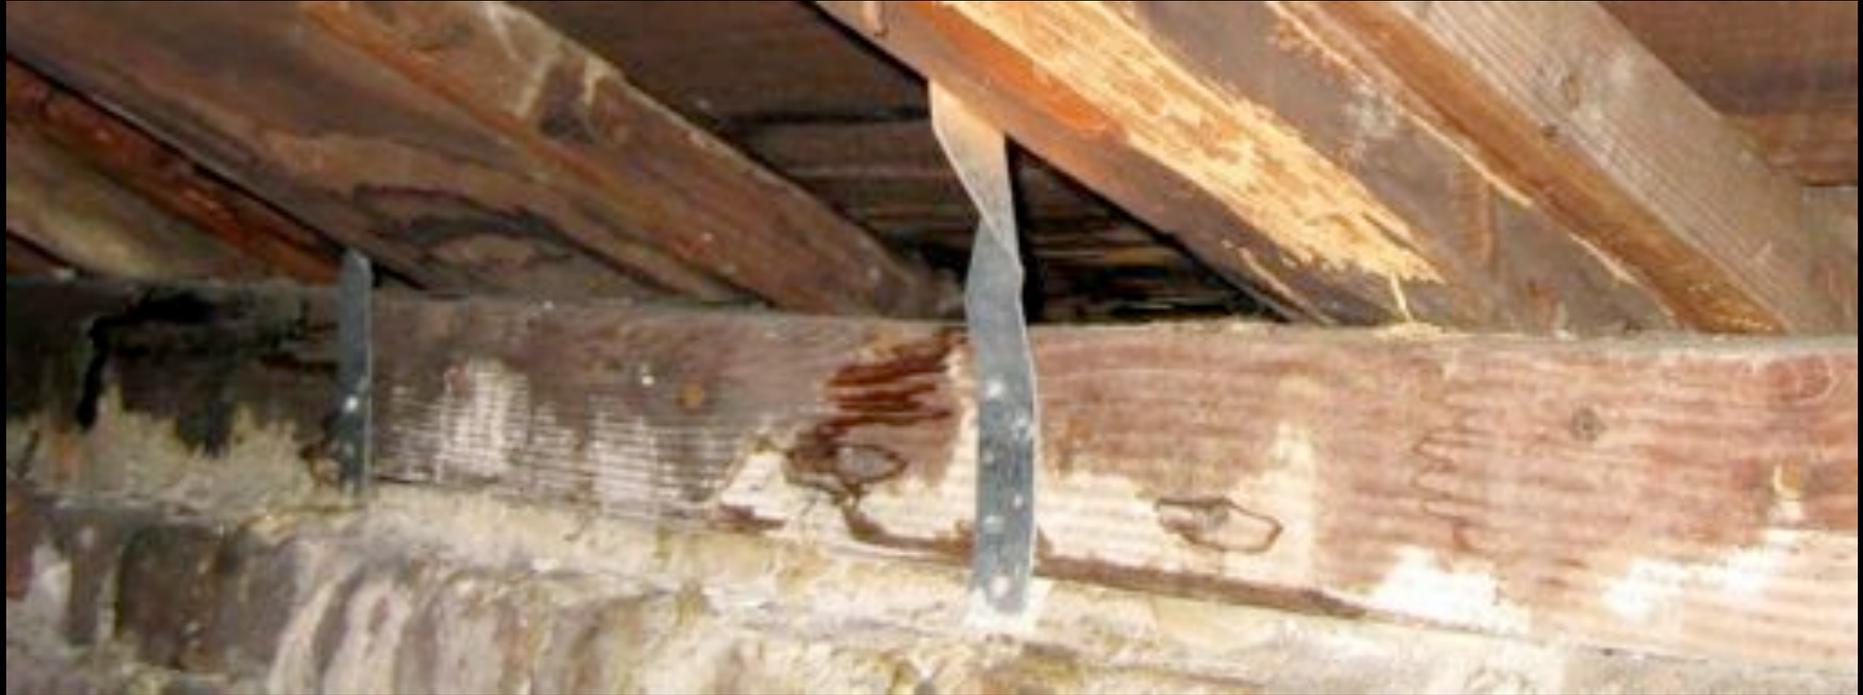
Signs of Water Infiltration

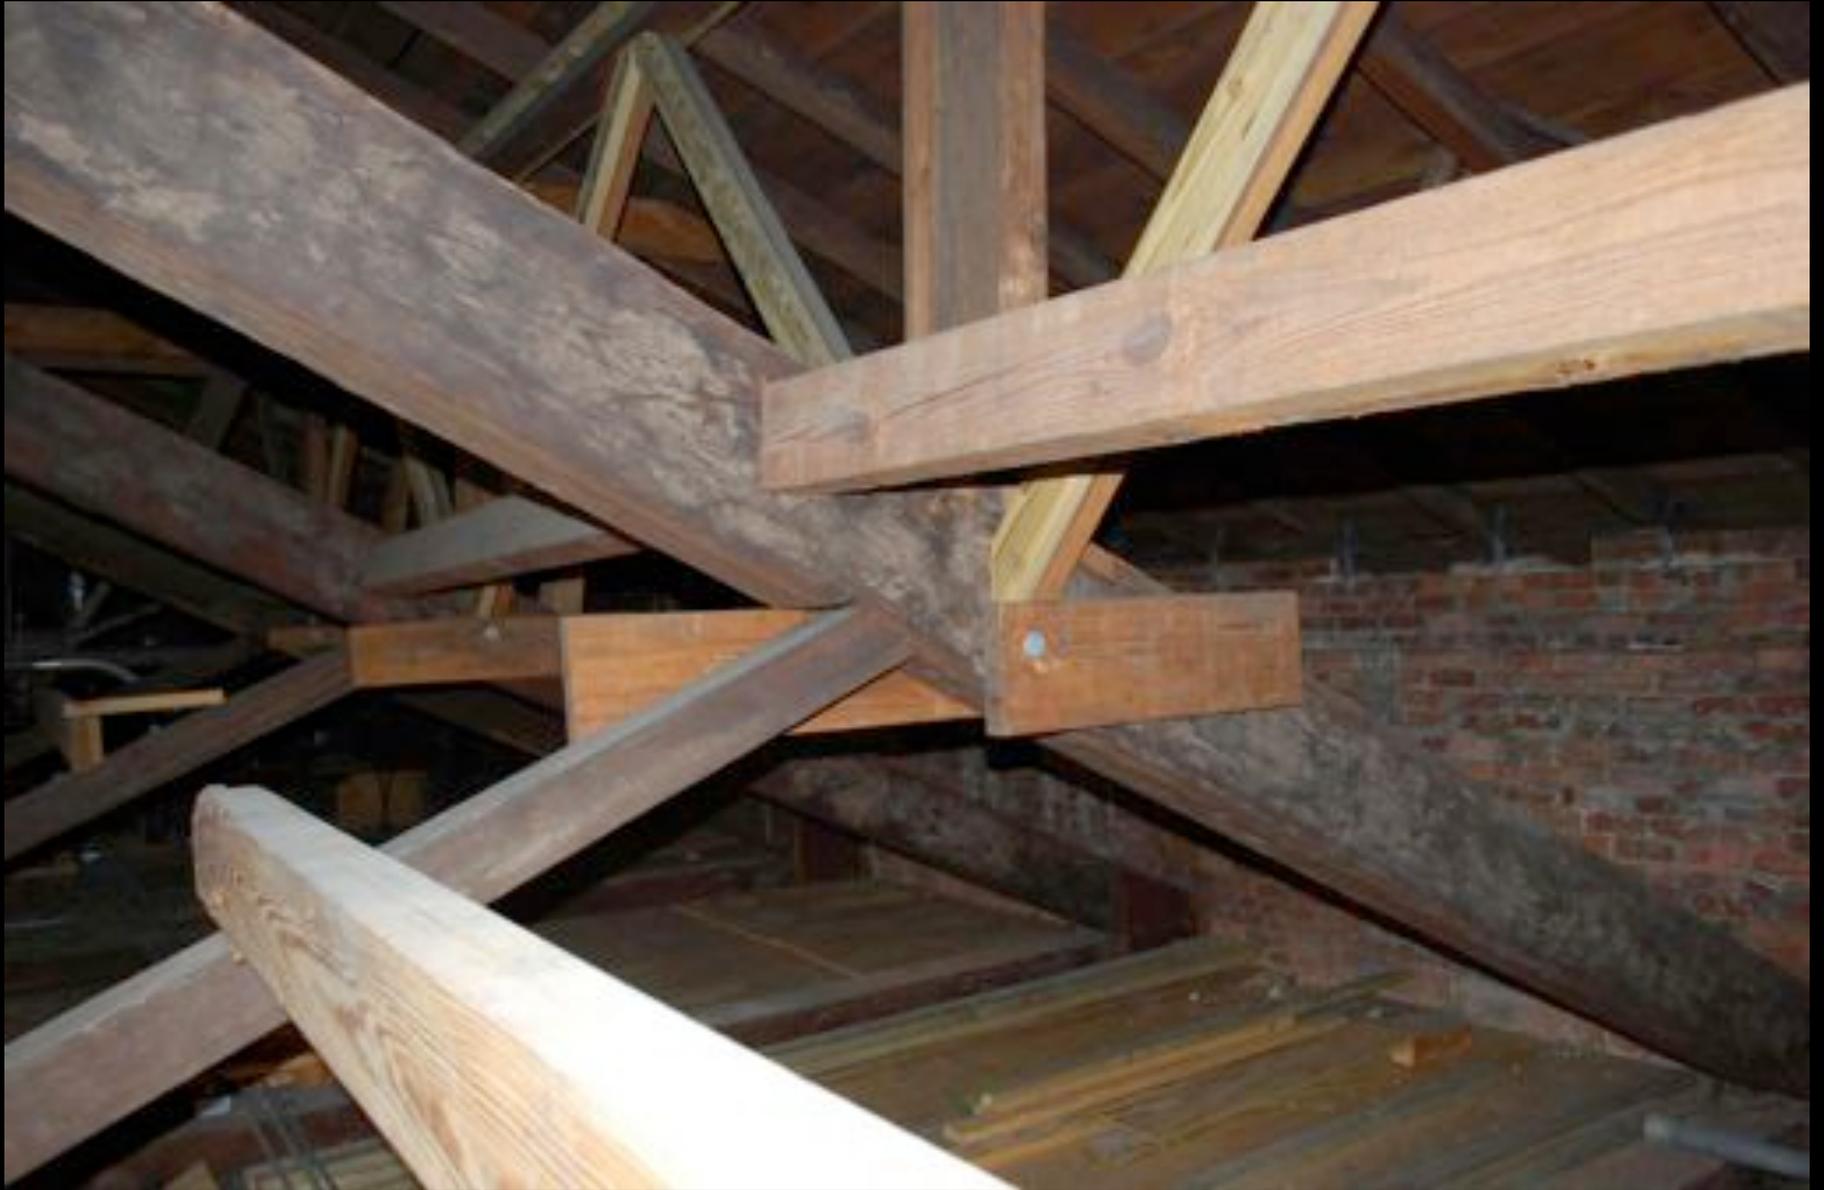
Signs of Water Infiltration

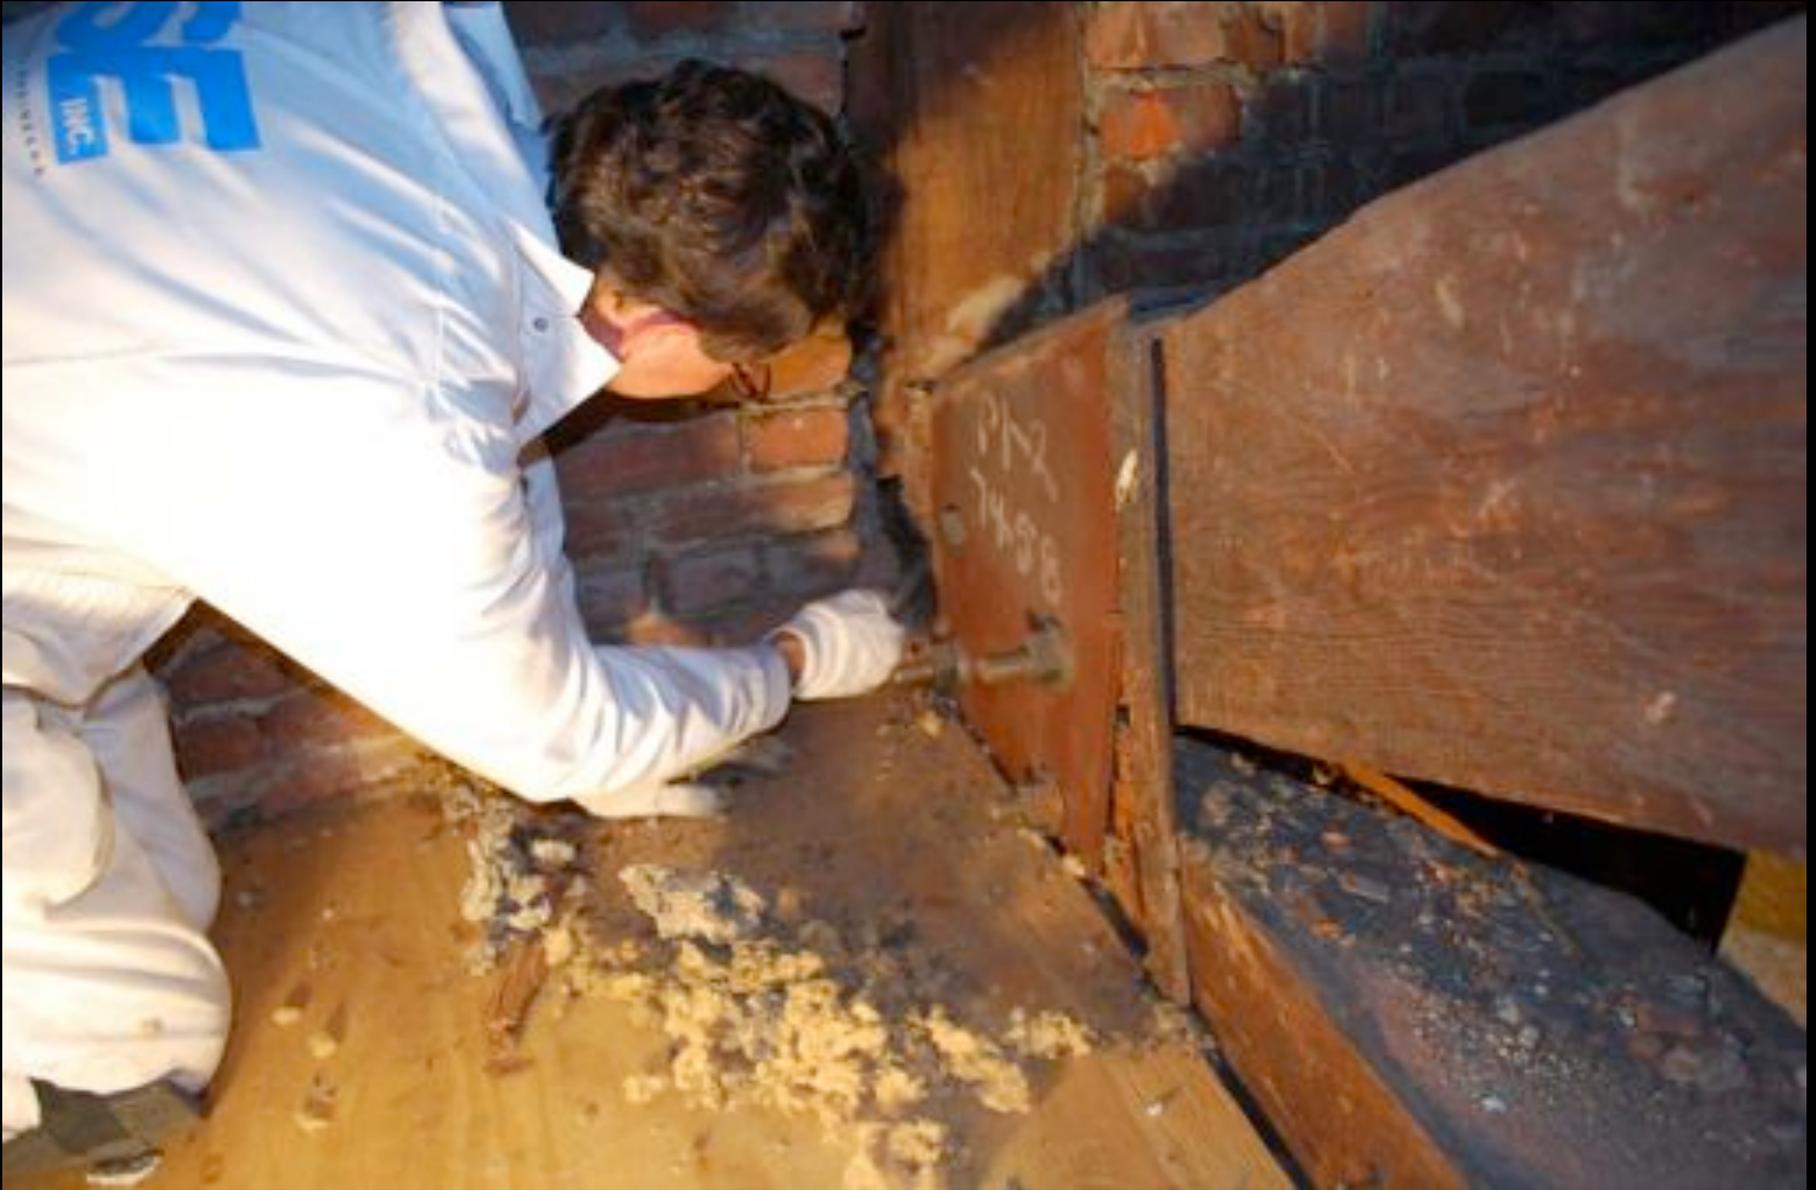
Investigation of Damage and Deterioration of Trusses
