The Forces that Destroy Historic Structures

The SC Historic Preservation Conference

Craig M. Bennett, Jr., PE

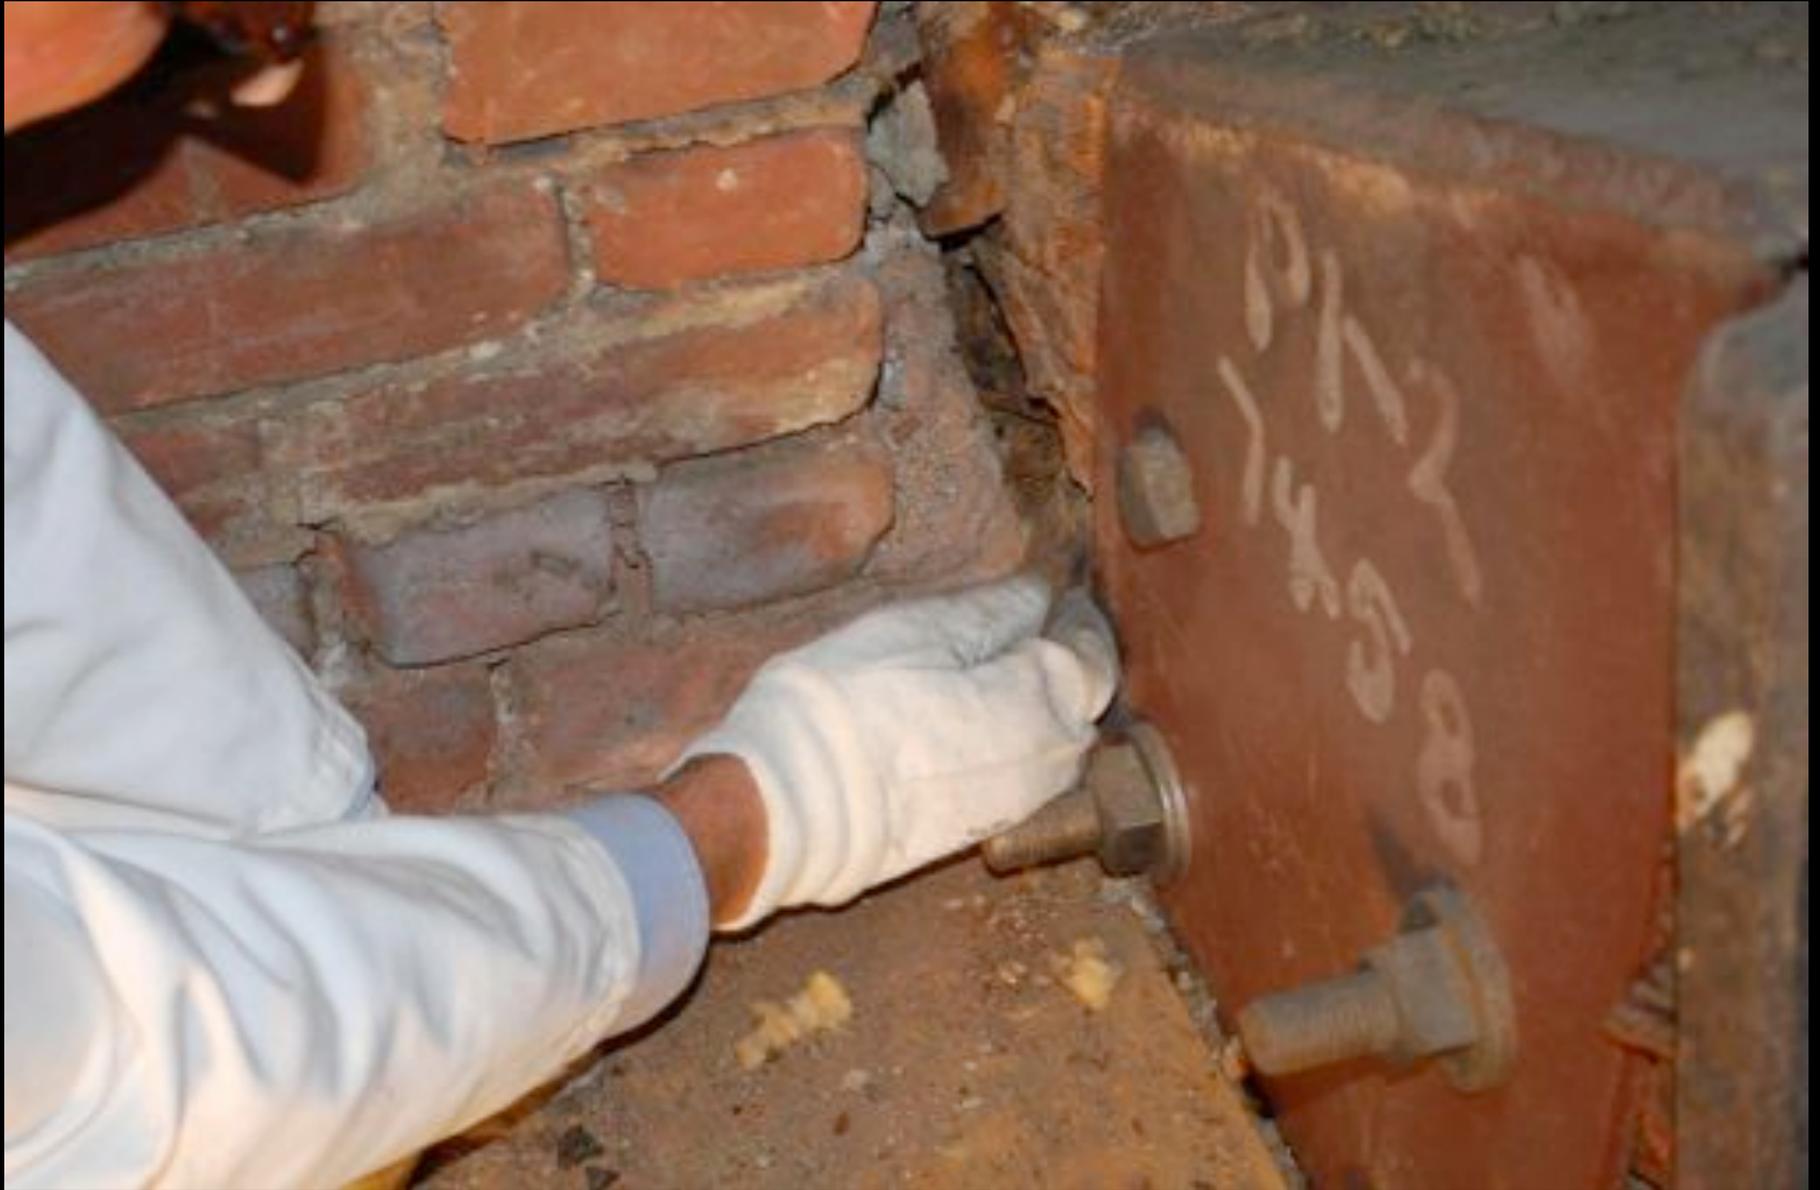
Investigation of Damage and Deterioration of Trusses

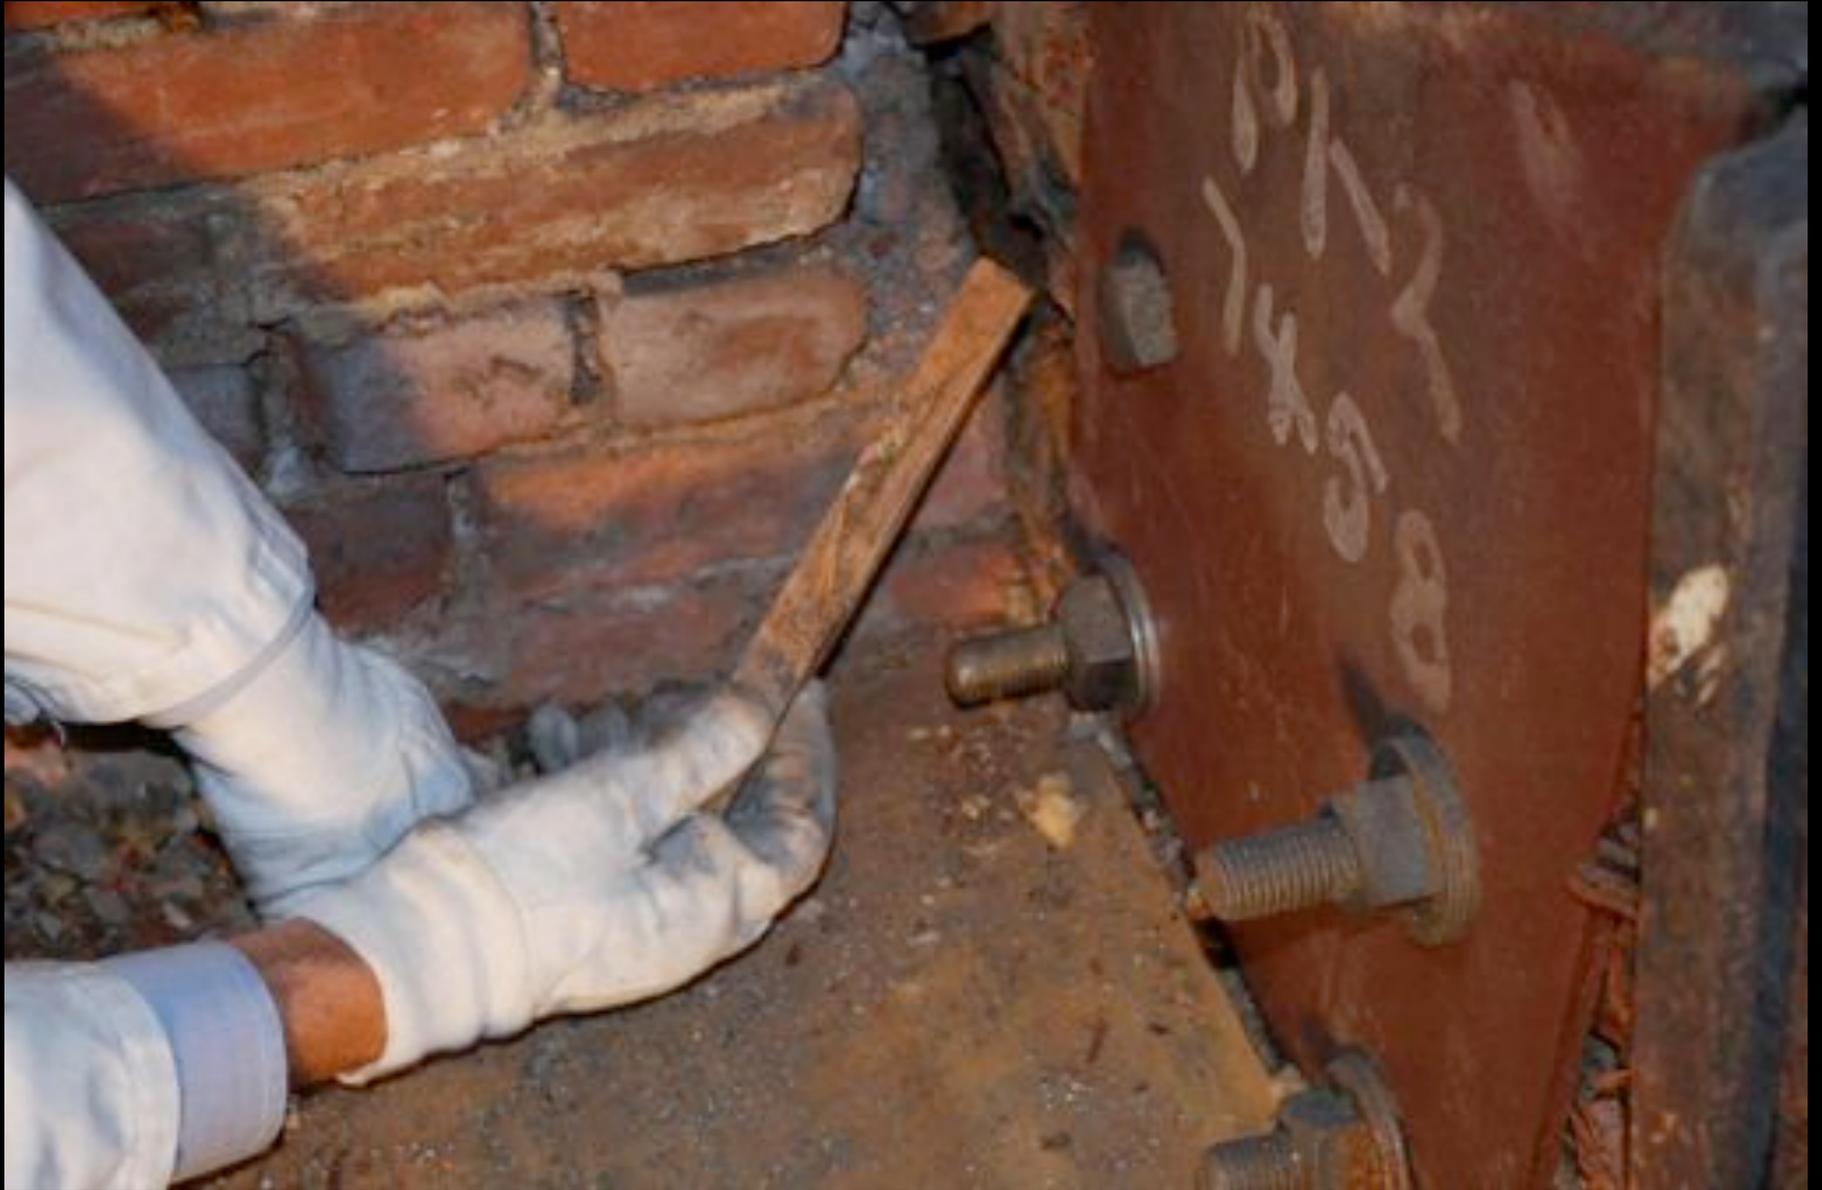
Investigation of Damage and Deterioration of Trusses

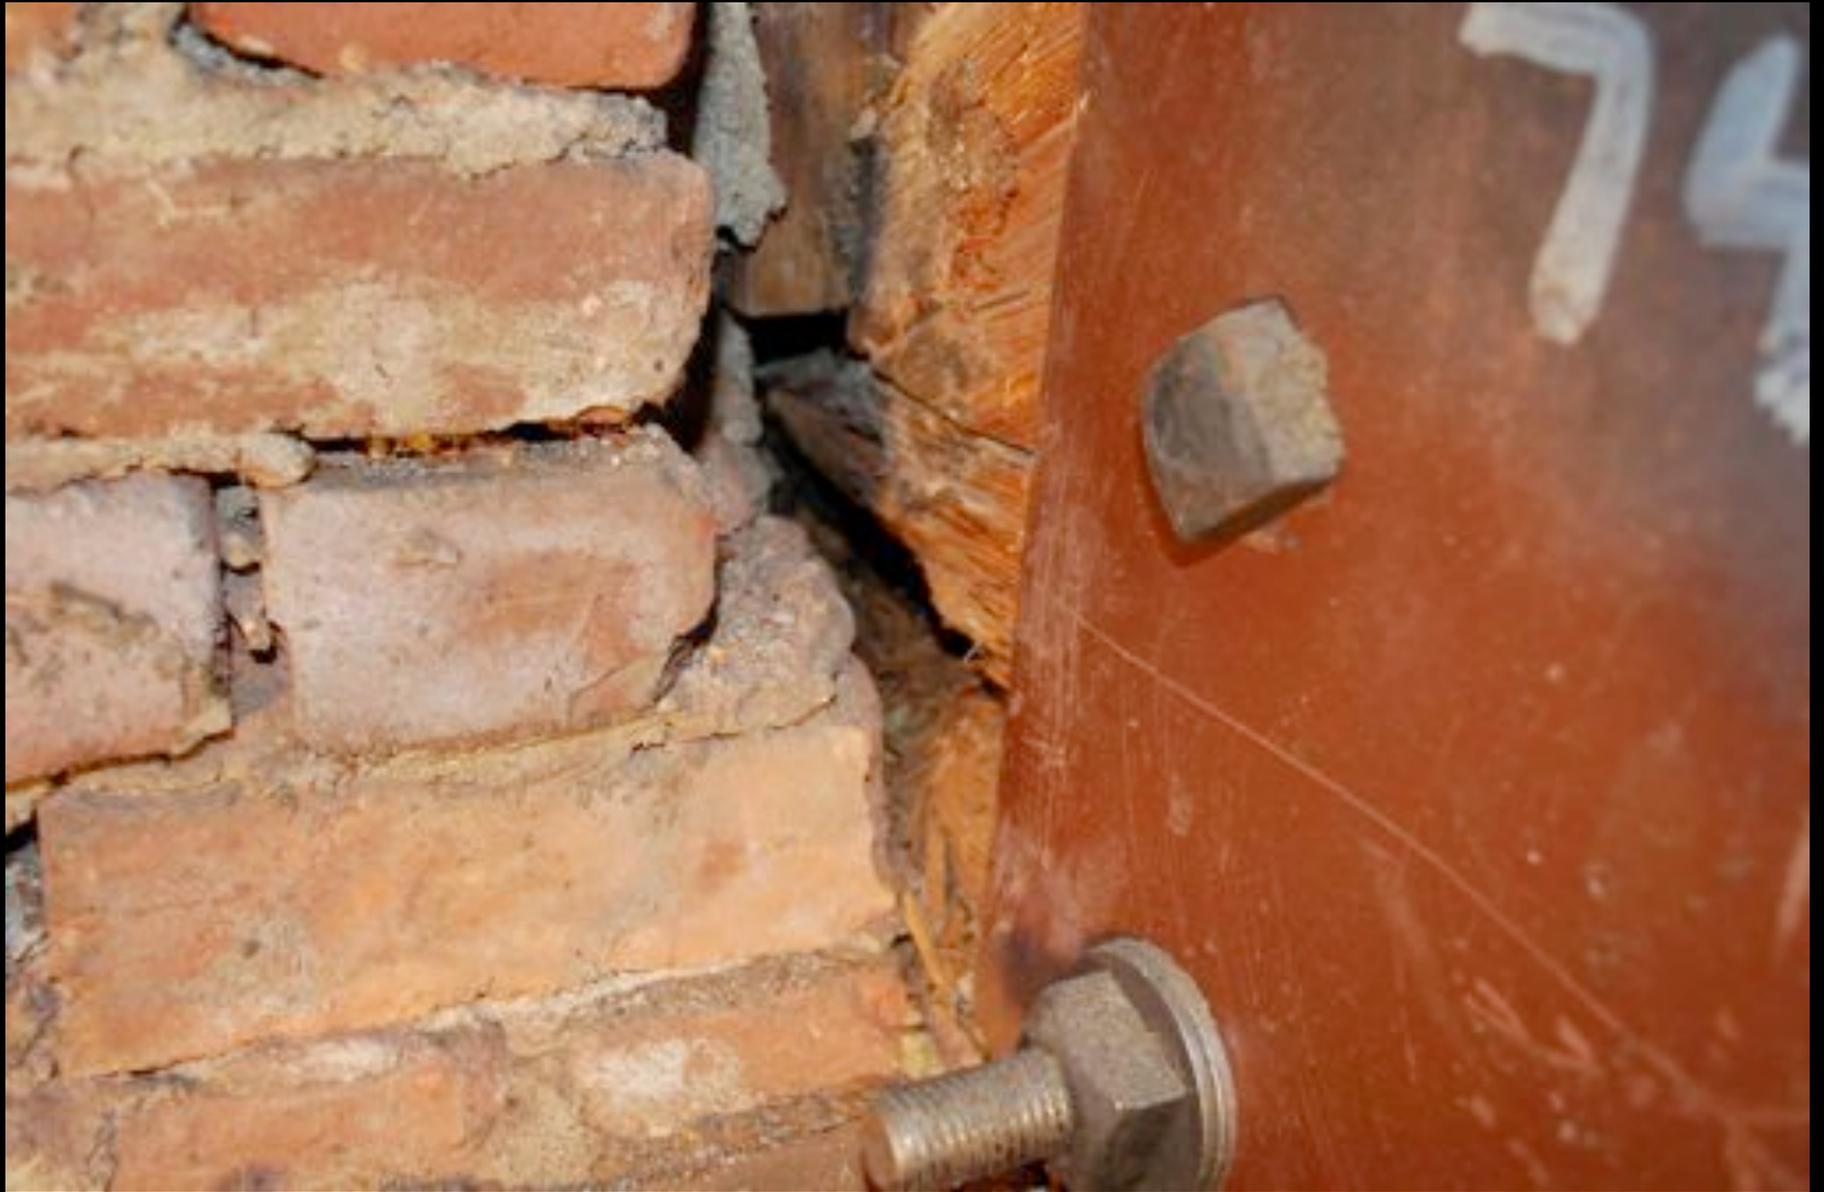
Deterioration: Truss Ends

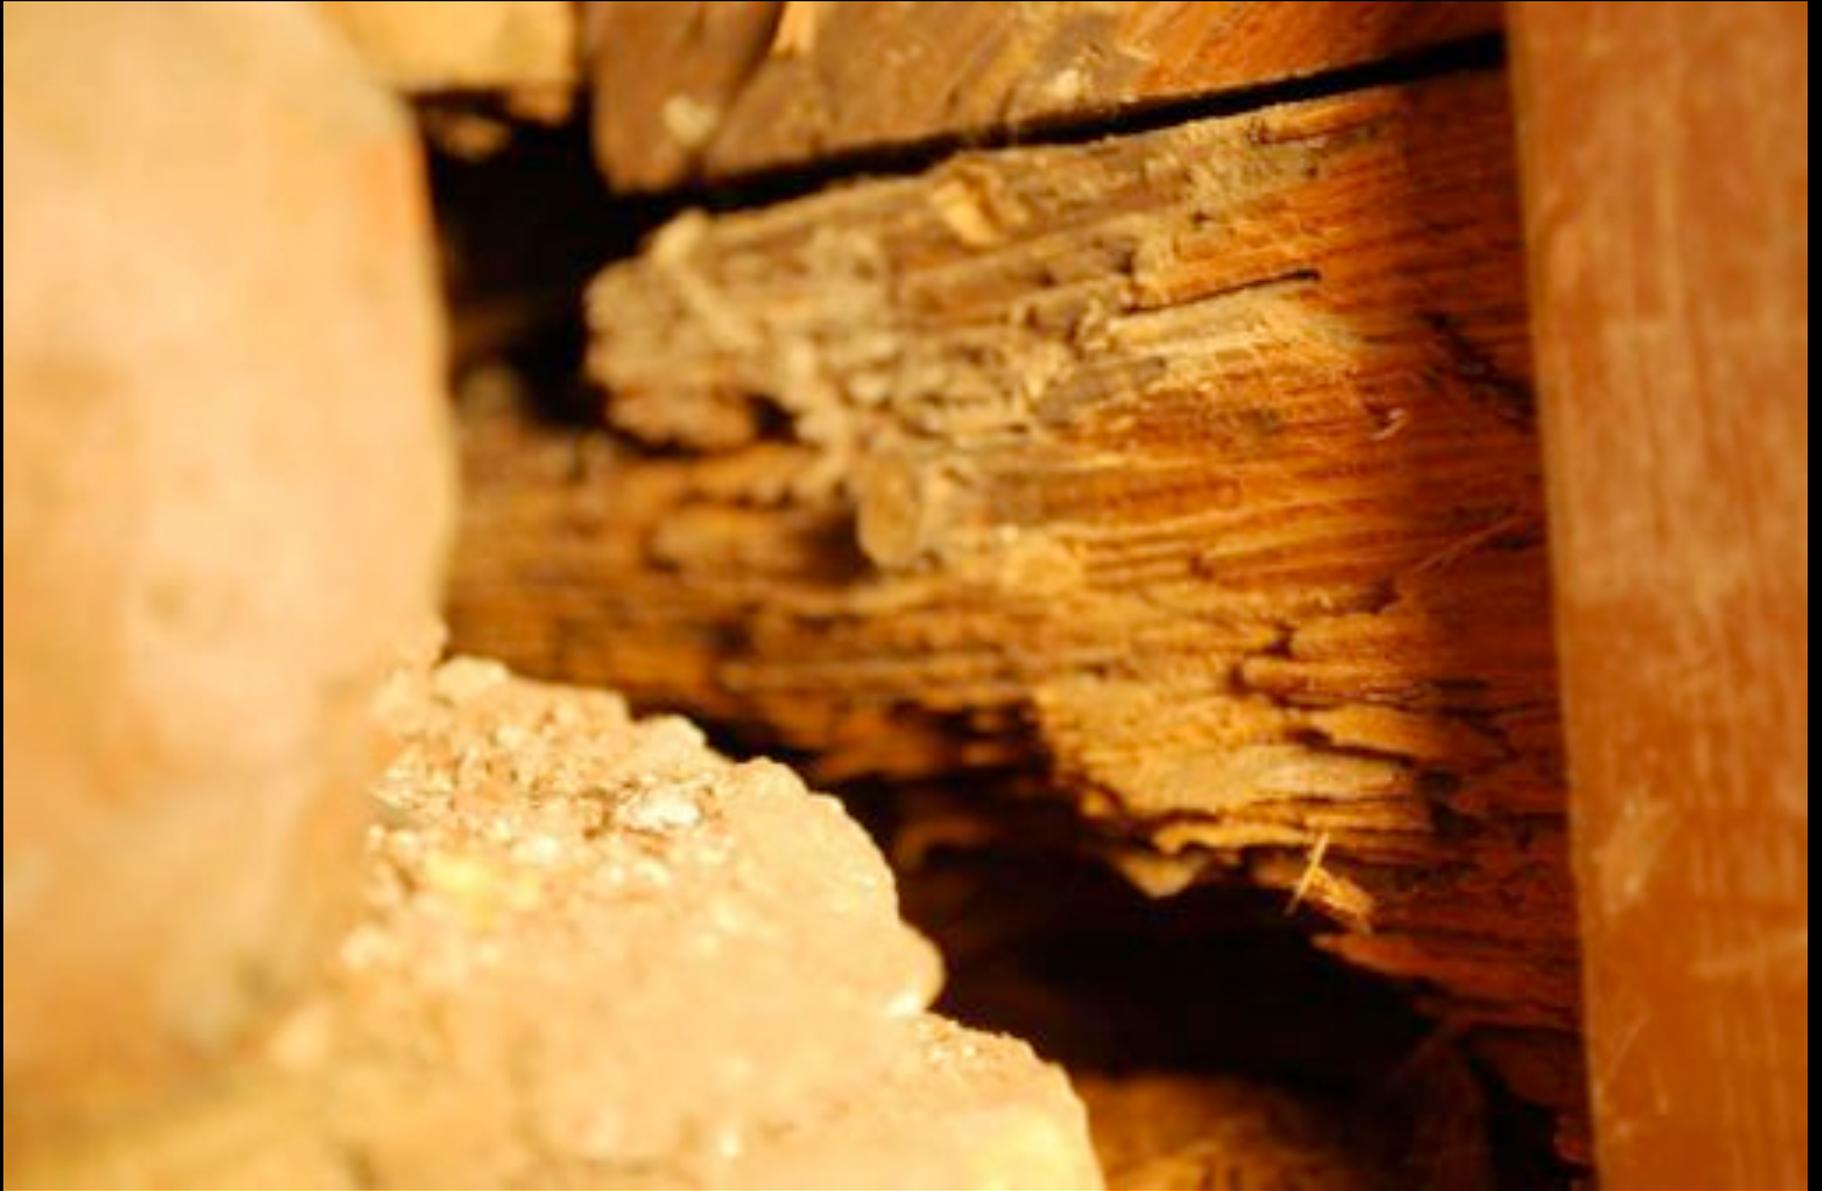
Deterioration: Truss Ends

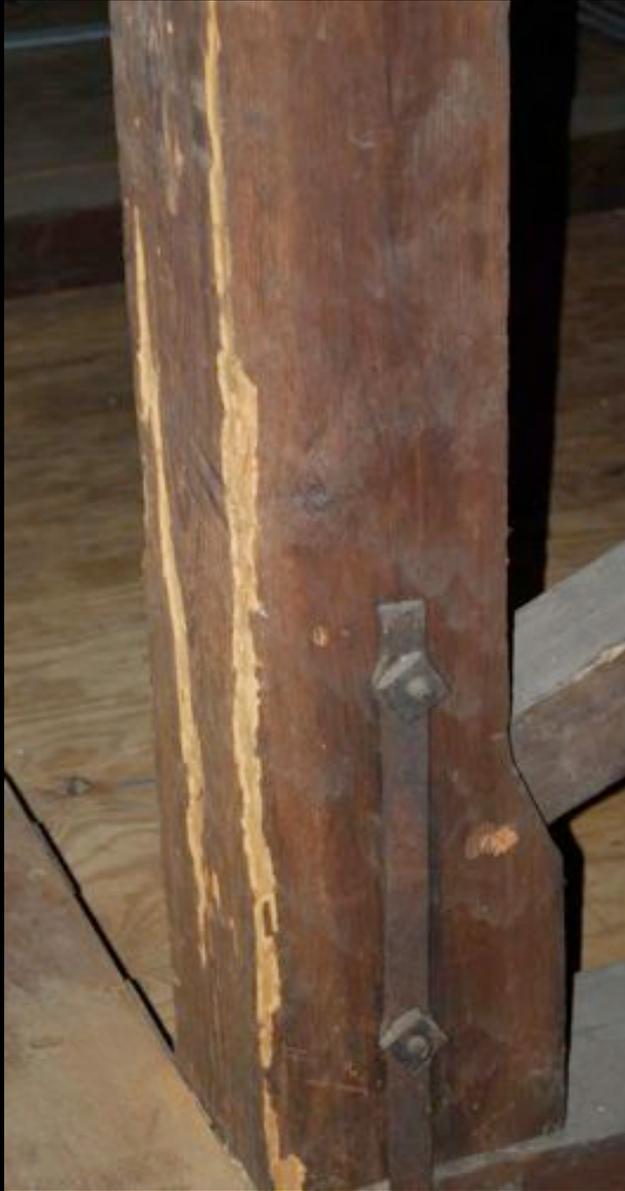
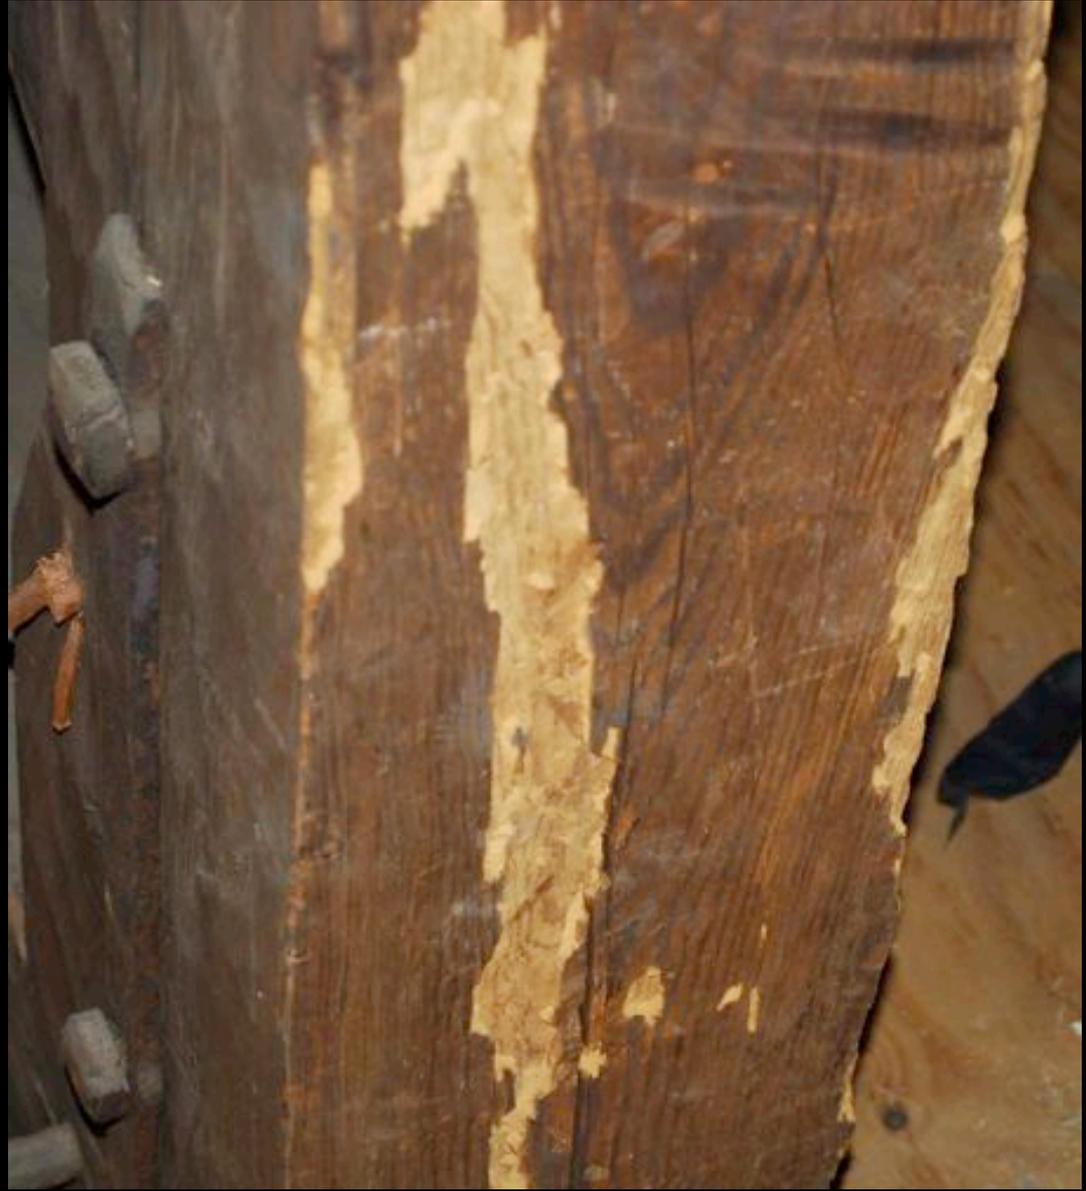
Termite Damage

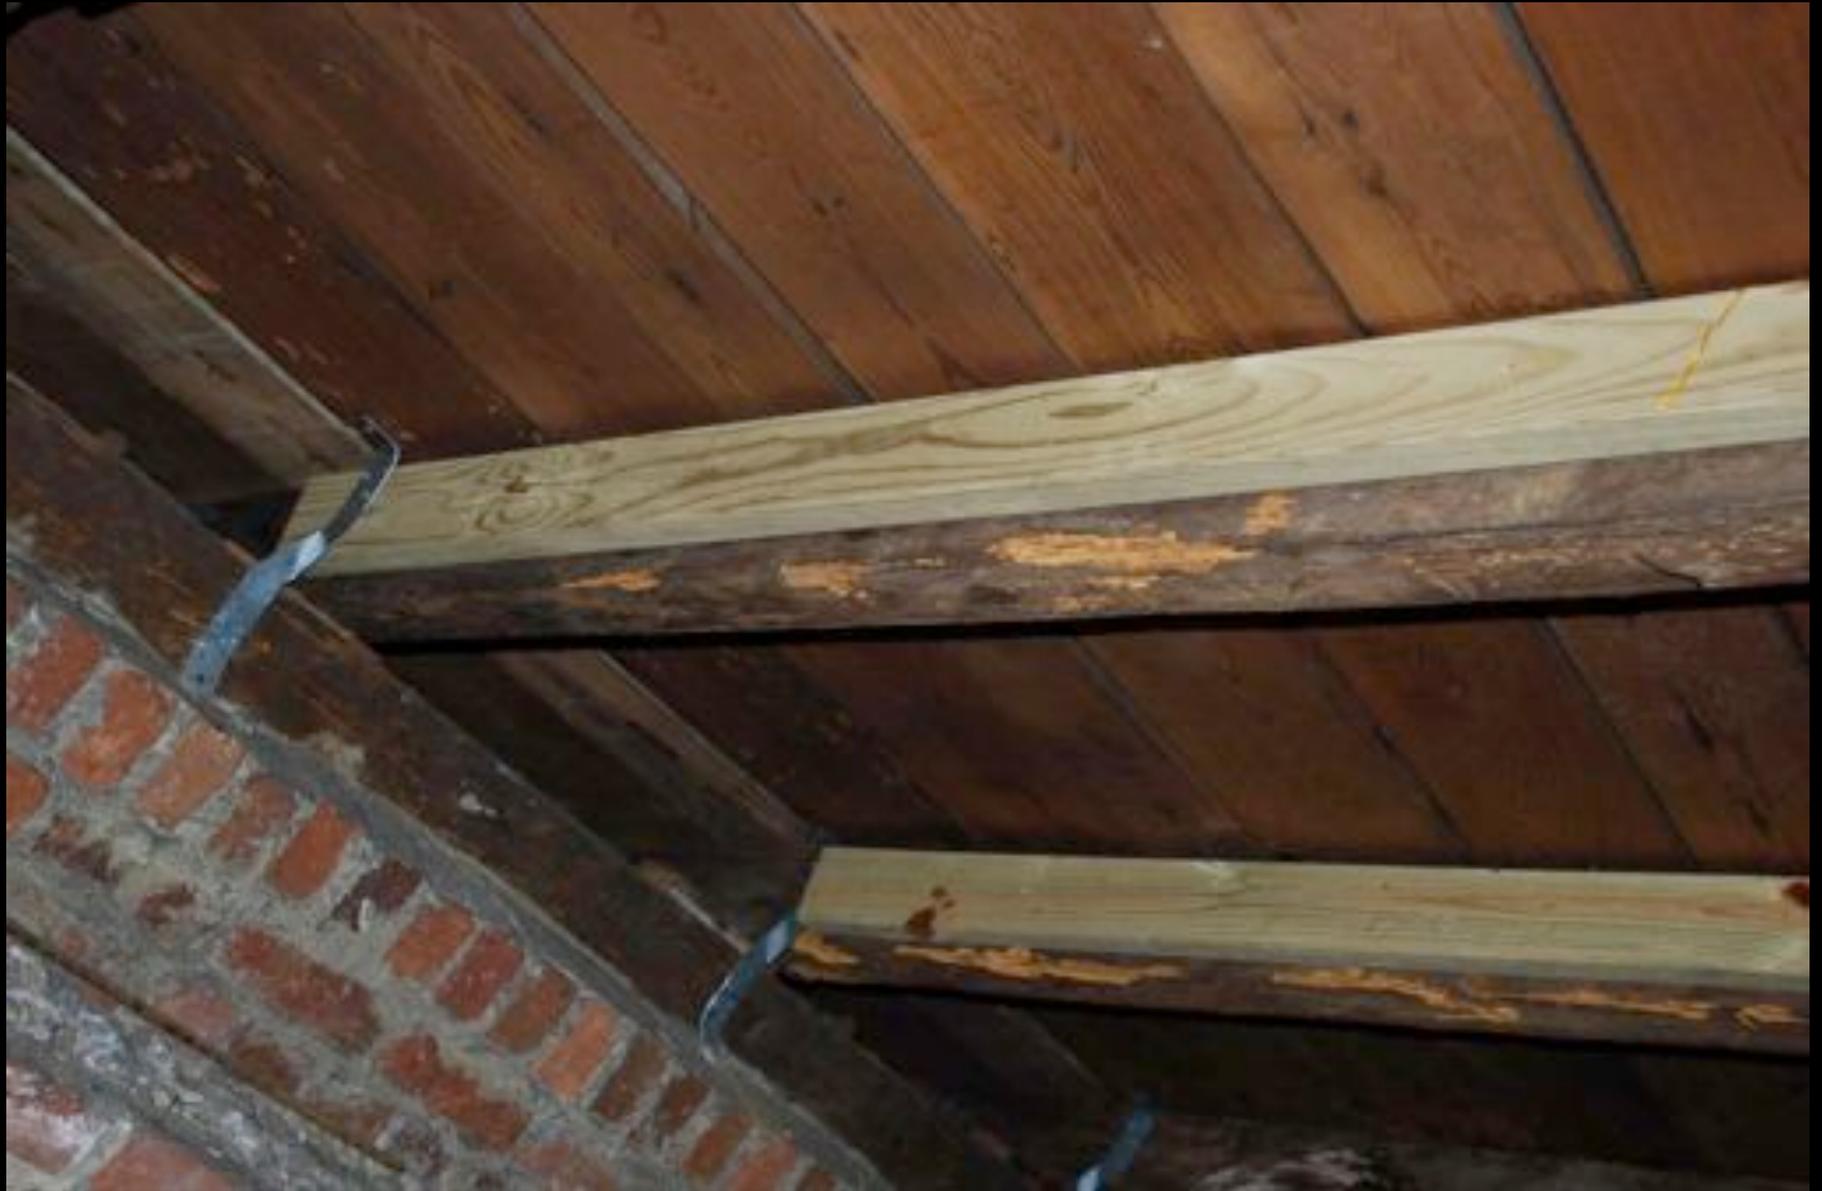
Termite Damage

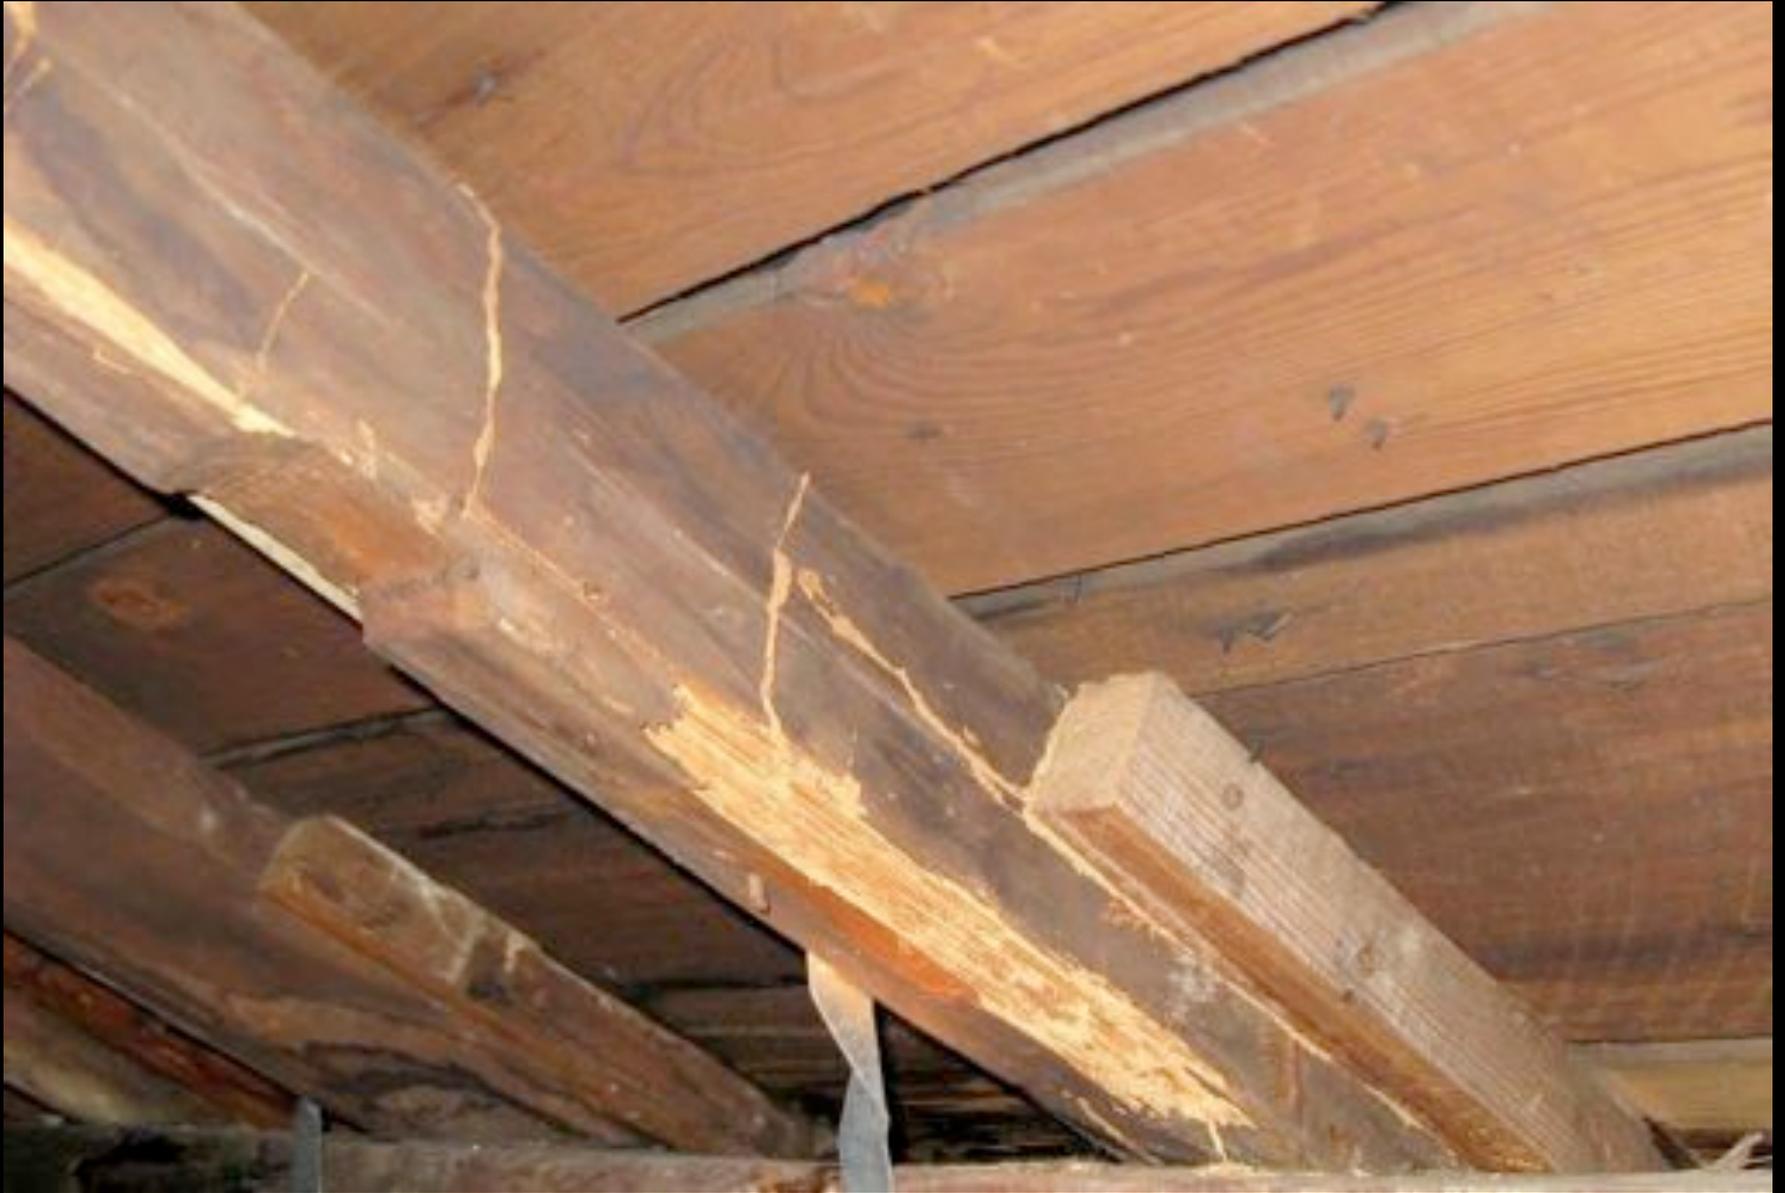
Termite Damage

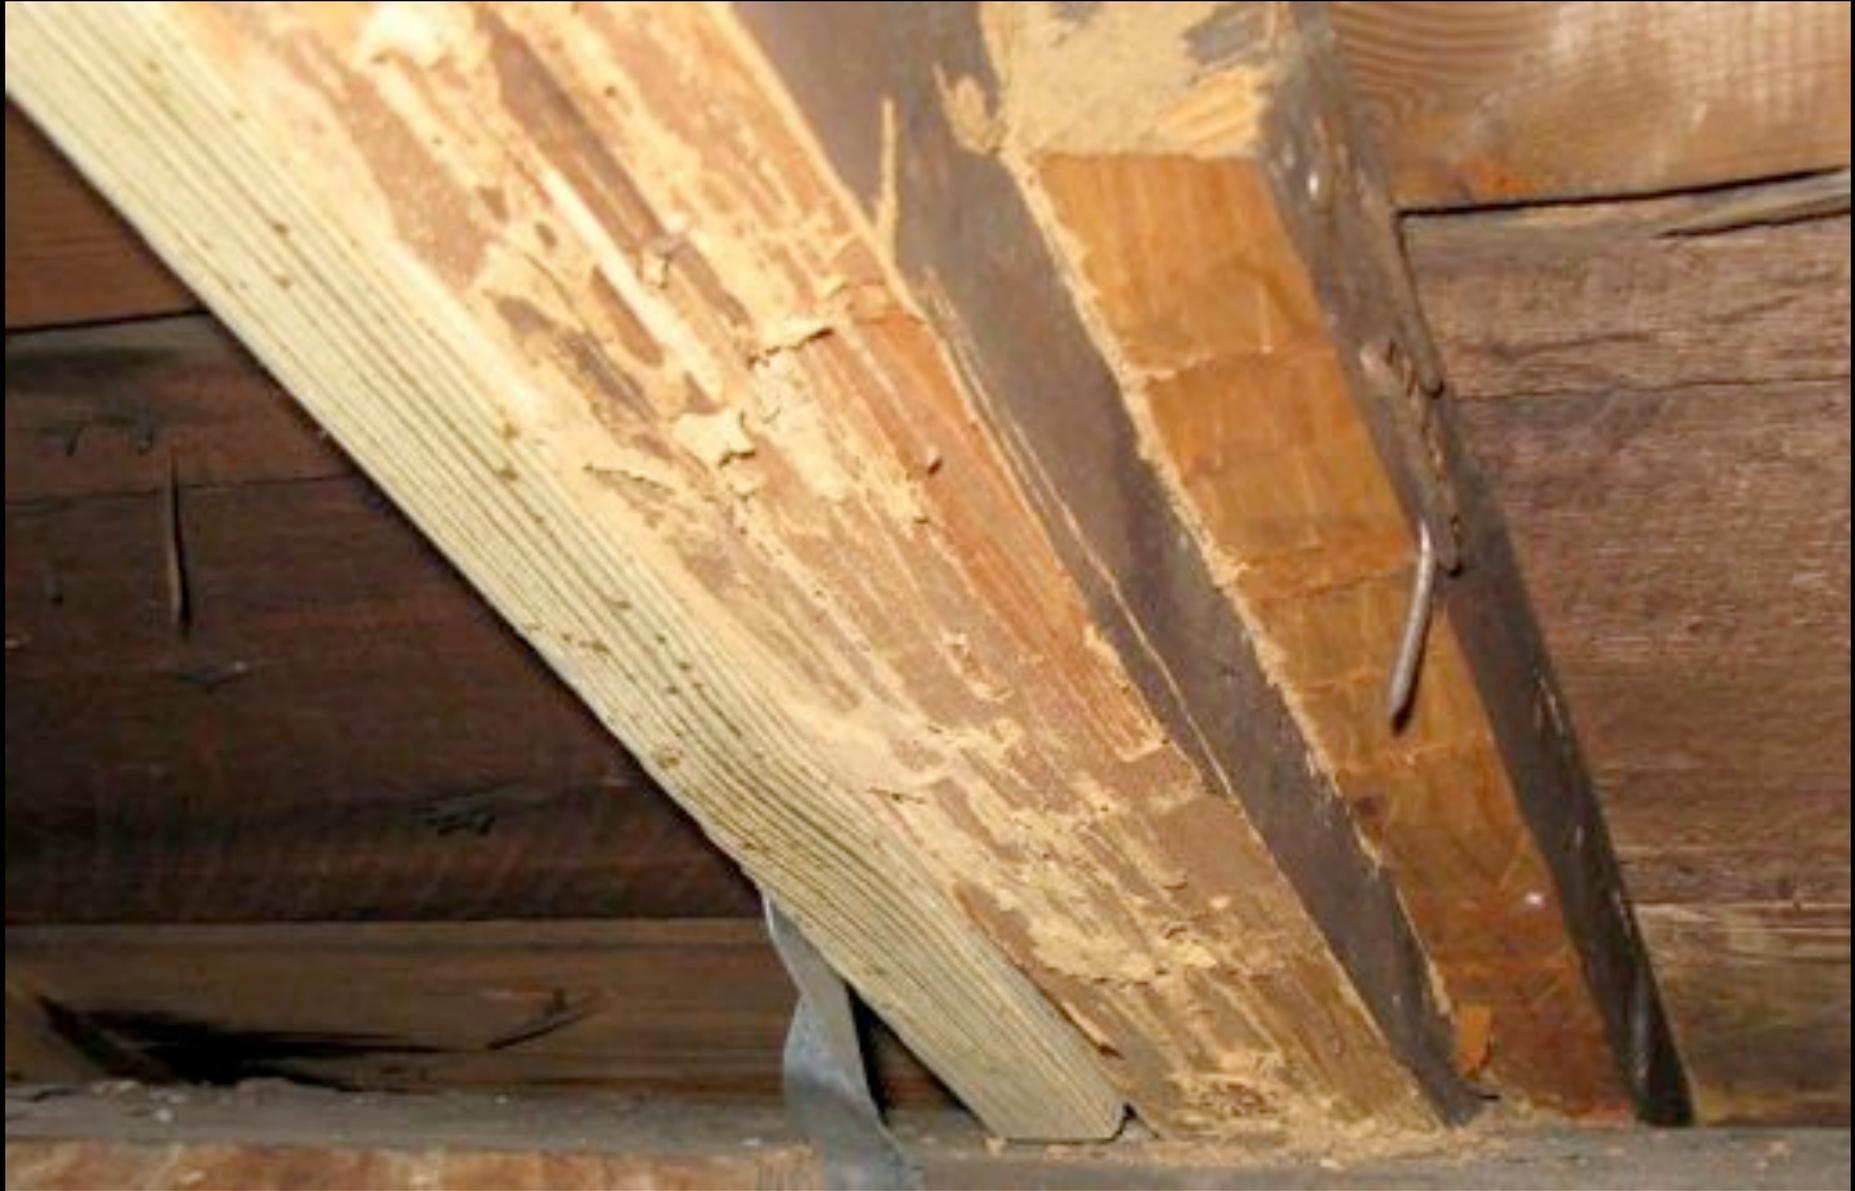
Termite Damage

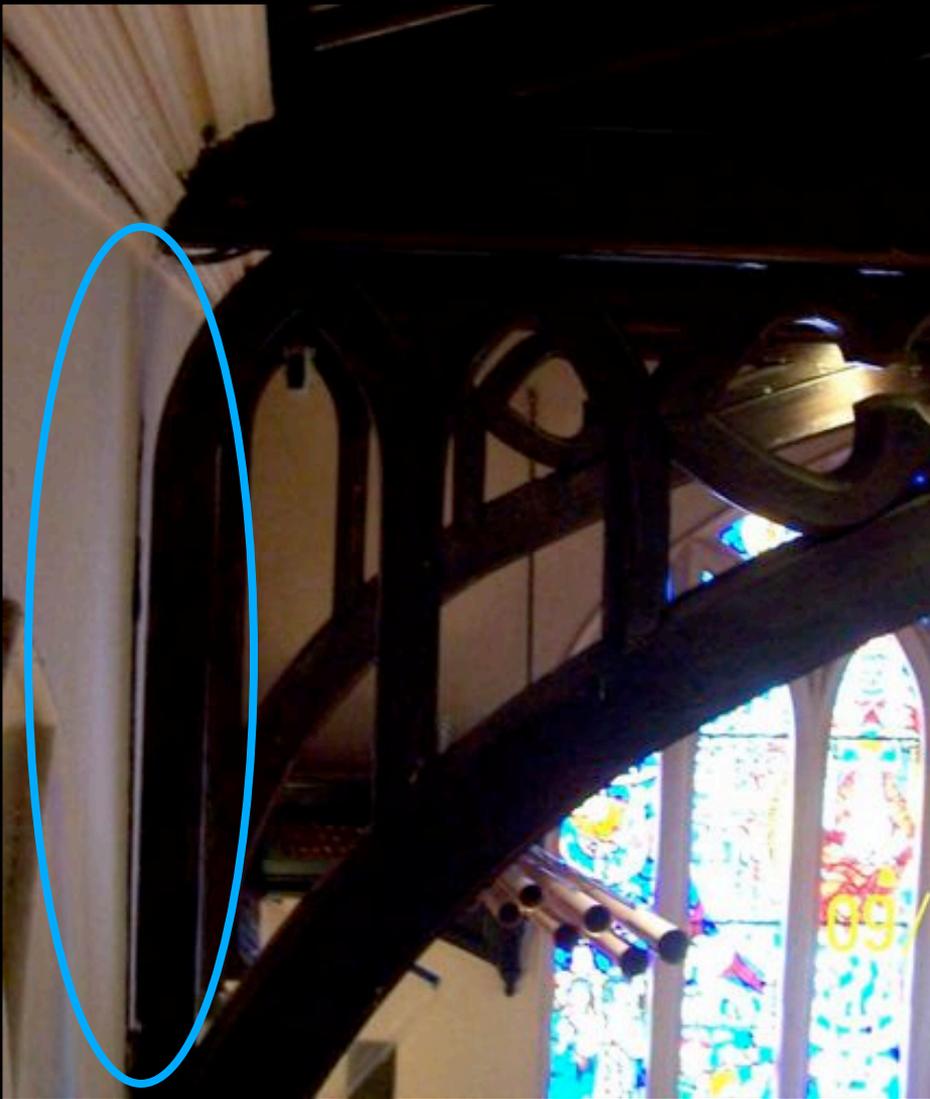
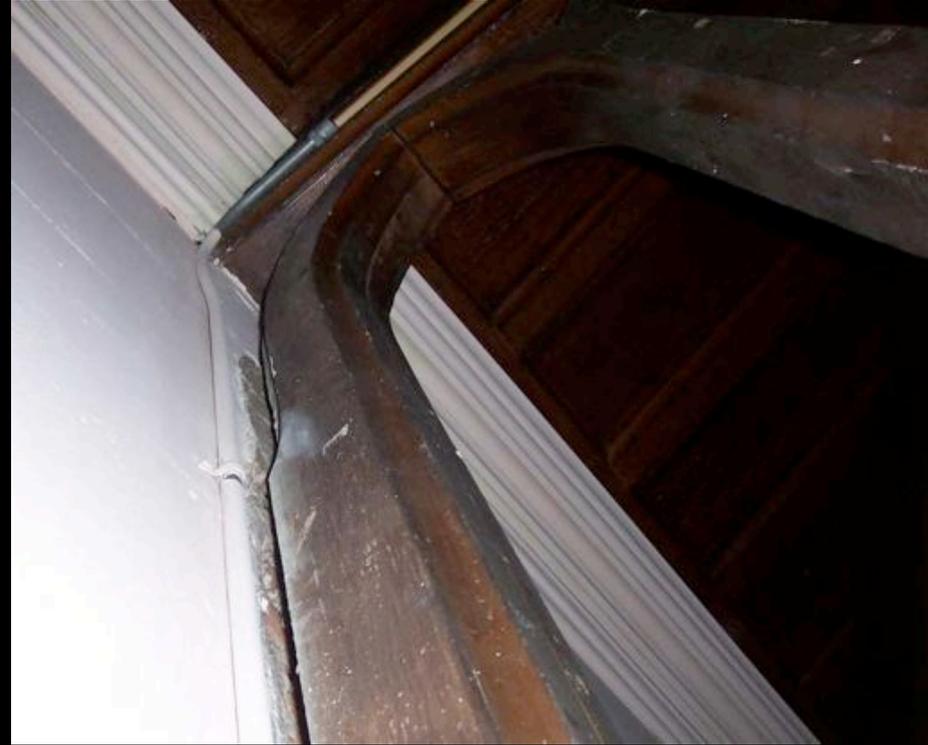
- Plaster deterioration due to water infiltration
- Separation of trusses from walls

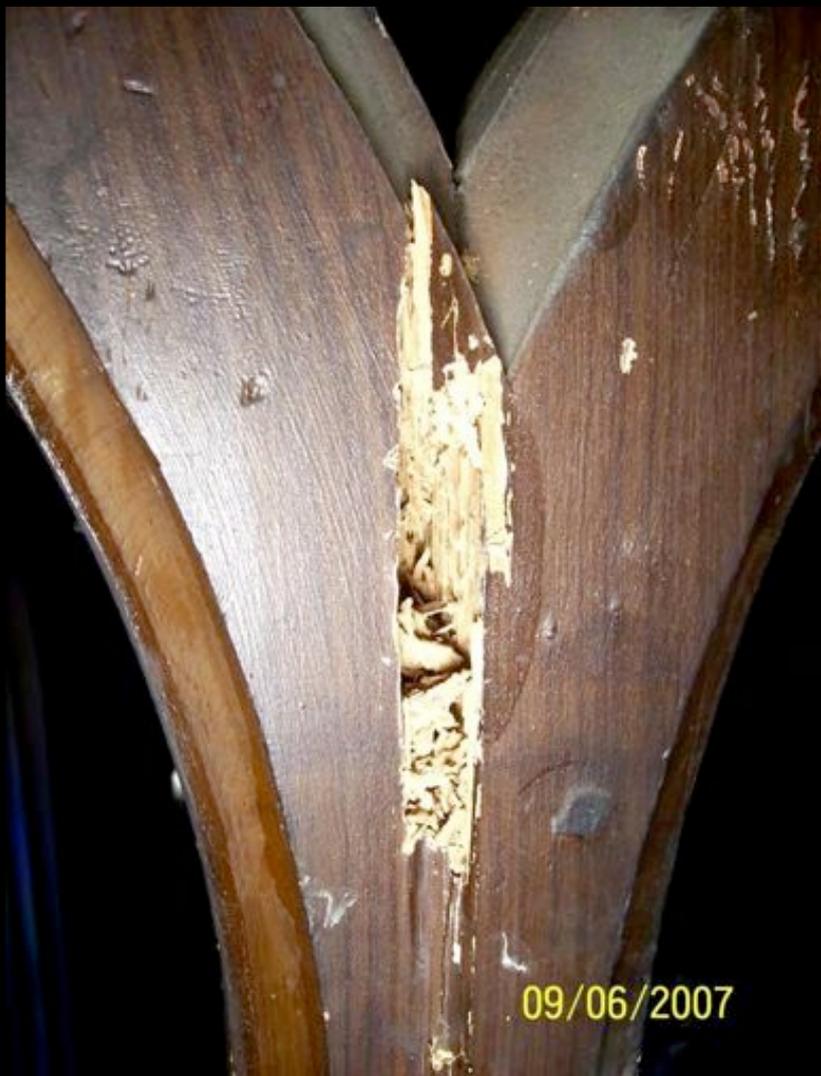
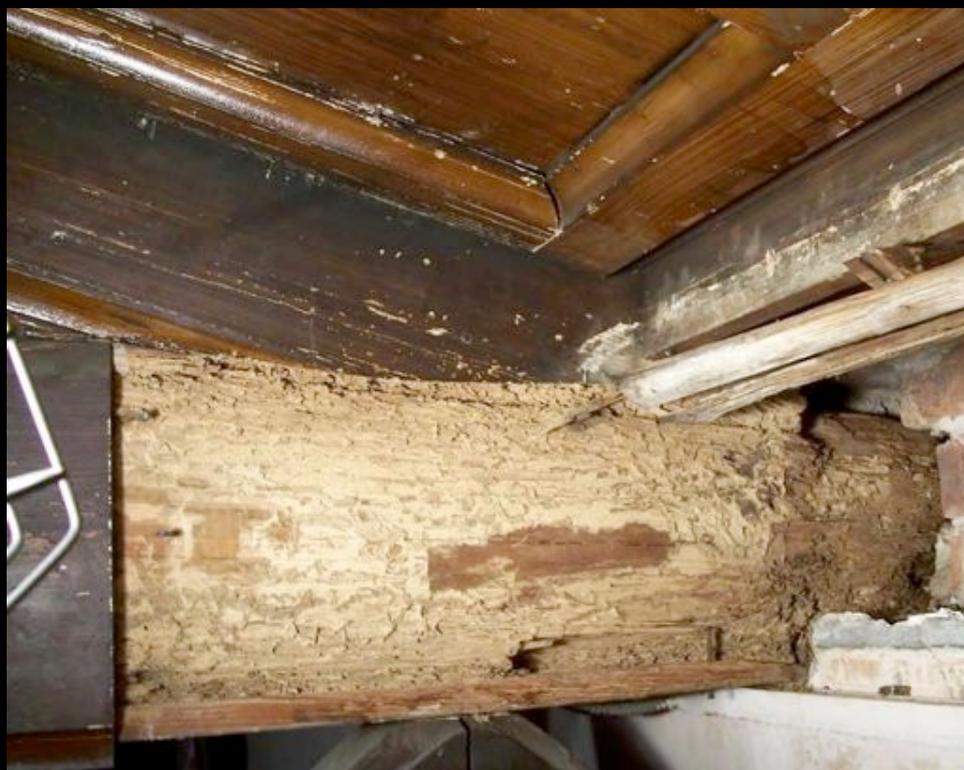
Termite Damage

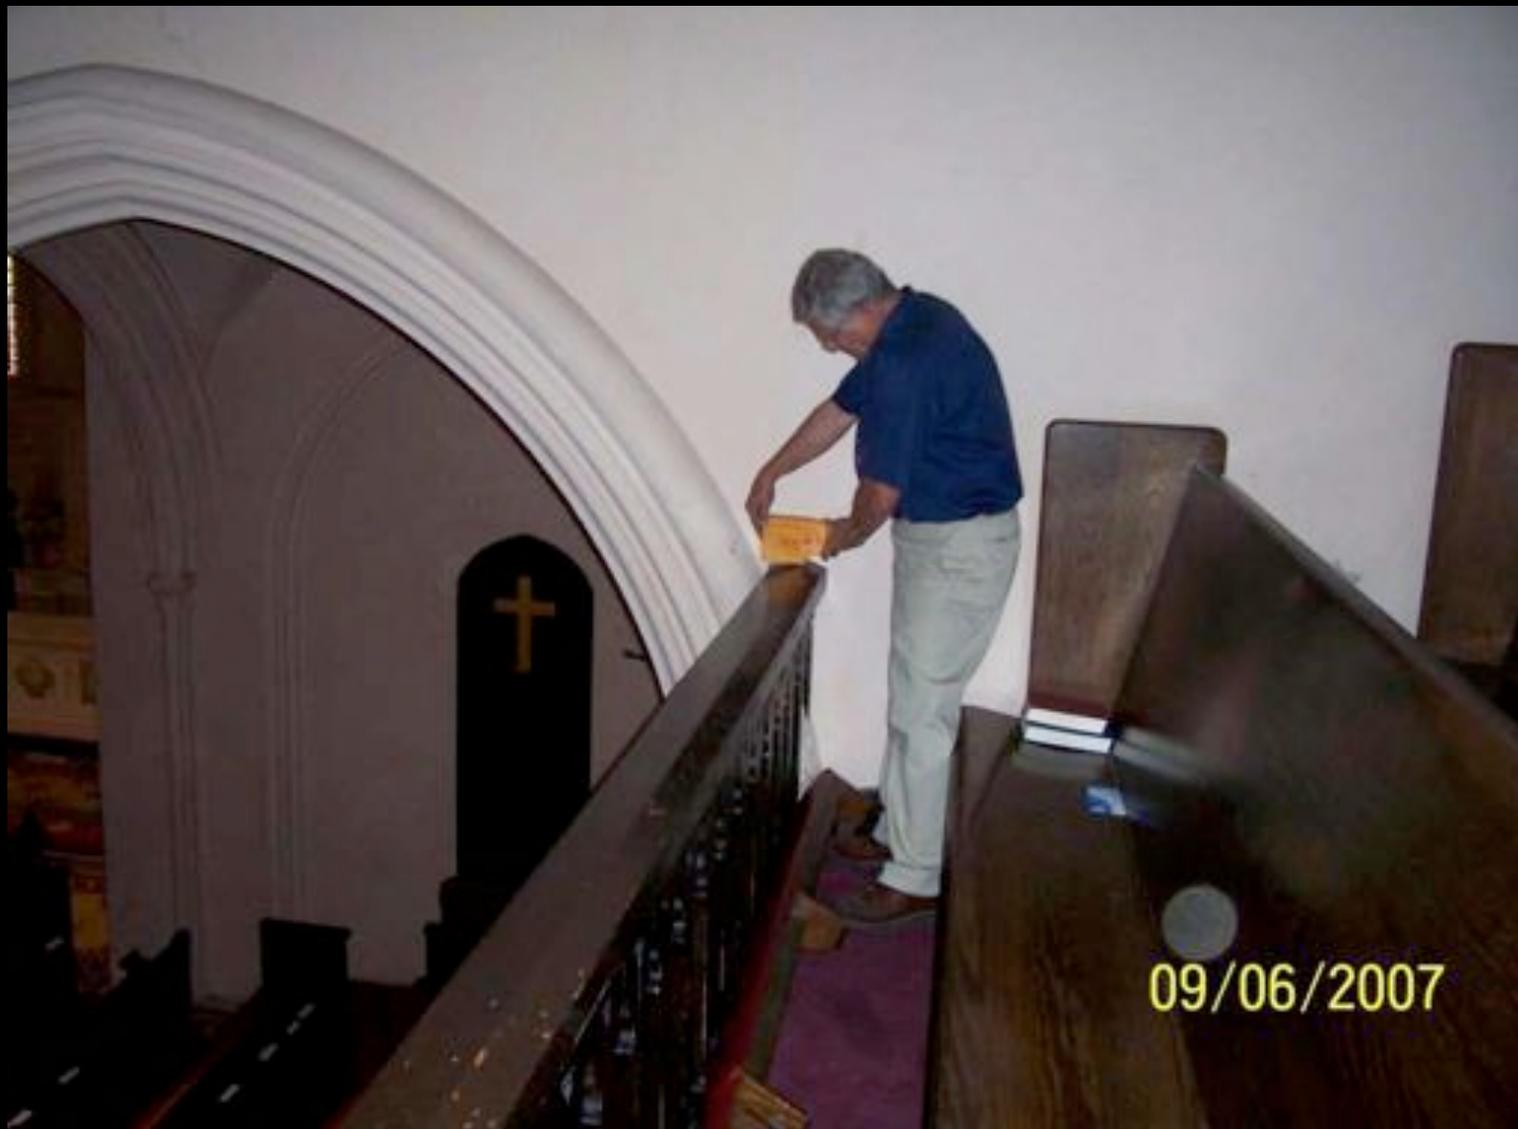
Sagging of front rail of balcony

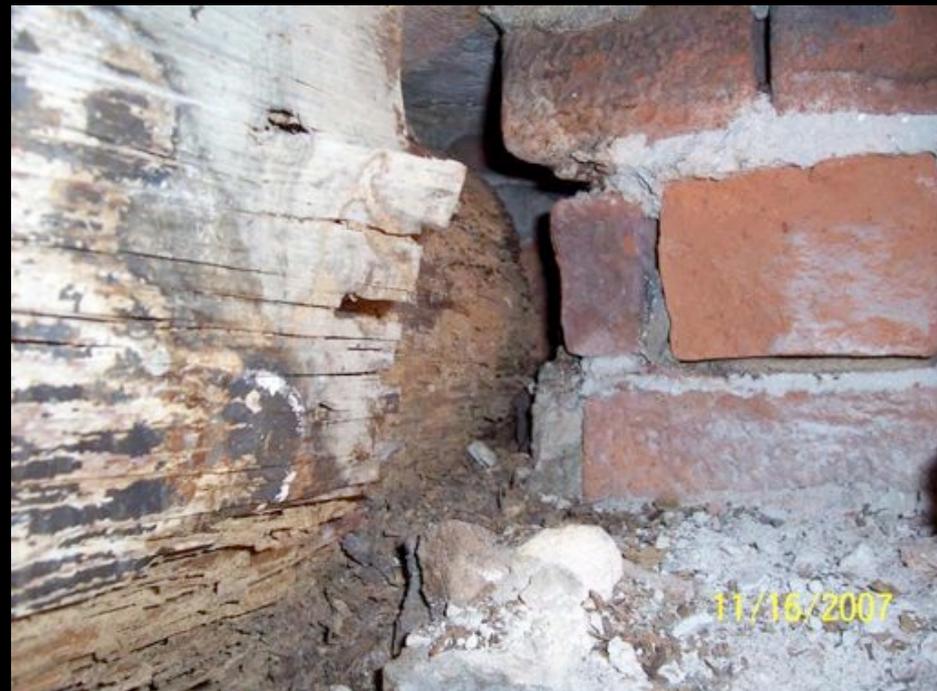
Severe wood deterioration of trusses at masonry pockets
