The Forces that Destroy Historic Structures

The SC Historic Preservation Conference

Craig M. Bennett, Jr., PE

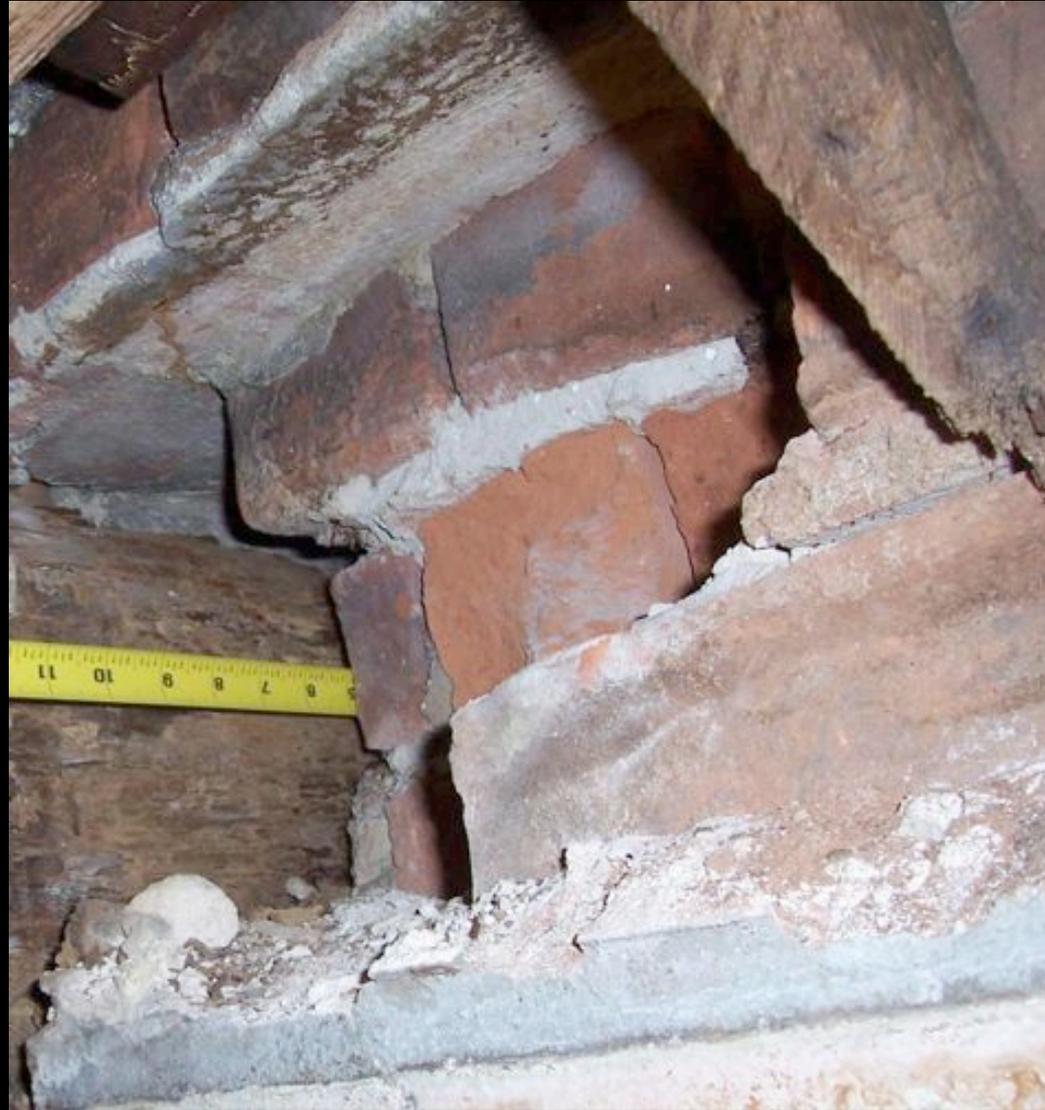
Damage to masonry pockets

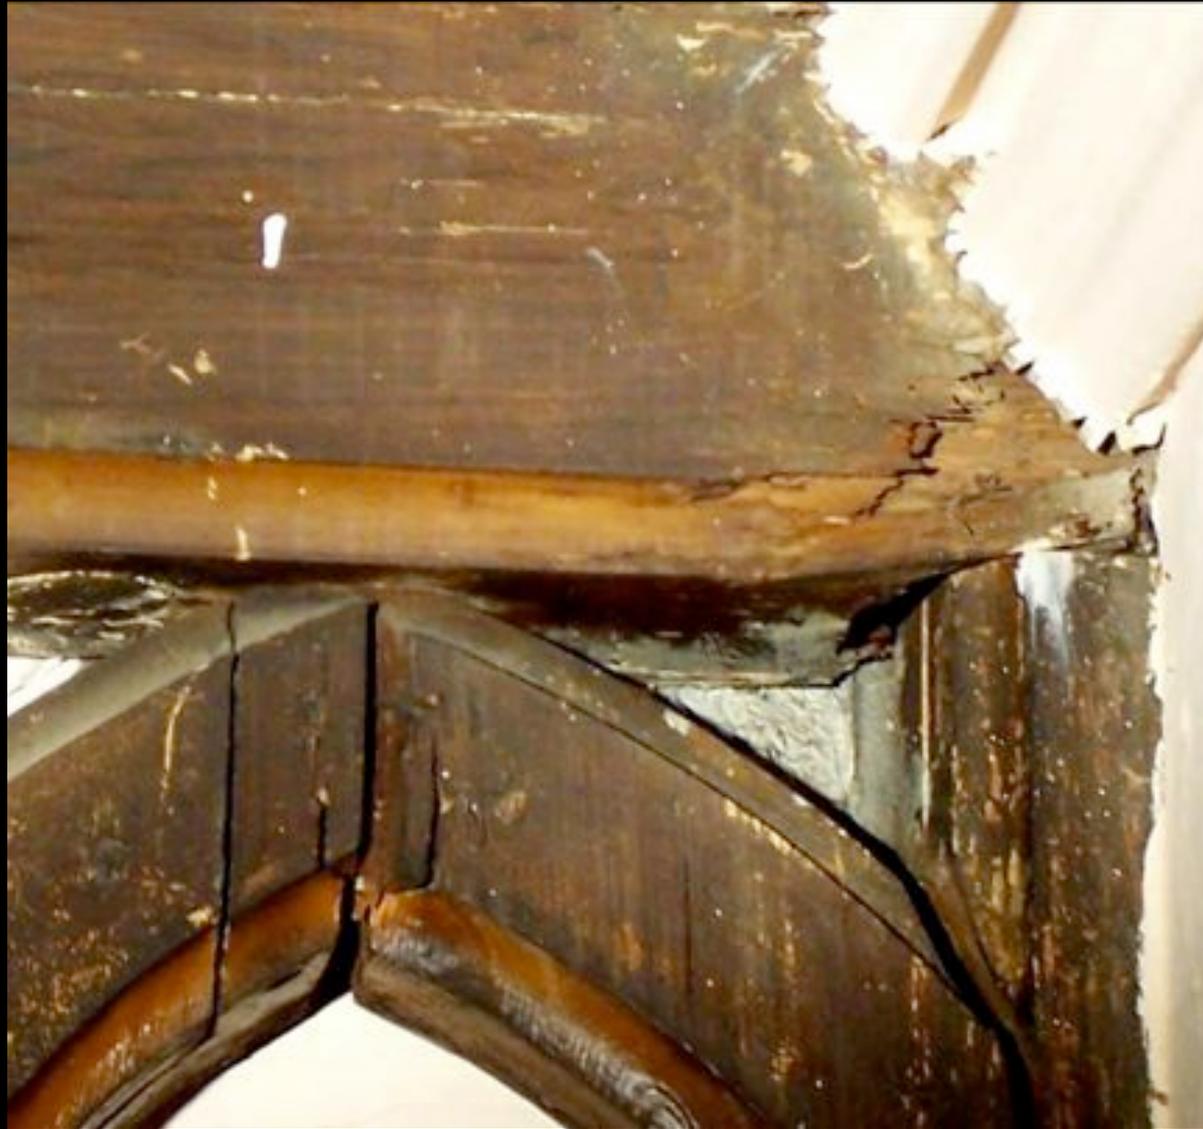
Crushing and splitting of truss members
