# Trinity Episcopal Church: Preservation Case Study of a Gothic Revival Church

MEADORS CONSERVATION

# [Case Study: Trinity Episcopal Church]

*Abbeville, SC*

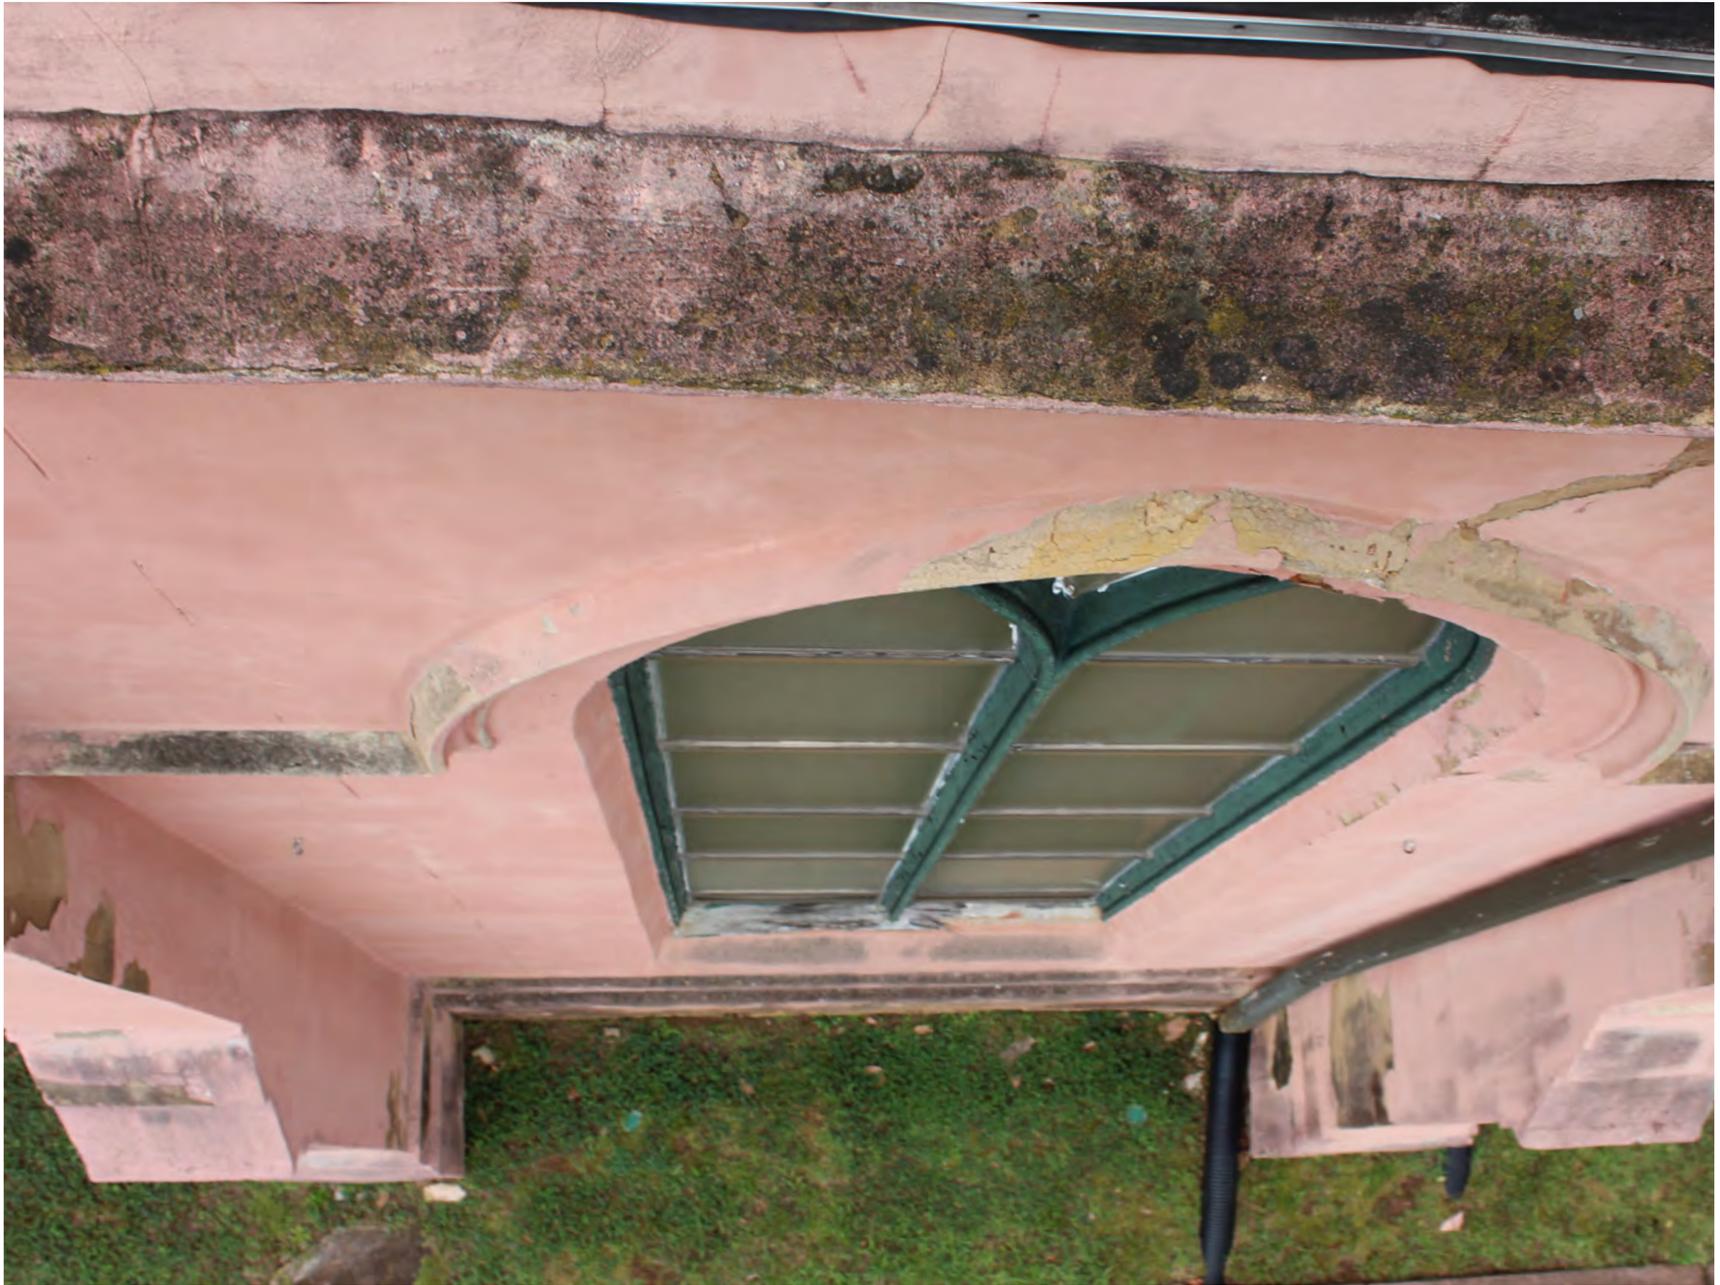
# [North Wall: Structural Movement]

*“Is the north wall stable ?”*

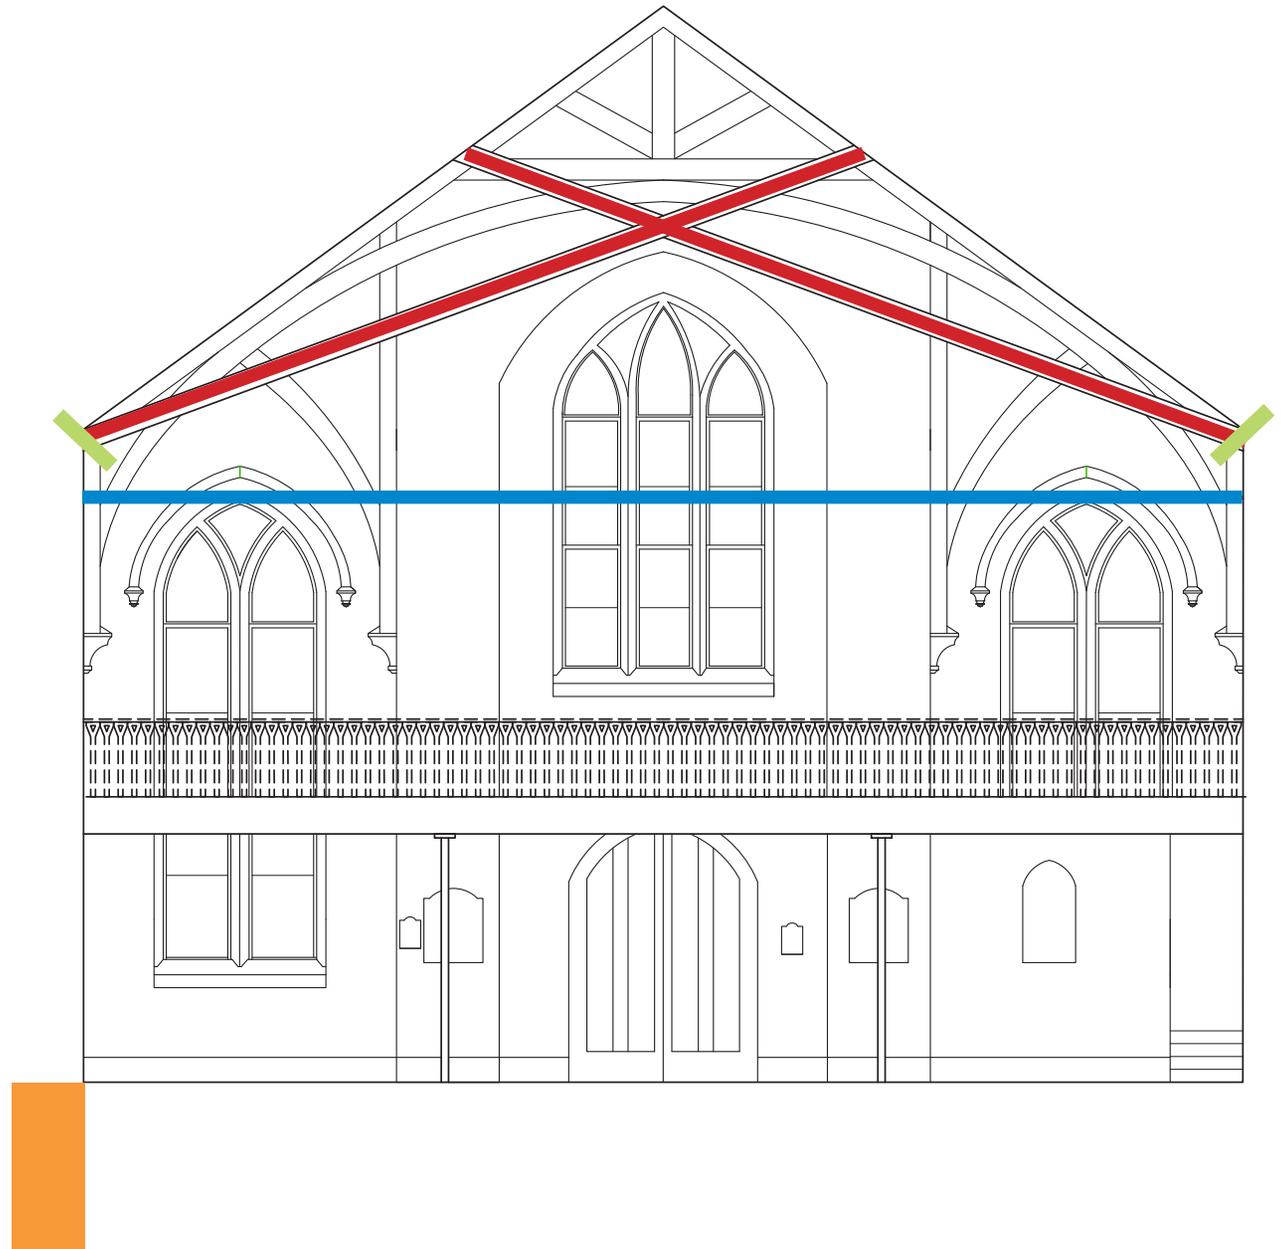
# [Structural Diagrams: Interventions Over Time]

c. 1860 Church Completed

— 1900 Scissor Bracing Added

— 1957 Horizontal Tie Rods Installed

— 1993 Steel Tube to Masonry Wall Bearing Plate Connection Installed

— 2006 Earth Adjacent to the North Wall was Excavated to Install Underpinning, Underpinning never Installed and Area was Backfilled

2014 Soils Testing Completed, Determined that Backfilling was Not Compacted Appropriately
