Woman's Club of Rock Hill, Rock Hill, South Carolina
SC Historic Preservation Conference - Education Session Proposal
April 22, 2014

Case Study: The Mauldin Gardens at the Woman's Club of Rock Hill: Funding, Restoring and Preserving historic gardens

Components of the Project: pergola, reflecting pool, lily pond, brick walks, landscaping

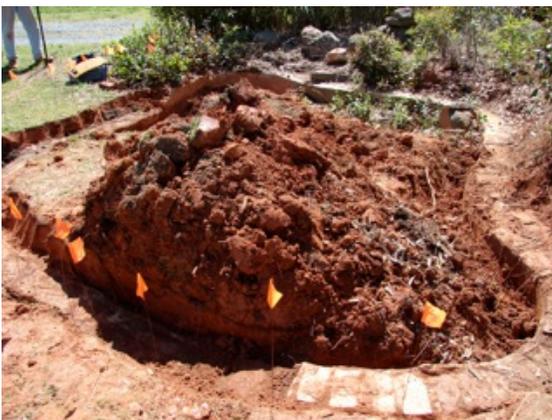
Partially unearthed lily pond.

The reflecting pool, lily pond and brick walks were unearthed by hand-digging by a member and her husband; bricks and stone were saved and re-used. The pools were rebuilt, and modern crane fountains were installed at the reflecting pool, since similar ones to the originals were not found. The couple also unearthed the brick paths which were in remarkably fine condition; only small portions needed re-building.

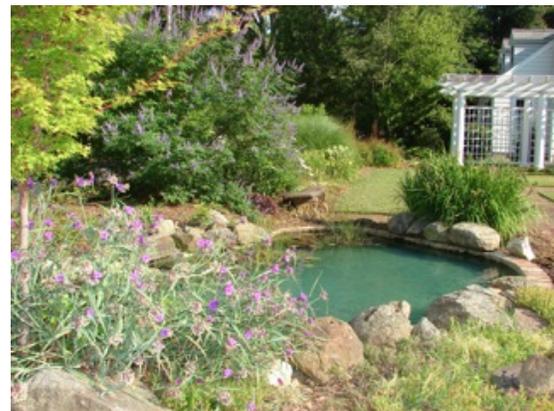
Lily pond, summer, 2012

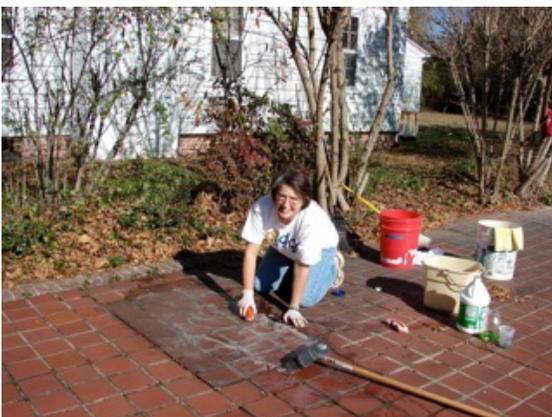
Club member scrubbing tiles of original pergola floor.

The restoration project included reconstruction of the pergola, using drawings prepared by an architect who used just a few old photos. Original bricks, floor tiles, and roof tiles were used. (Members and husbands scrubbed tiles with Simple Green and removed mortar and adhesive from the floor tiles). These materials were supplemented where necessary with purchased vintage materials and a limited amount of perfectly matched new ones. The late James Cothran, FASLA, historic landscape architect and author of several books on southern gardens (Gardens of Historic Charleston; Gardens and Historic Plants of the Antebellum South; and Charleston Gardens and the Landscape Legacy of Loutrel Briggs) said:

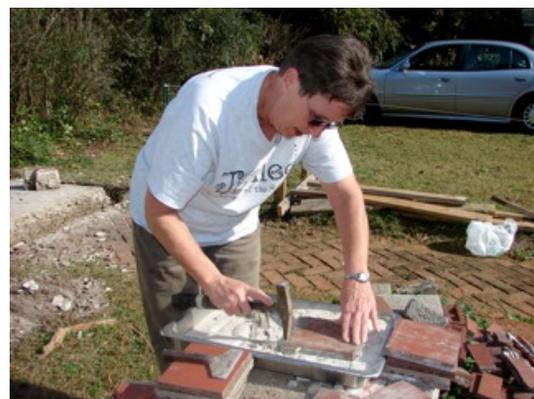
Club member gently tapping off mortar from pergola floor tiles using a tray of sand to cushion the tiles.

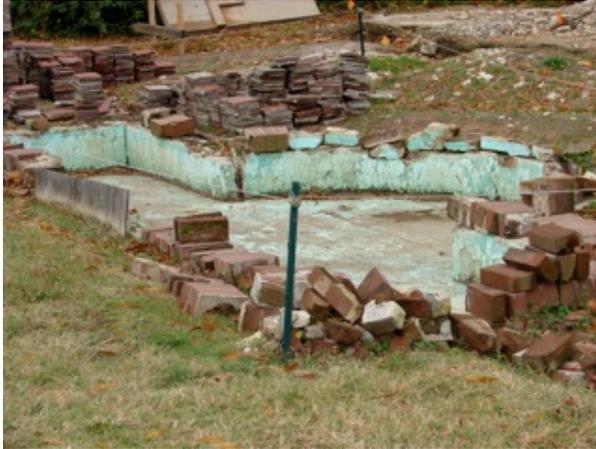
Unearthed, badly damaged reflecting pool surrounded by reclaimed tile from the pergola floor and reclaimed brick from pool.

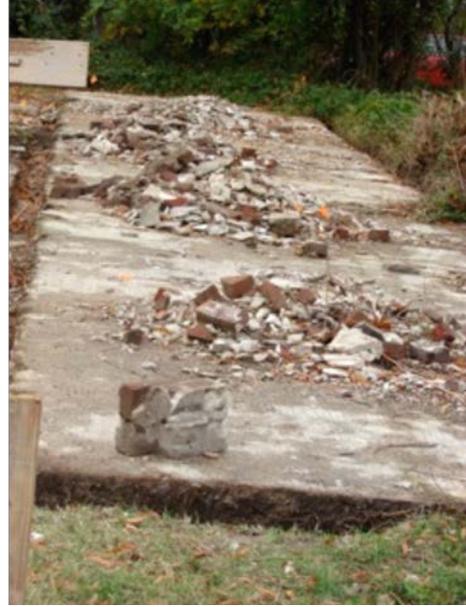
During the 70's, shortly after the purchase, the Club covered over brick walks and a reflecting pool to create a parking lot. An 18 column pergola, which existed at the time, collapsed later in the decade and only a deteriorated tile floor and underground brick foundation remained. A lily pond to the side of the yard was filled with rocks and covered over in the early 90's.

Remains of original pergola foundation

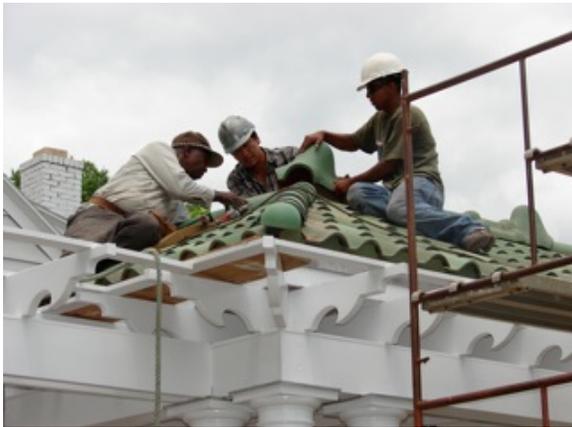
Roof hump being installed. One hump and some of the roof tiles are from the original pergola roof; second hump and remaining tiles are specially chosen vintage tiles.

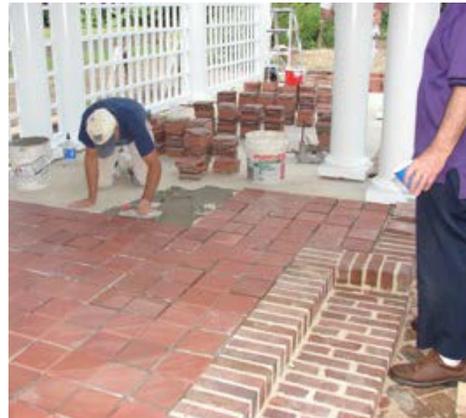
Installing reclaimed pergola tiles with a few new ones interspersed

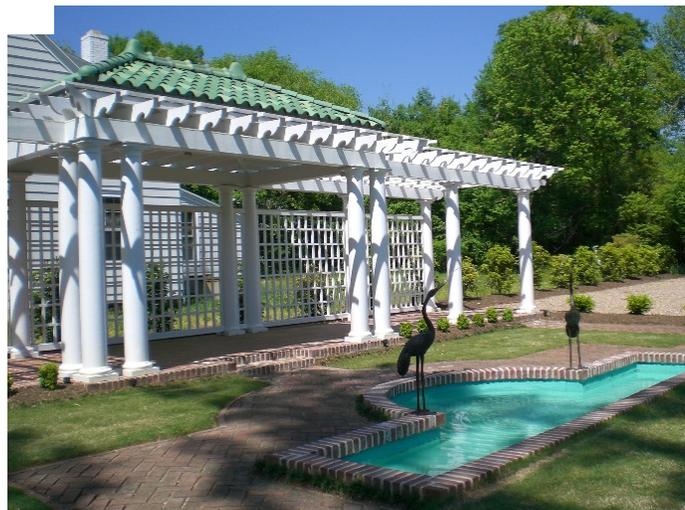
The reconstructed pergola with restored reflecting pool and crane fountains. Brick walks extend from either side of the pergola to the driveway and across to form a rectangle.

The restored pergola at the Armstrong Mauldin House represents one of the finest examples of "high-style pergolas" constructed in the South during the American landscape period (1880-1940), known as the Country Place Era. The pergola's unique design, creative use of decorative roof tiles, classical columns, and ornamental brick foundation creates a beautiful piece of garden art both in terms of scale and design.
