The Forces that Destroy Historic Structures

The SC Historic Preservation Conference

Craig M. Bennett, Jr., PE

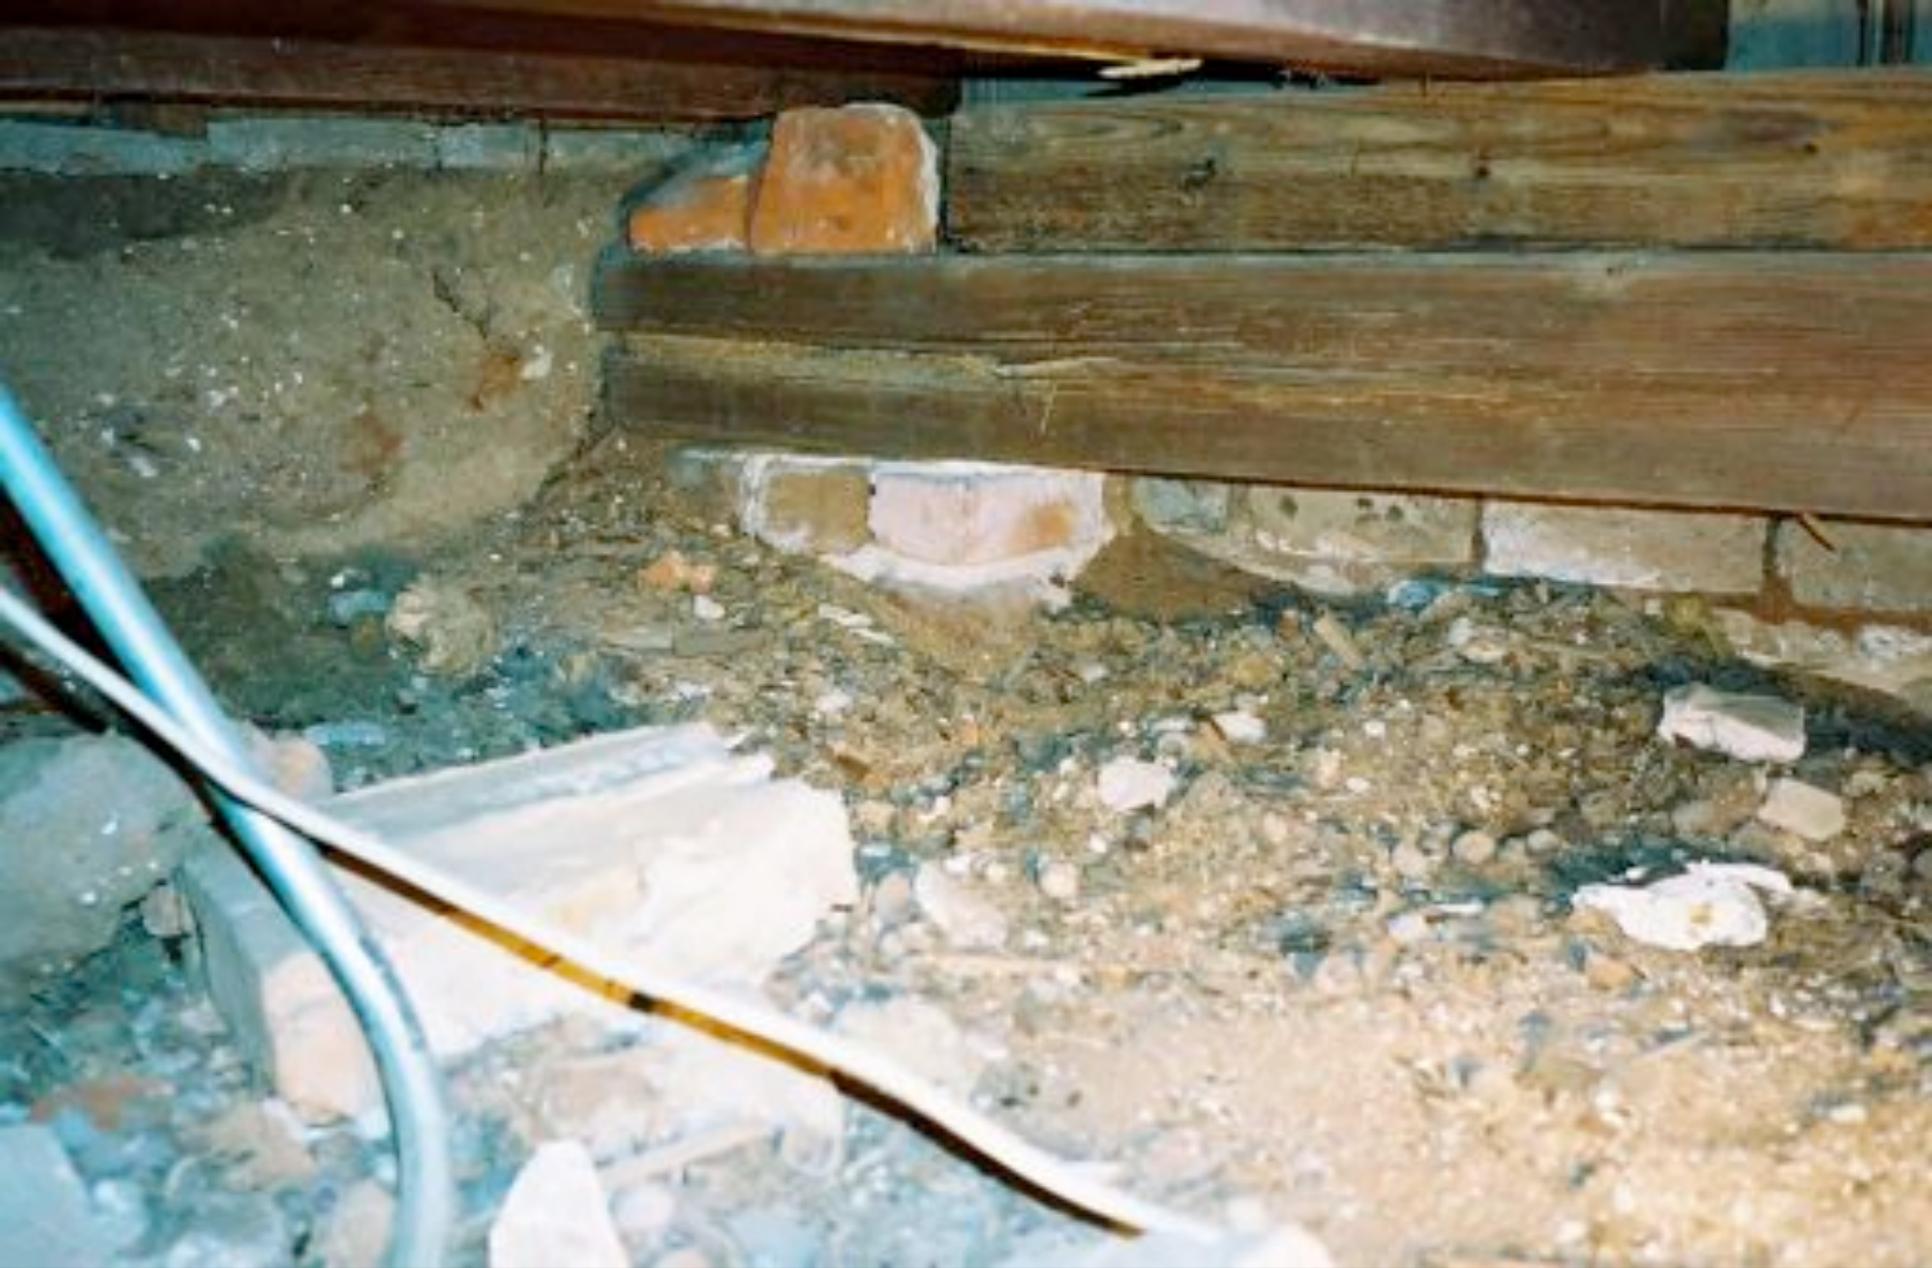
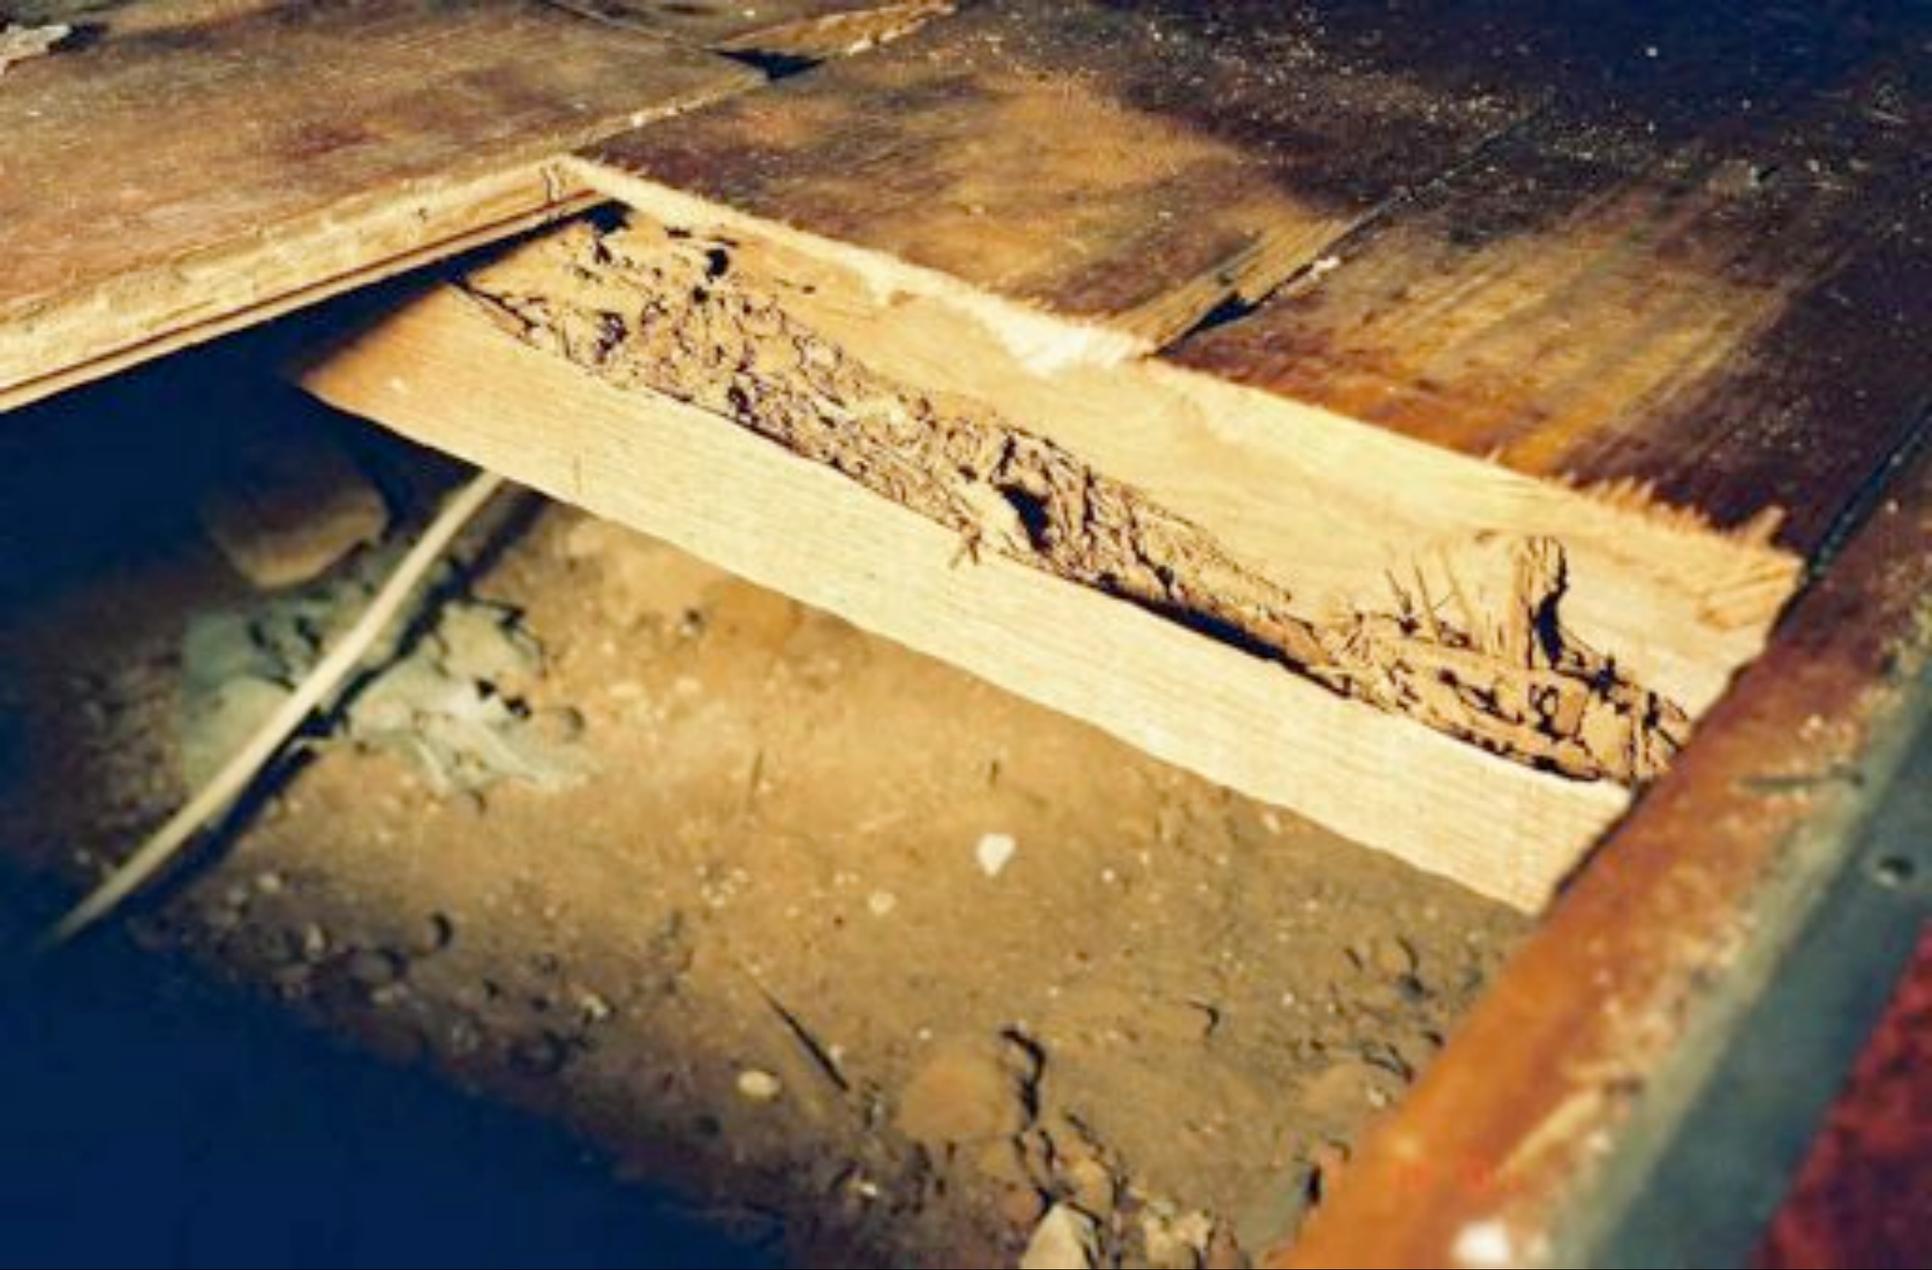
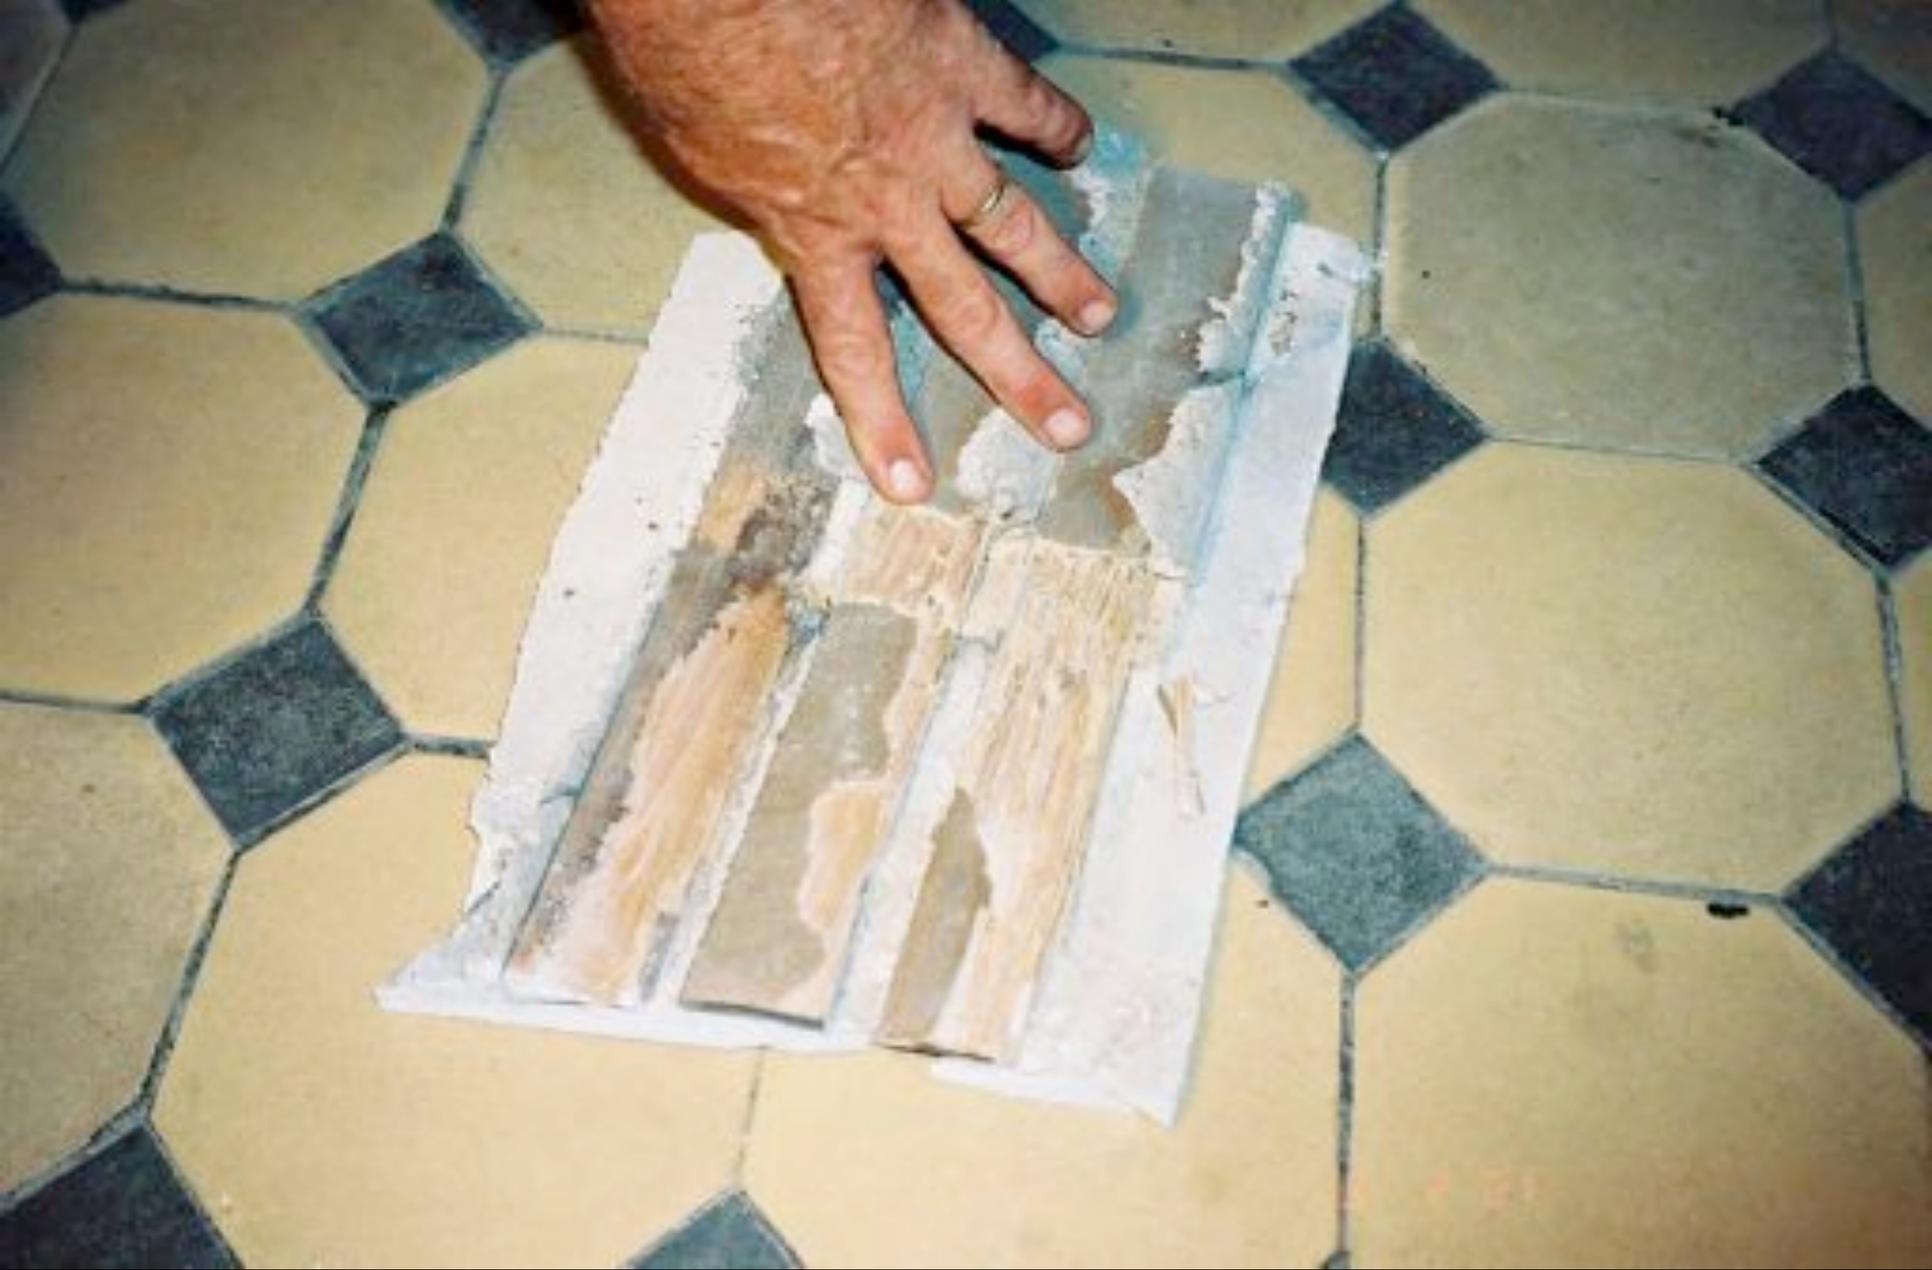
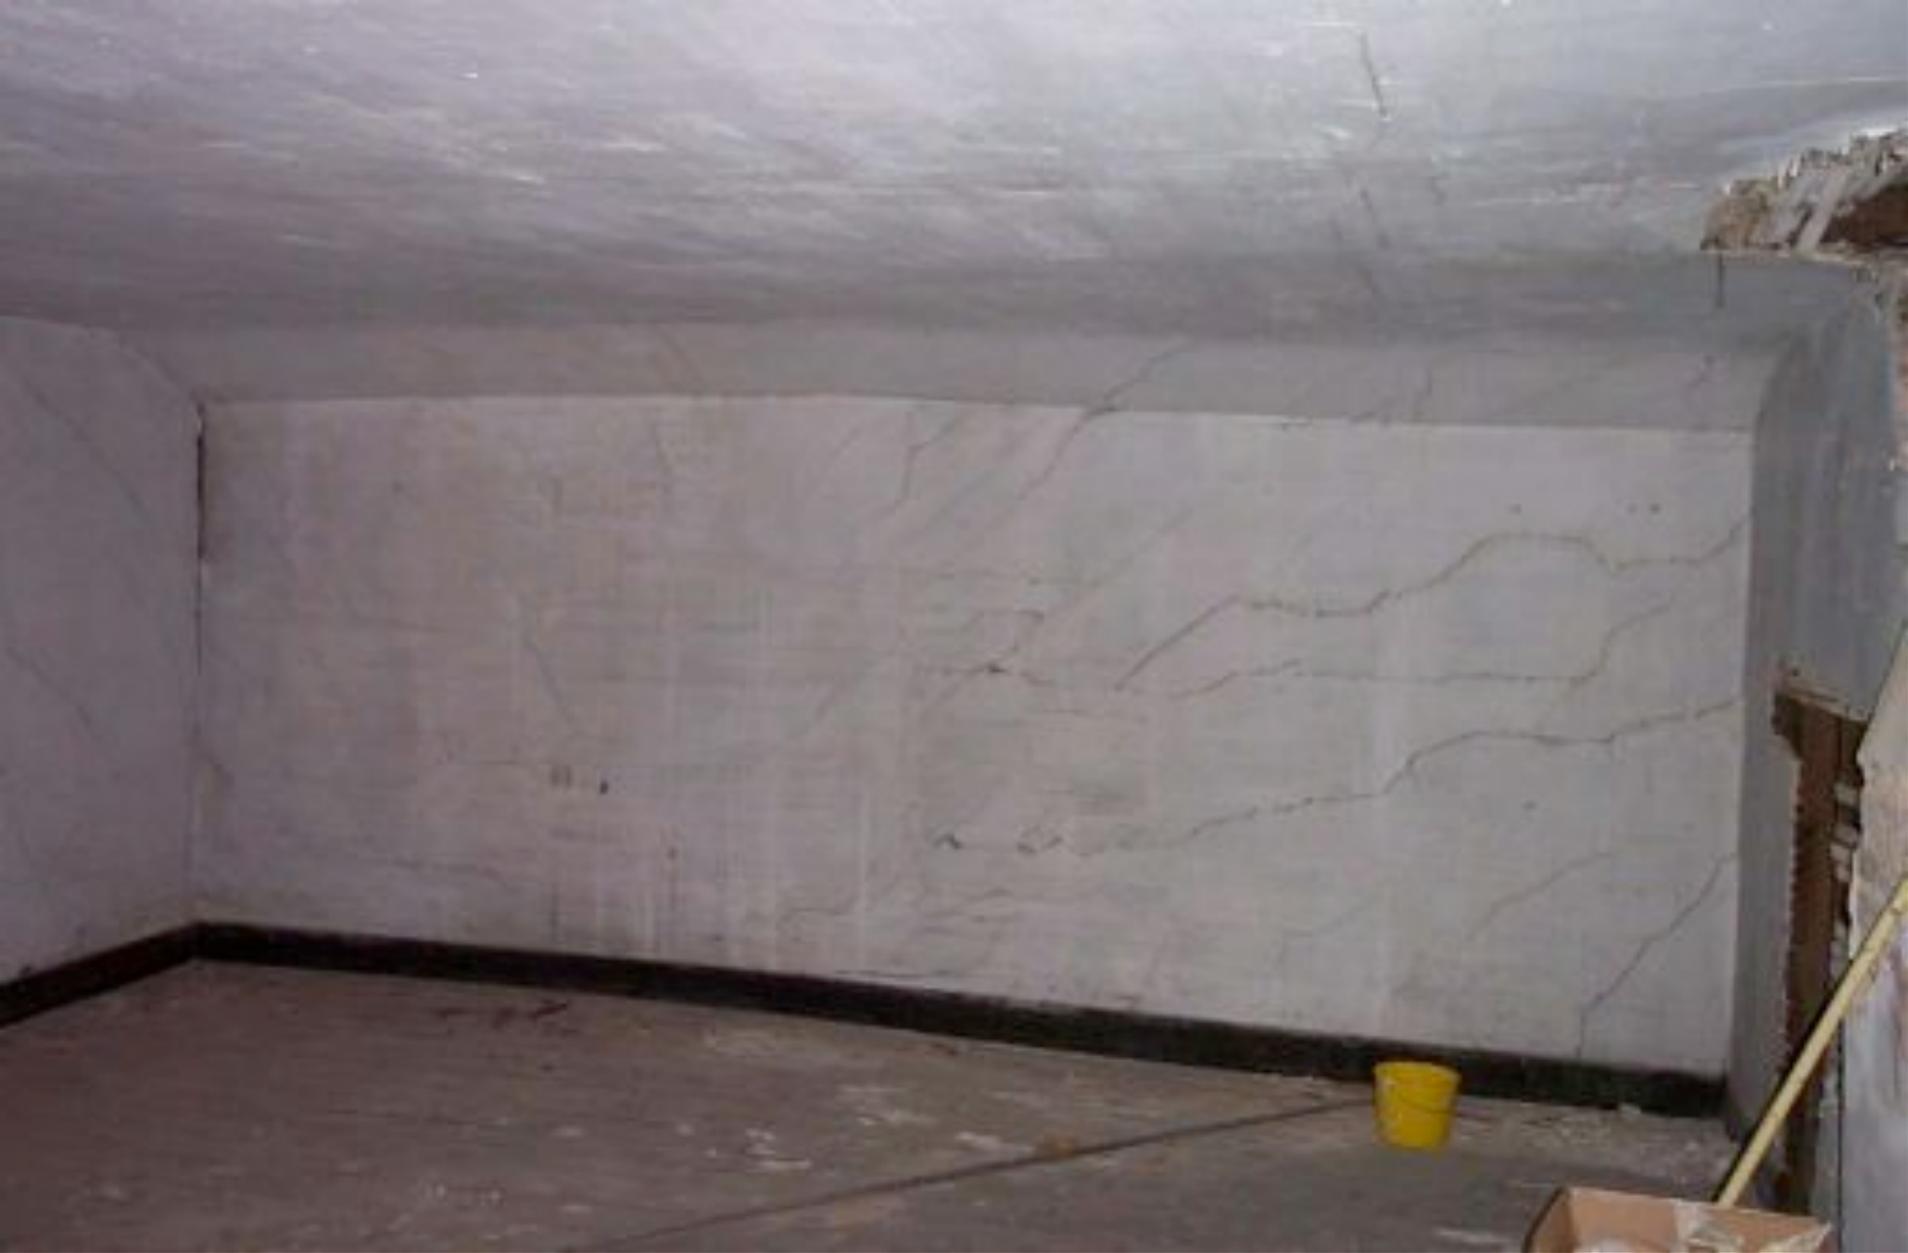
Wood

- Rot
- Insect infestation
 - Powderpost beetles
 - Subteranean termites
 - Formosan termites
 - Carpenter bees
- Overstress
