The Forces that Destroy Historic Structures

The SC Historic Preservation Conference

Craig M. Bennett, Jr., PE

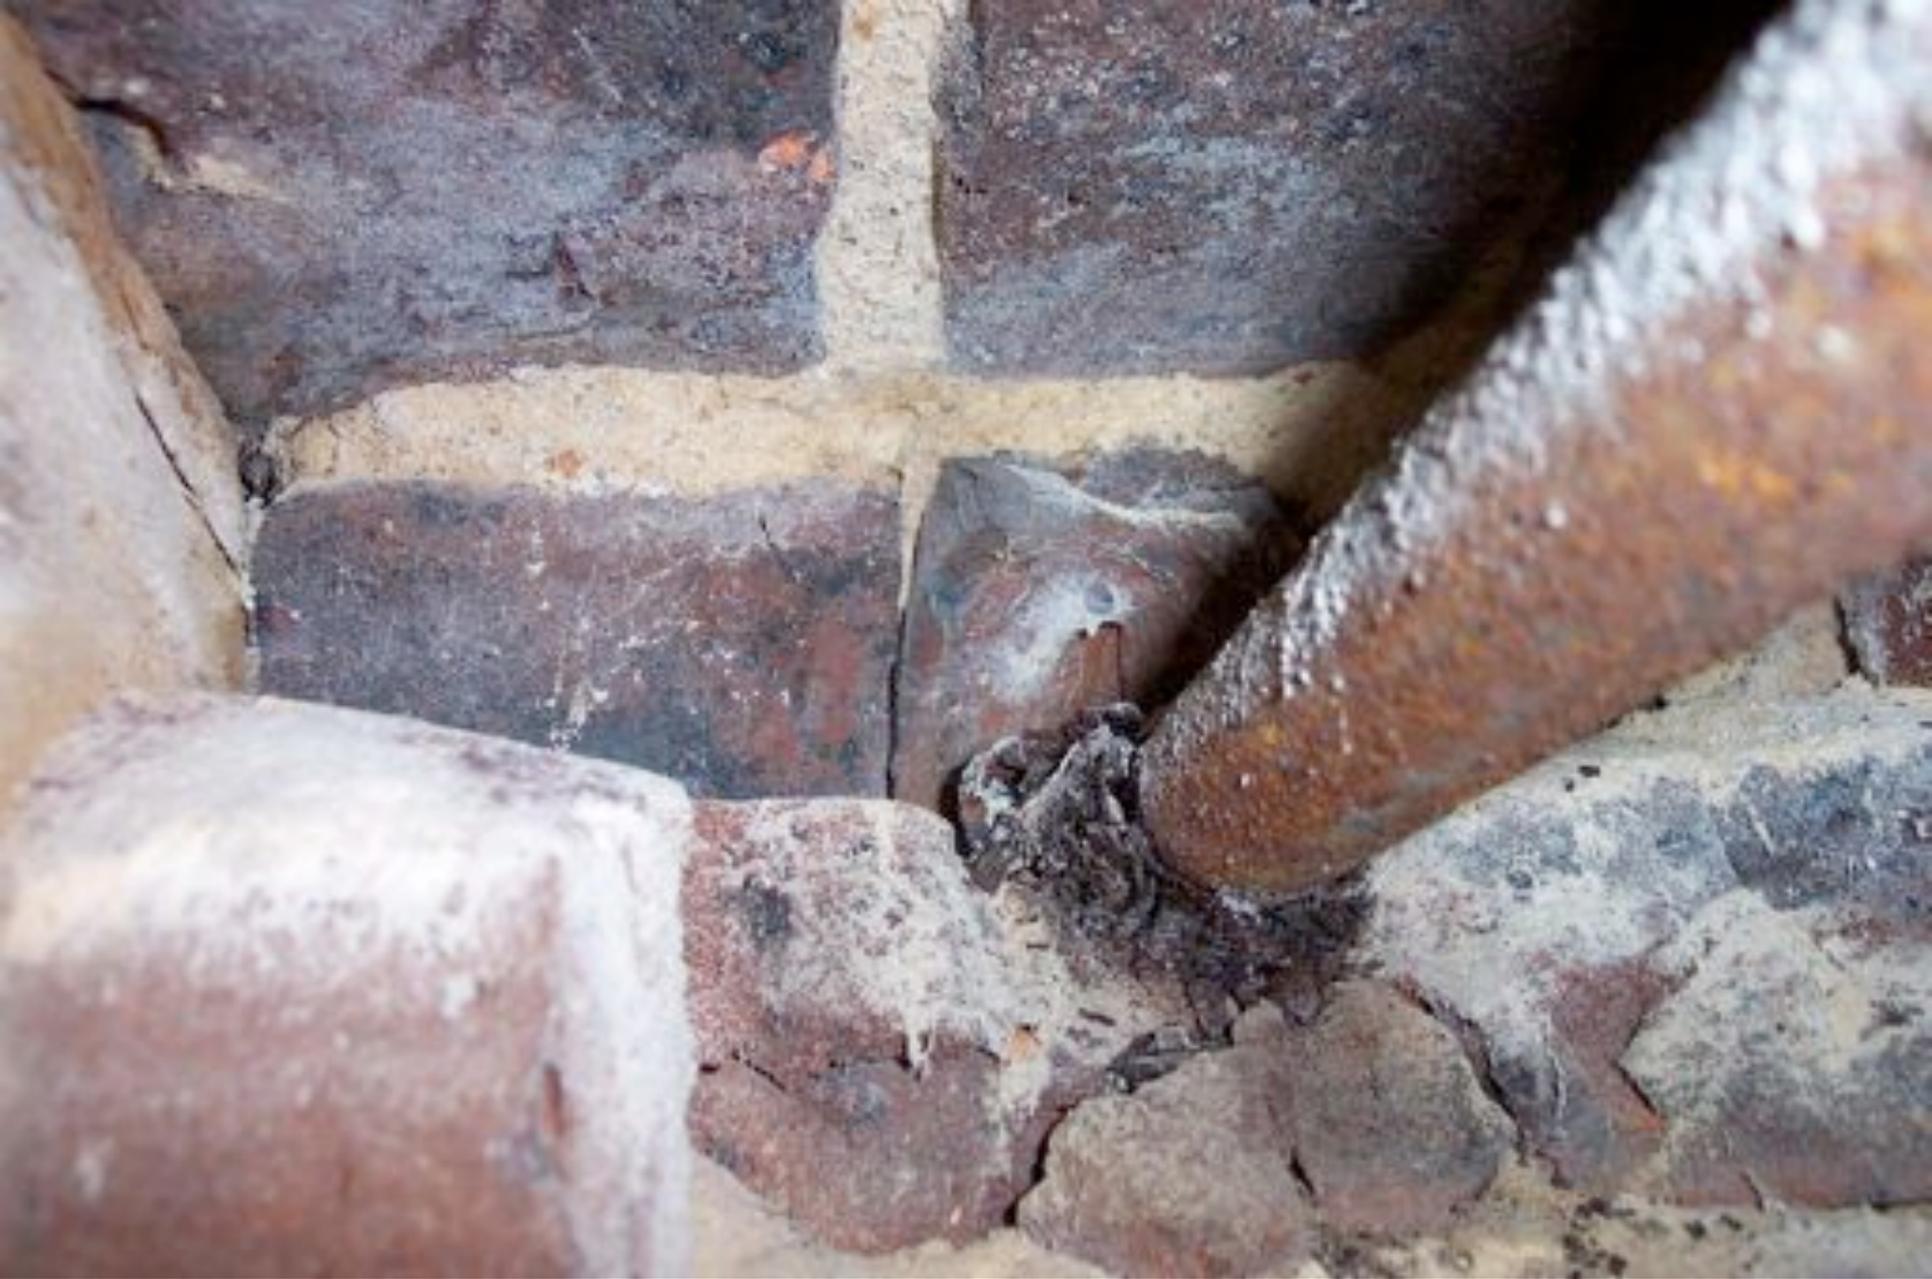
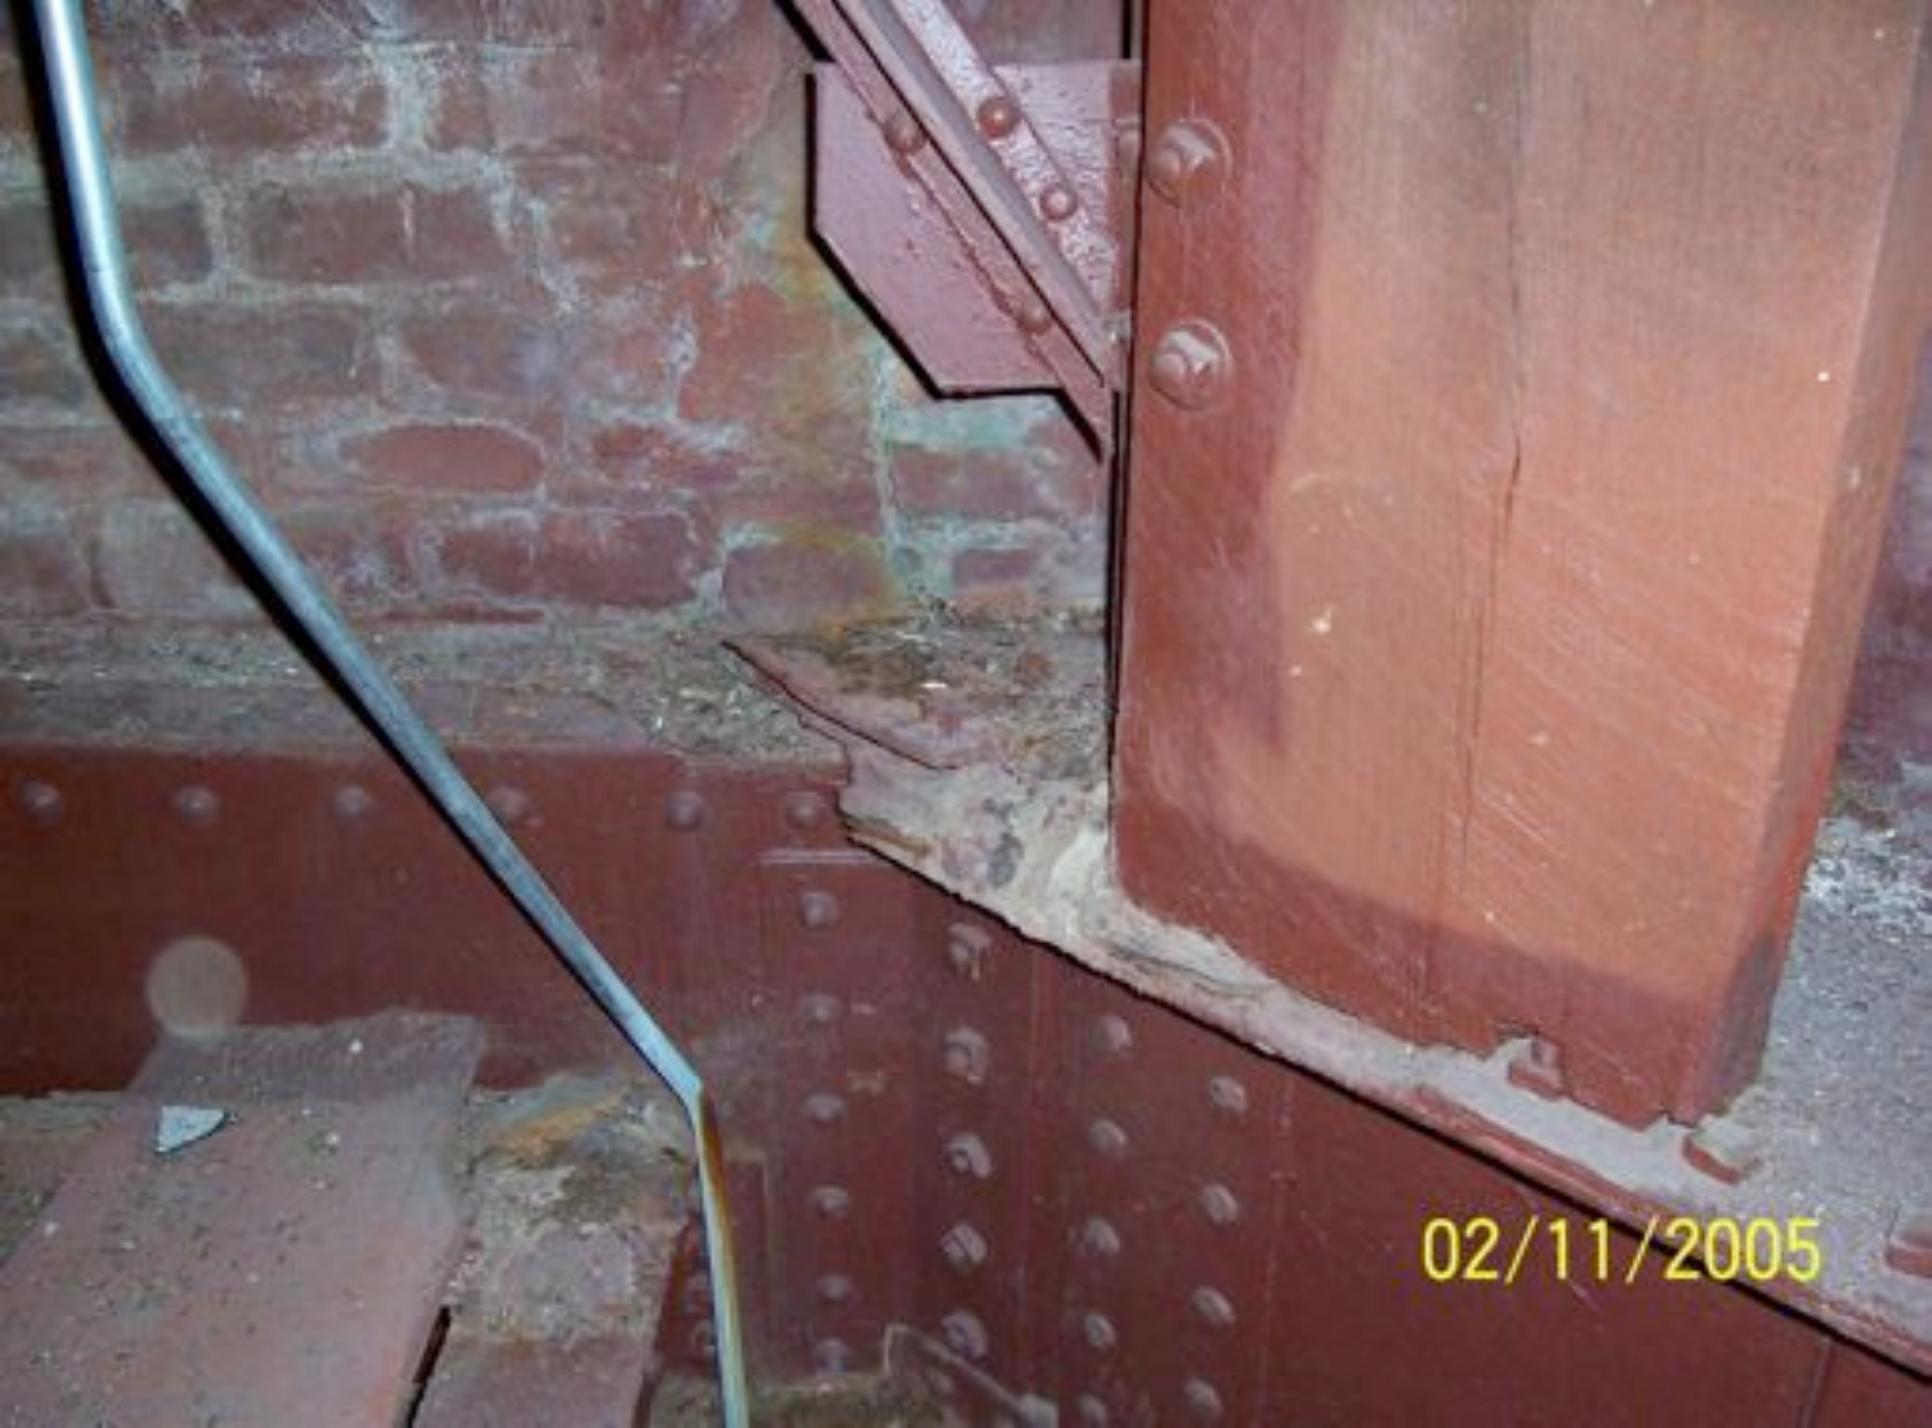
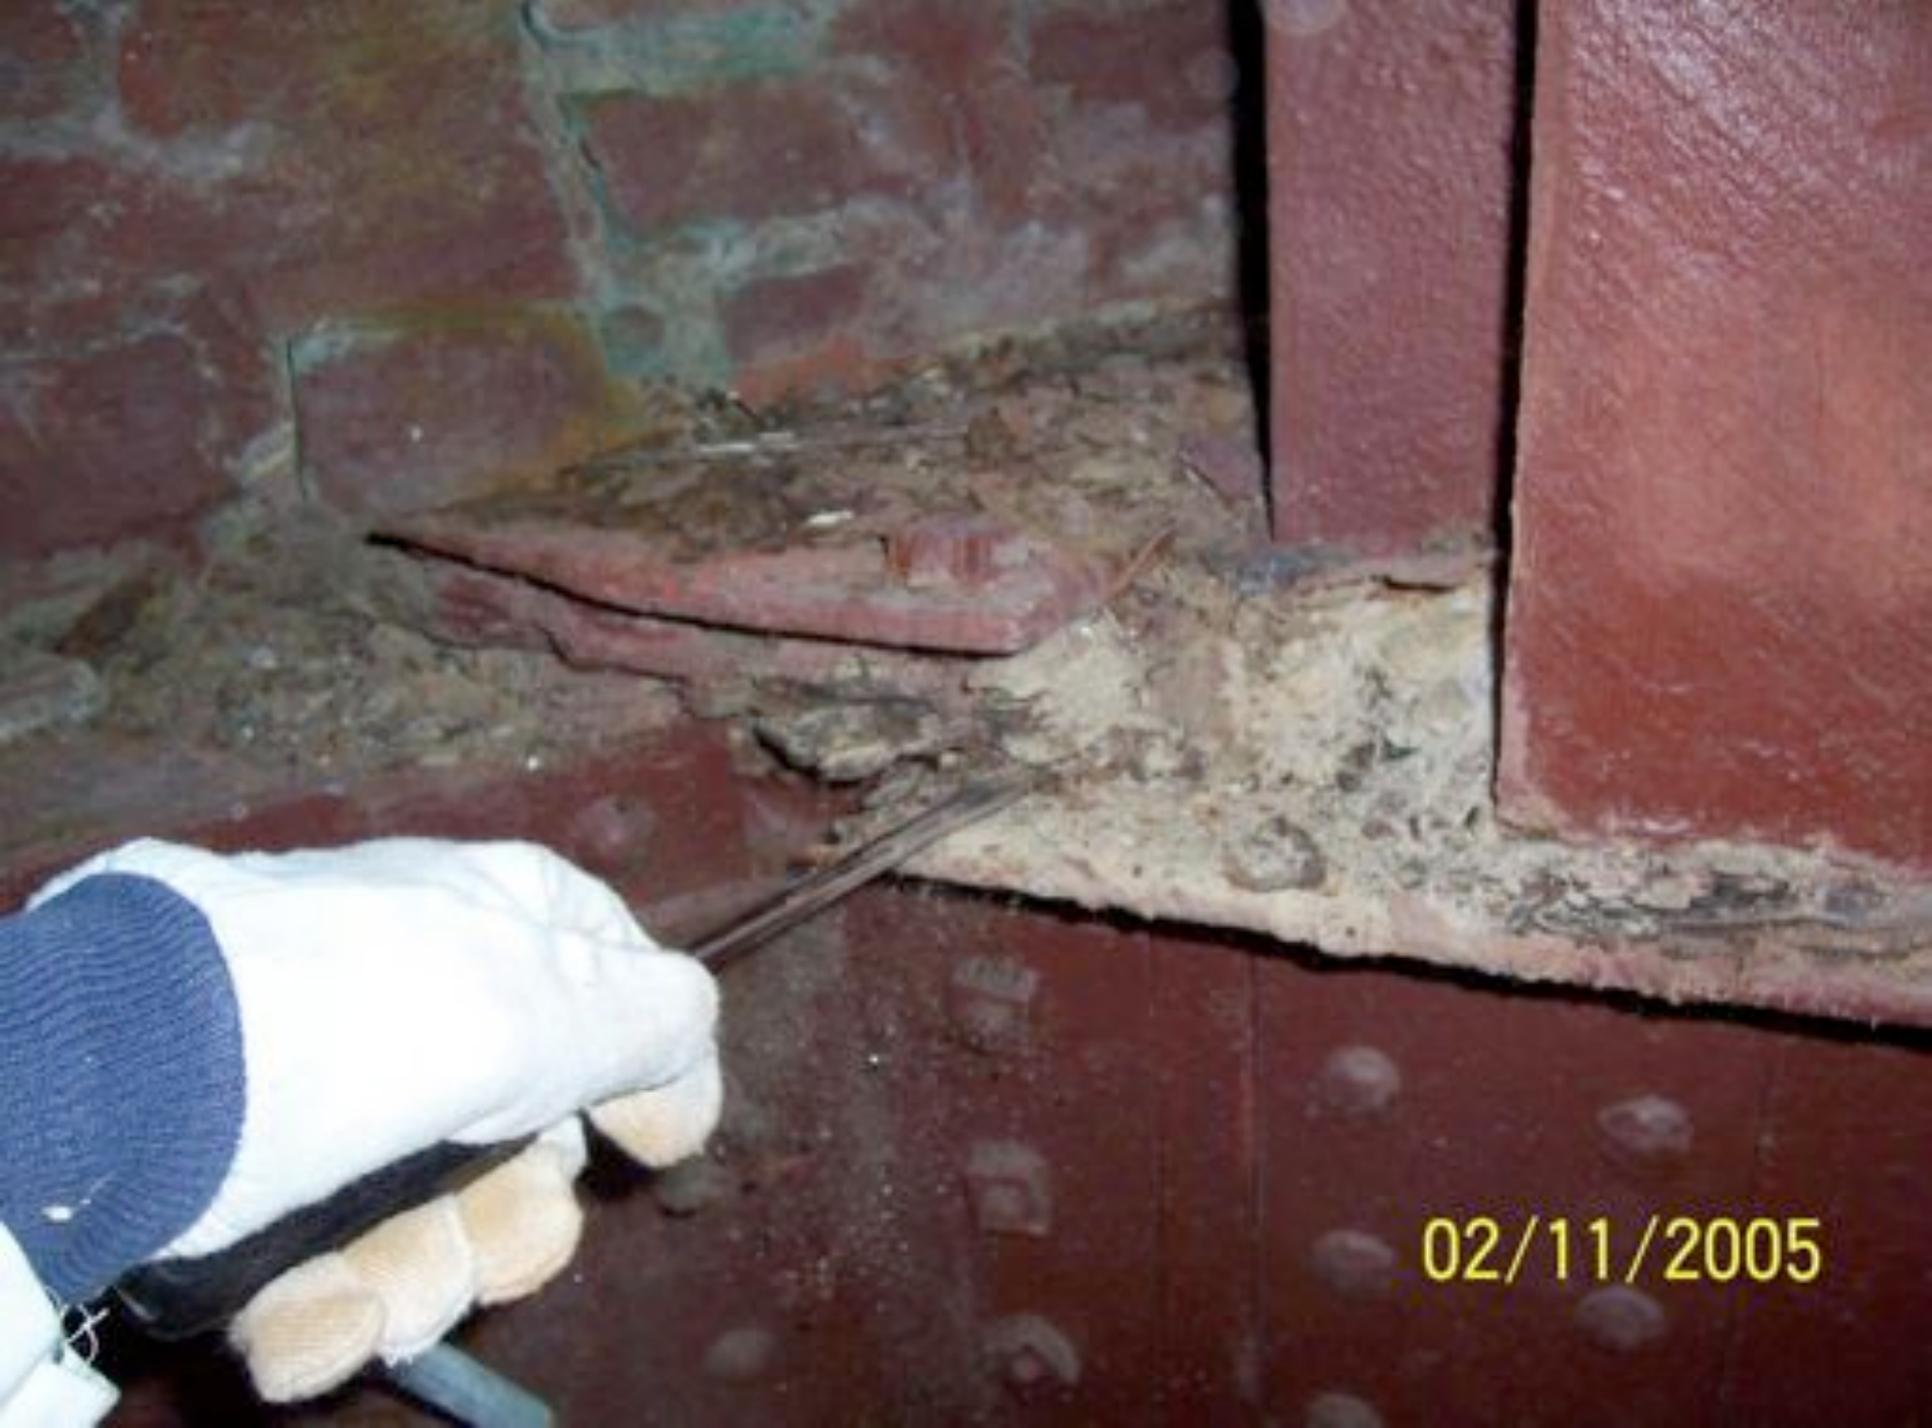
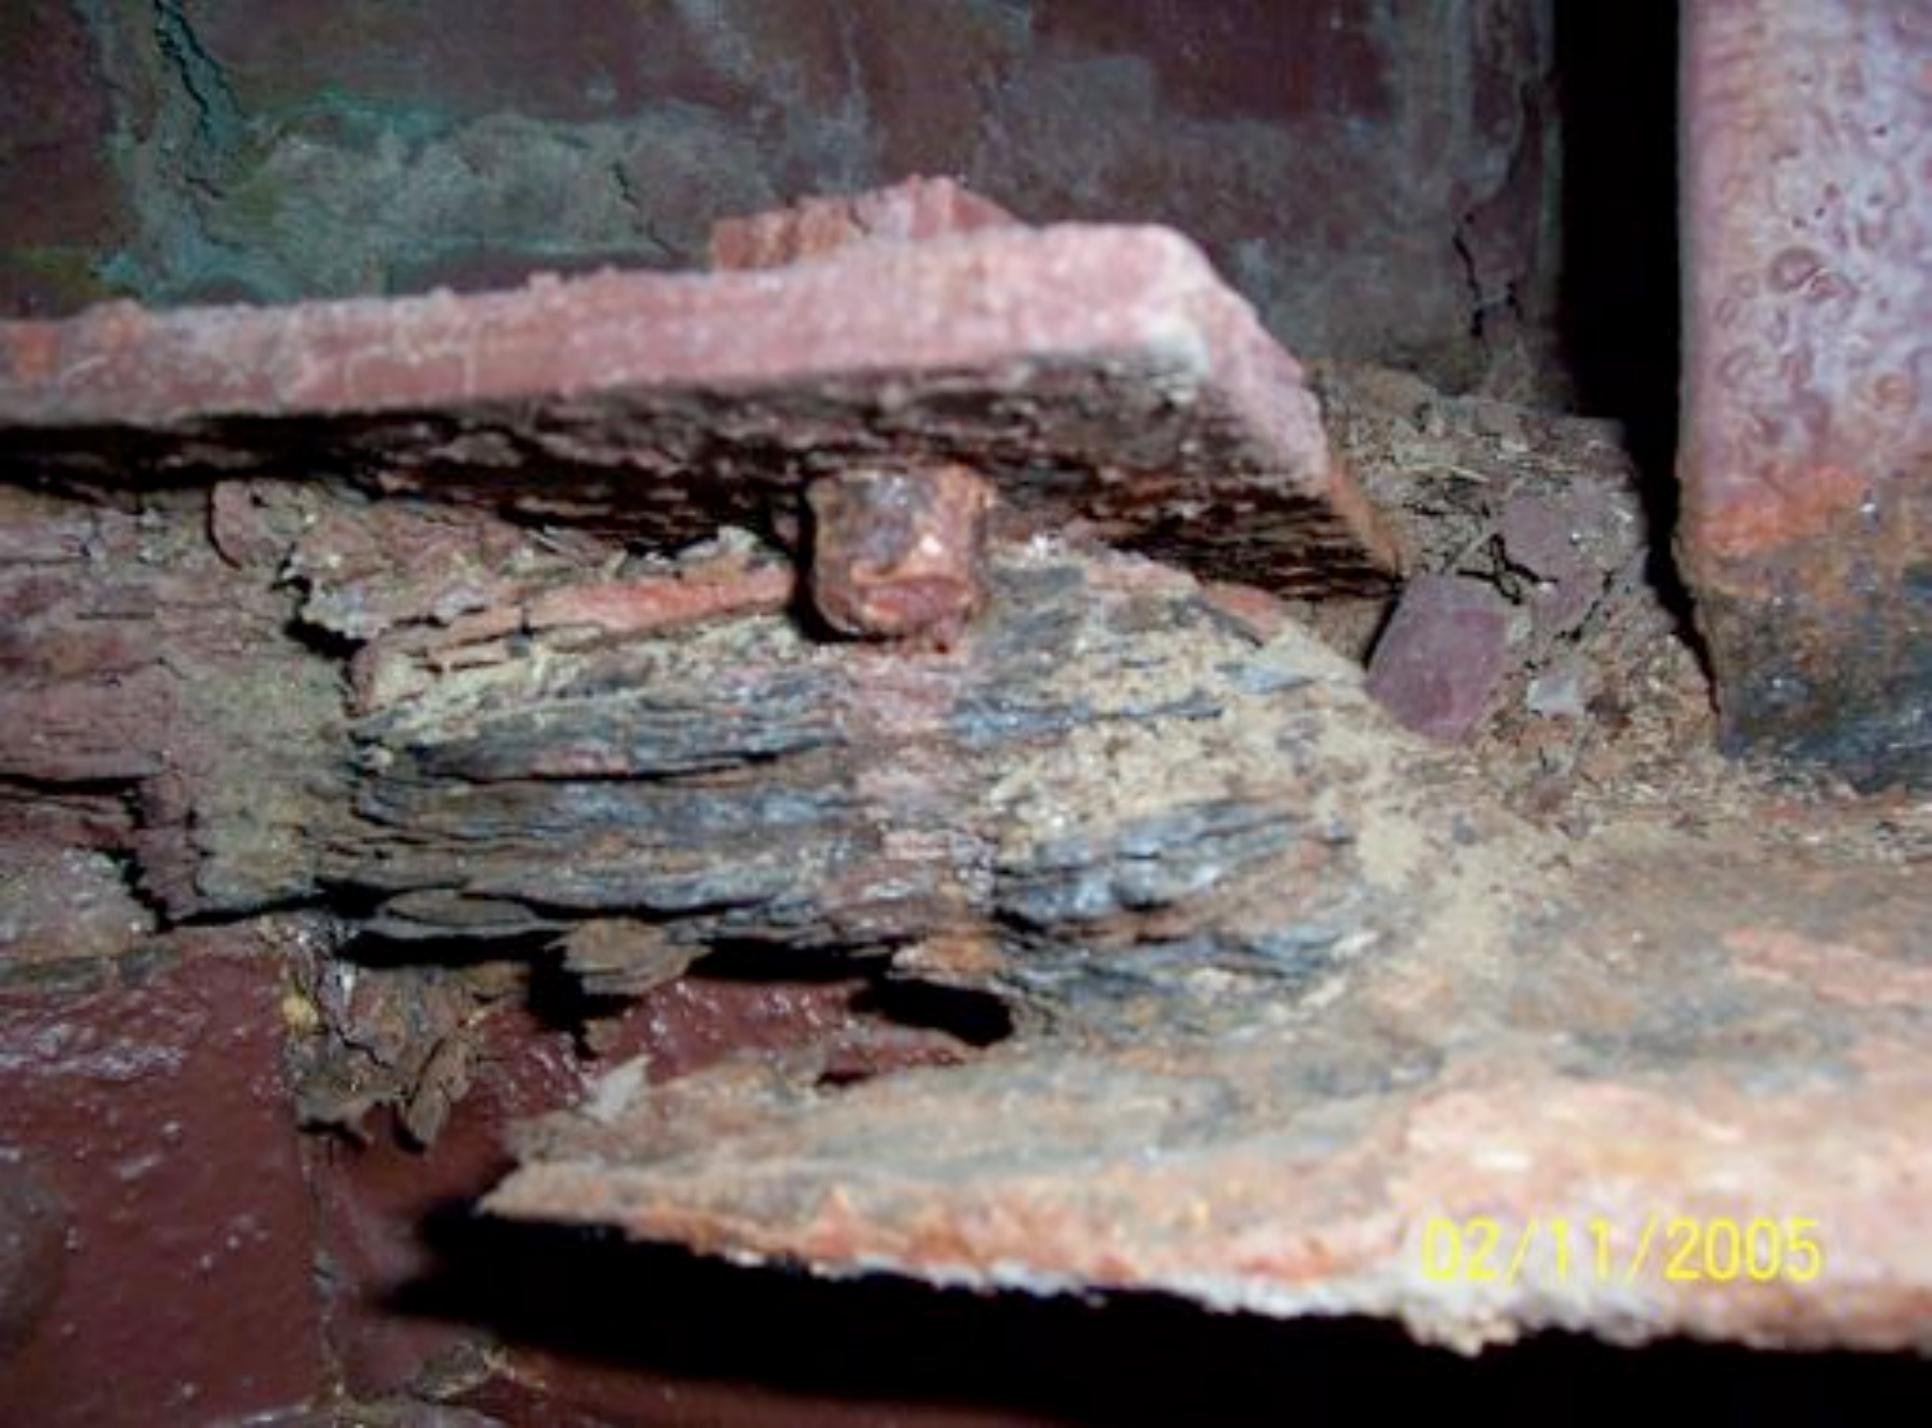
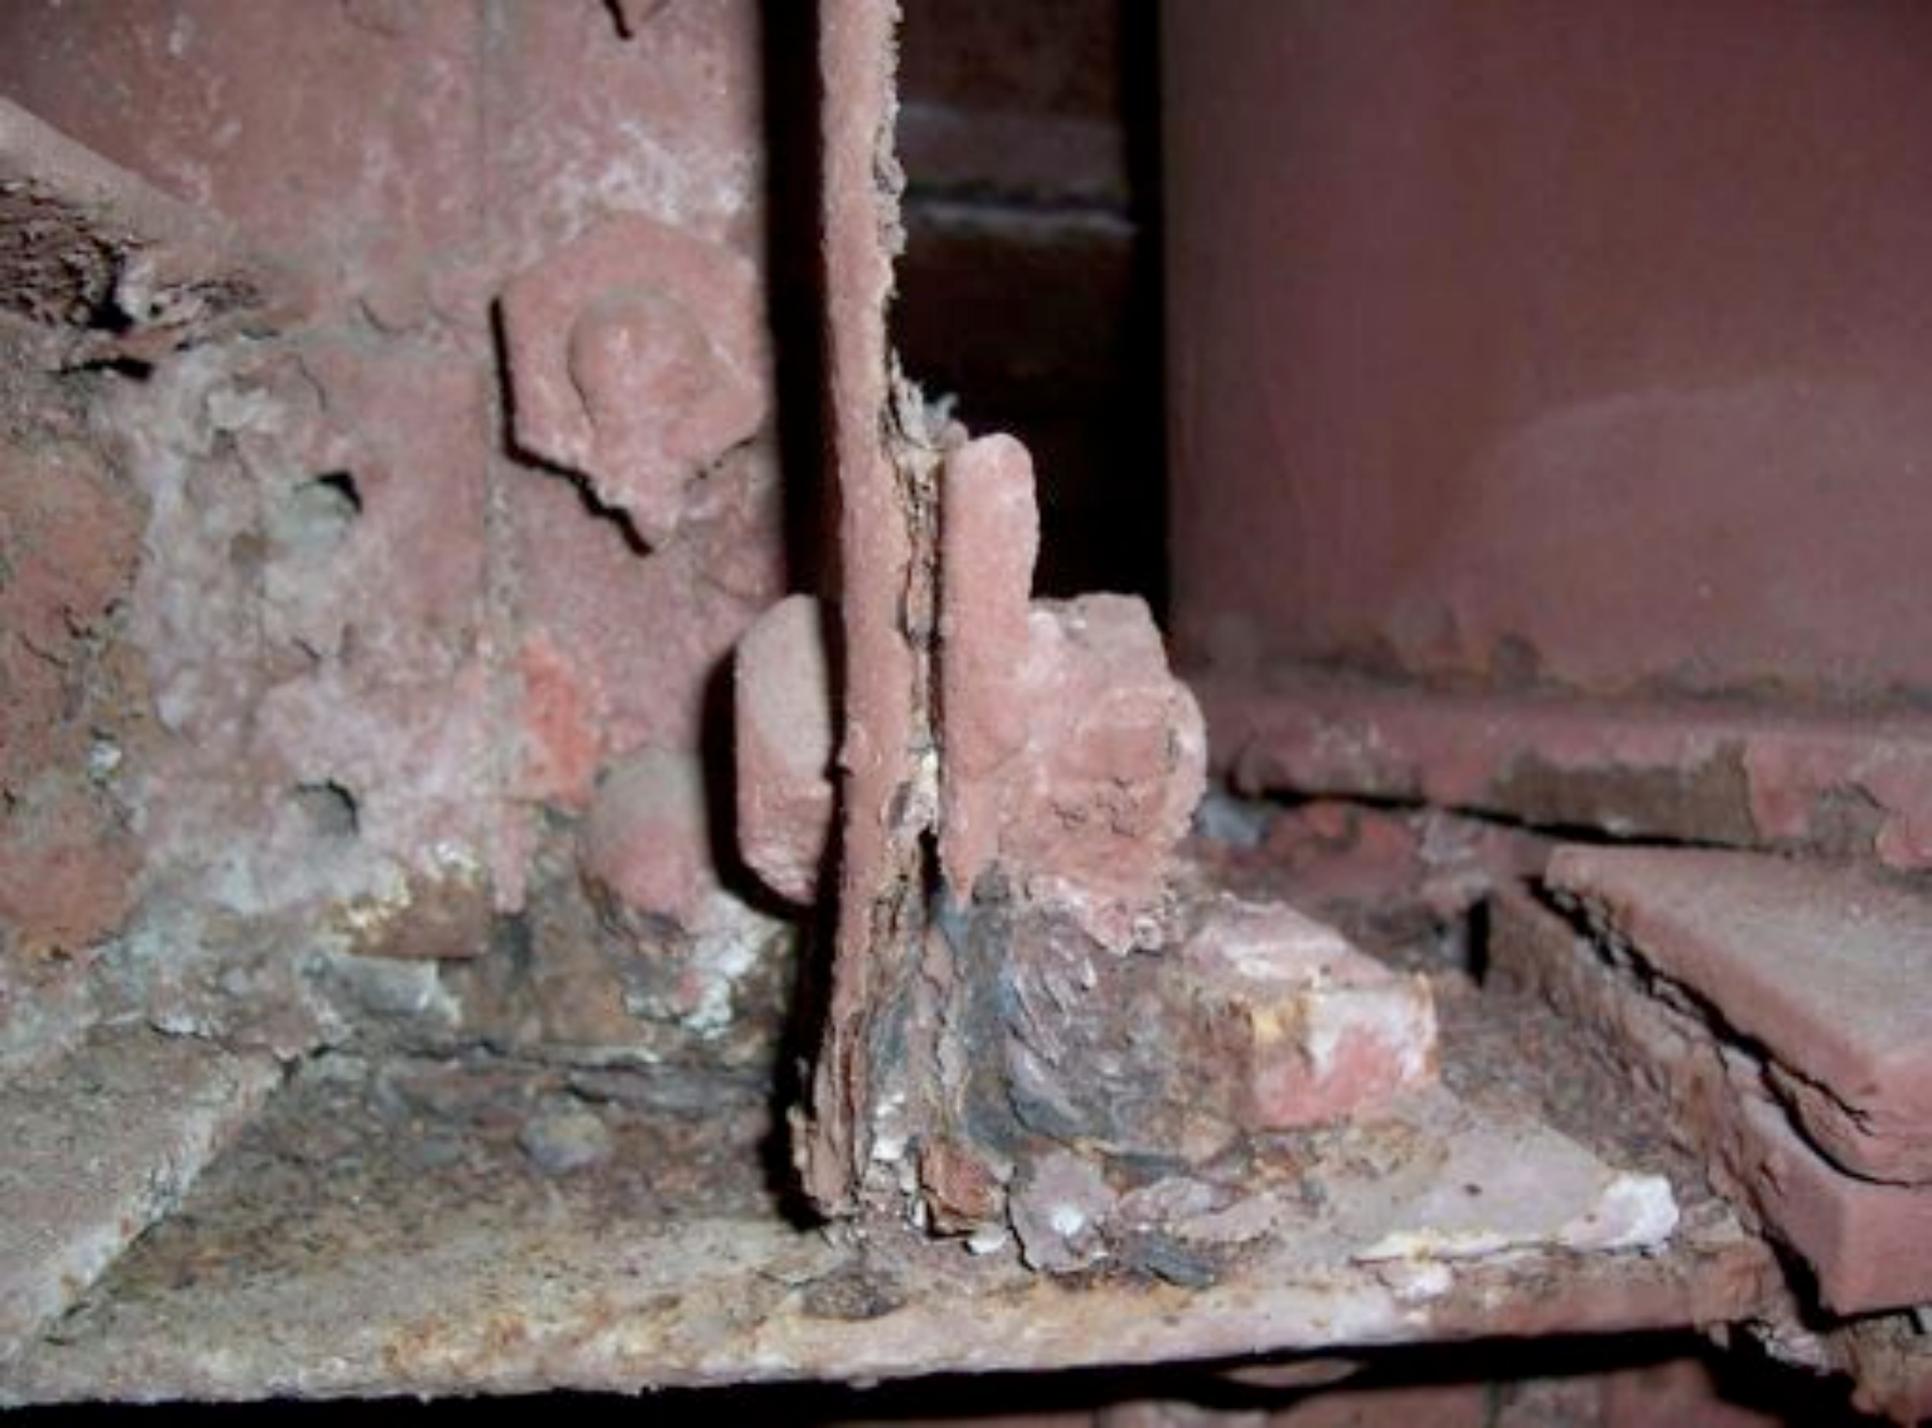
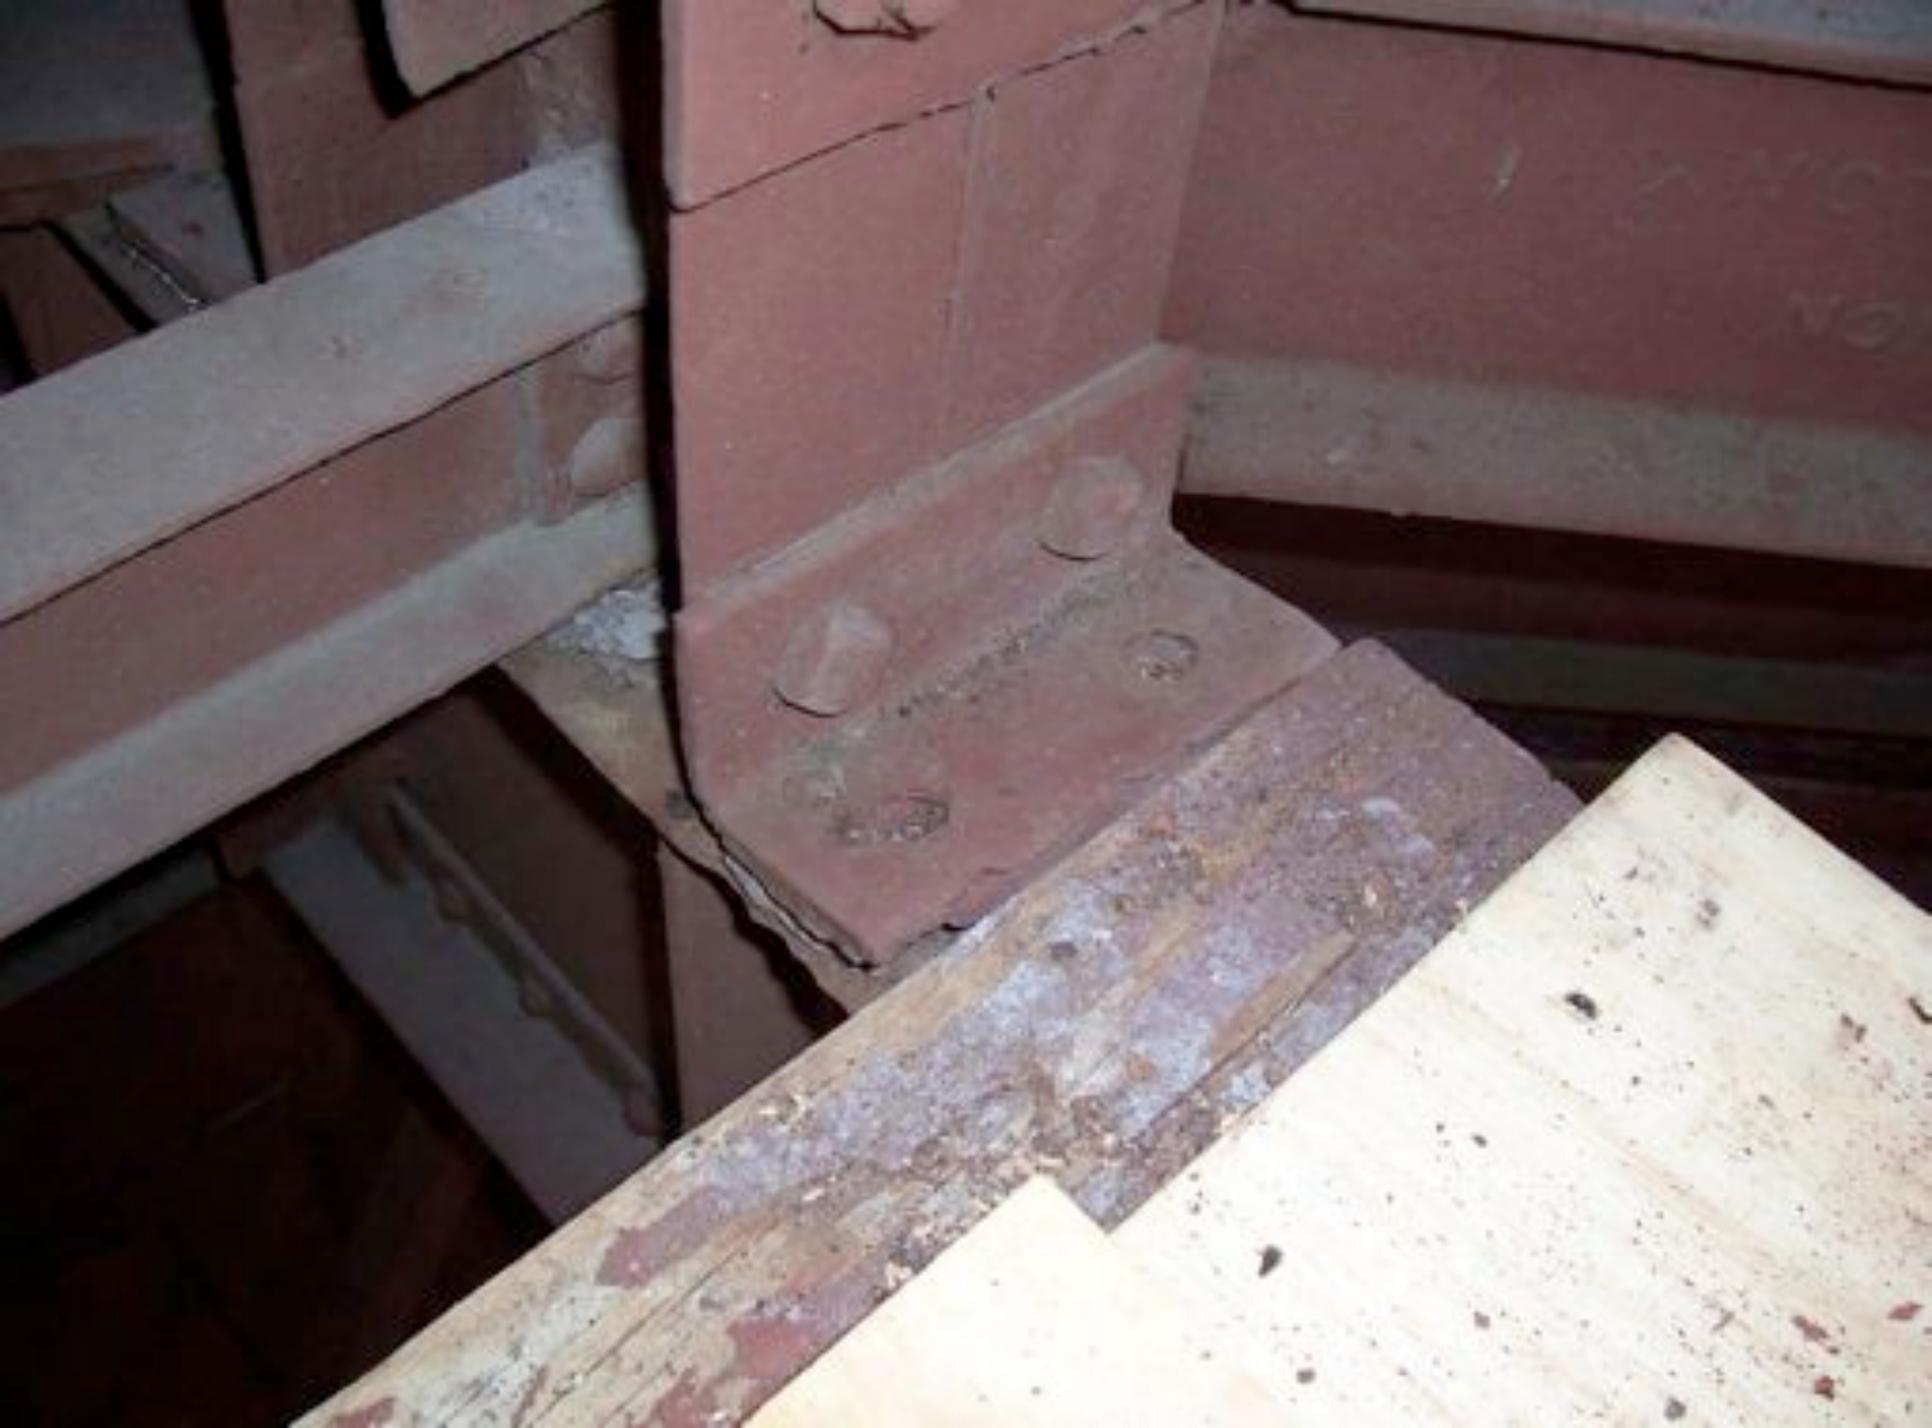
Iron and steel

- Corrosion, particularly in contact with masonry

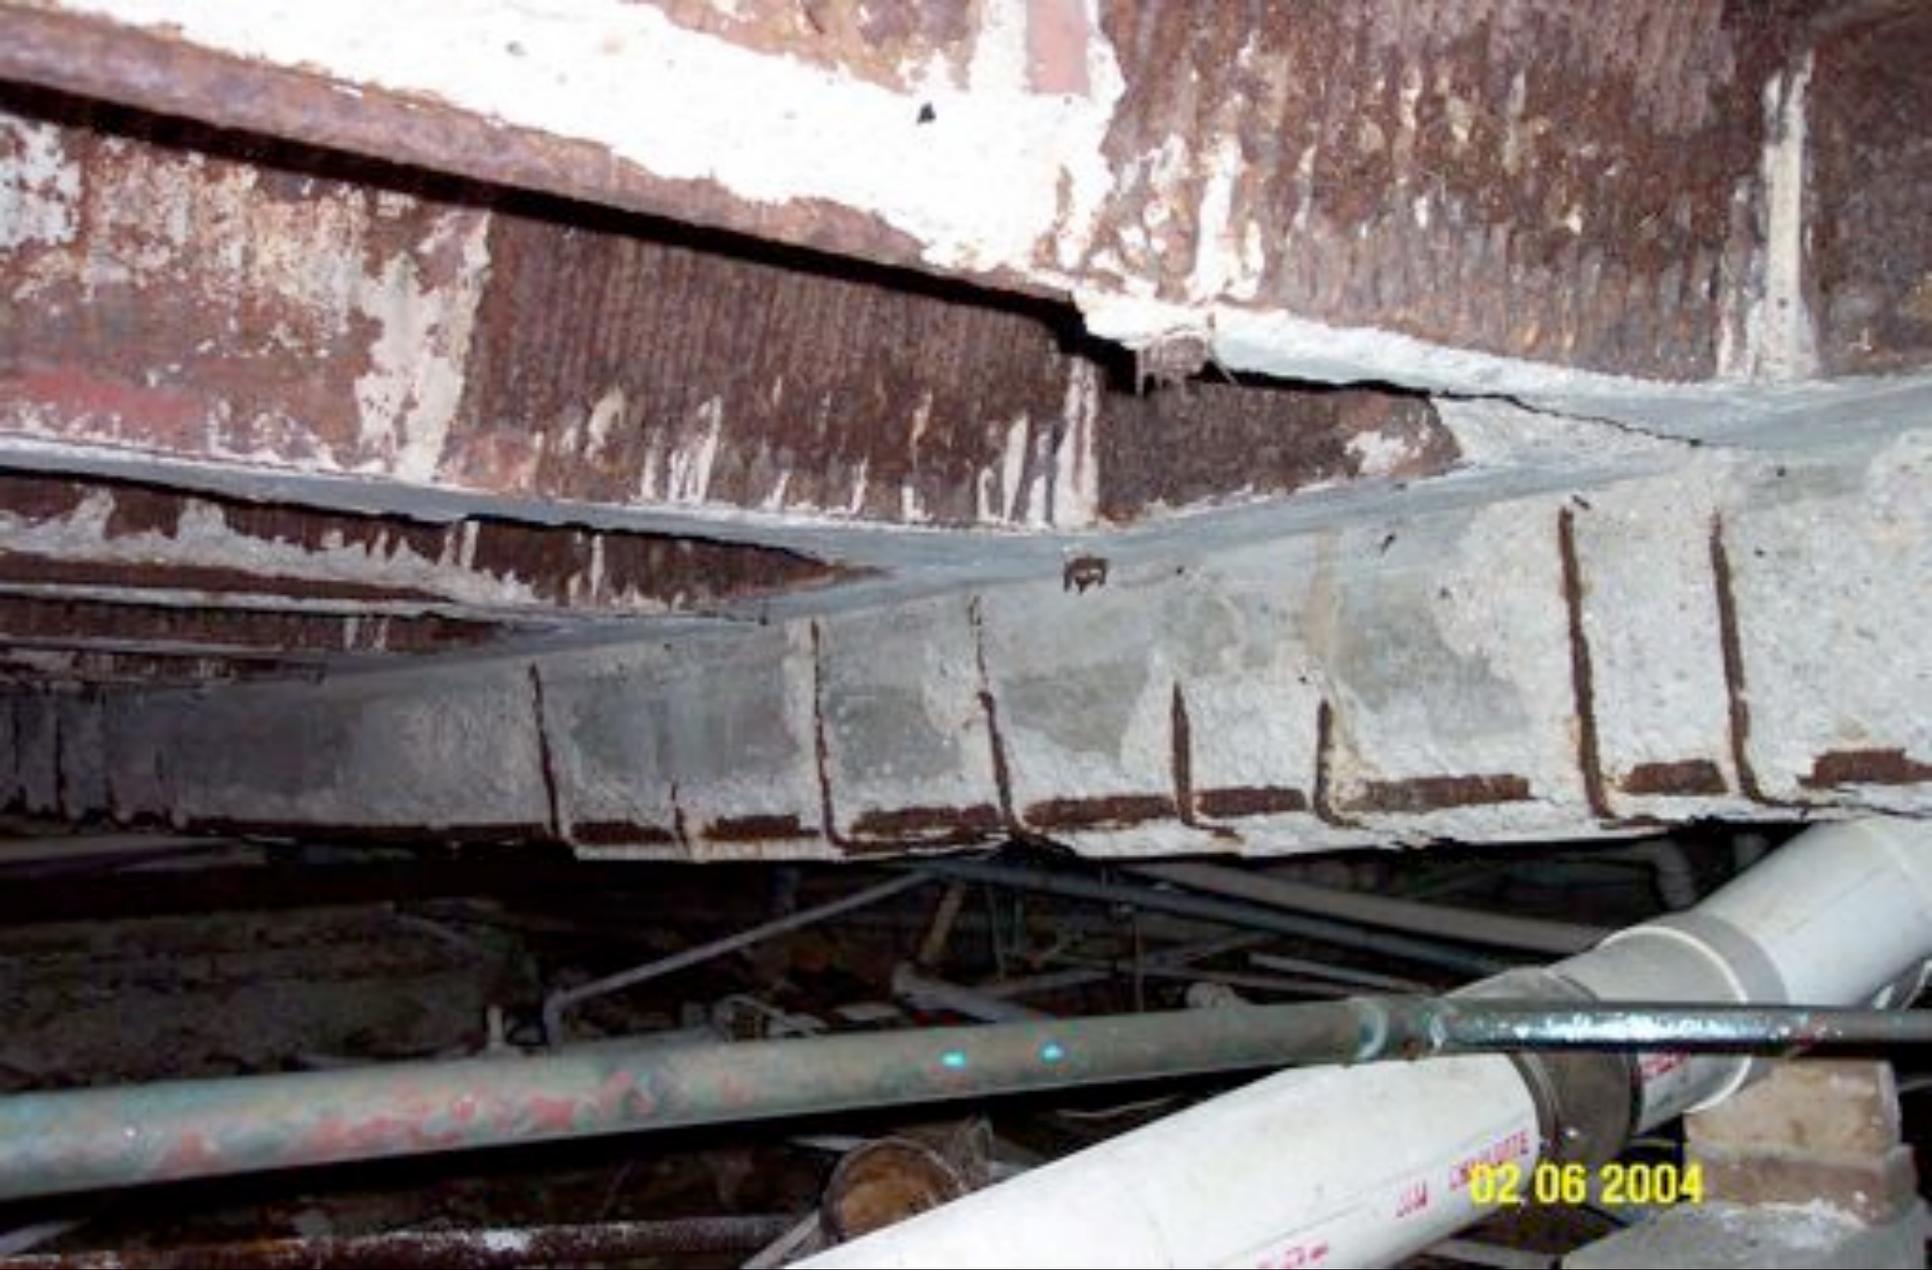
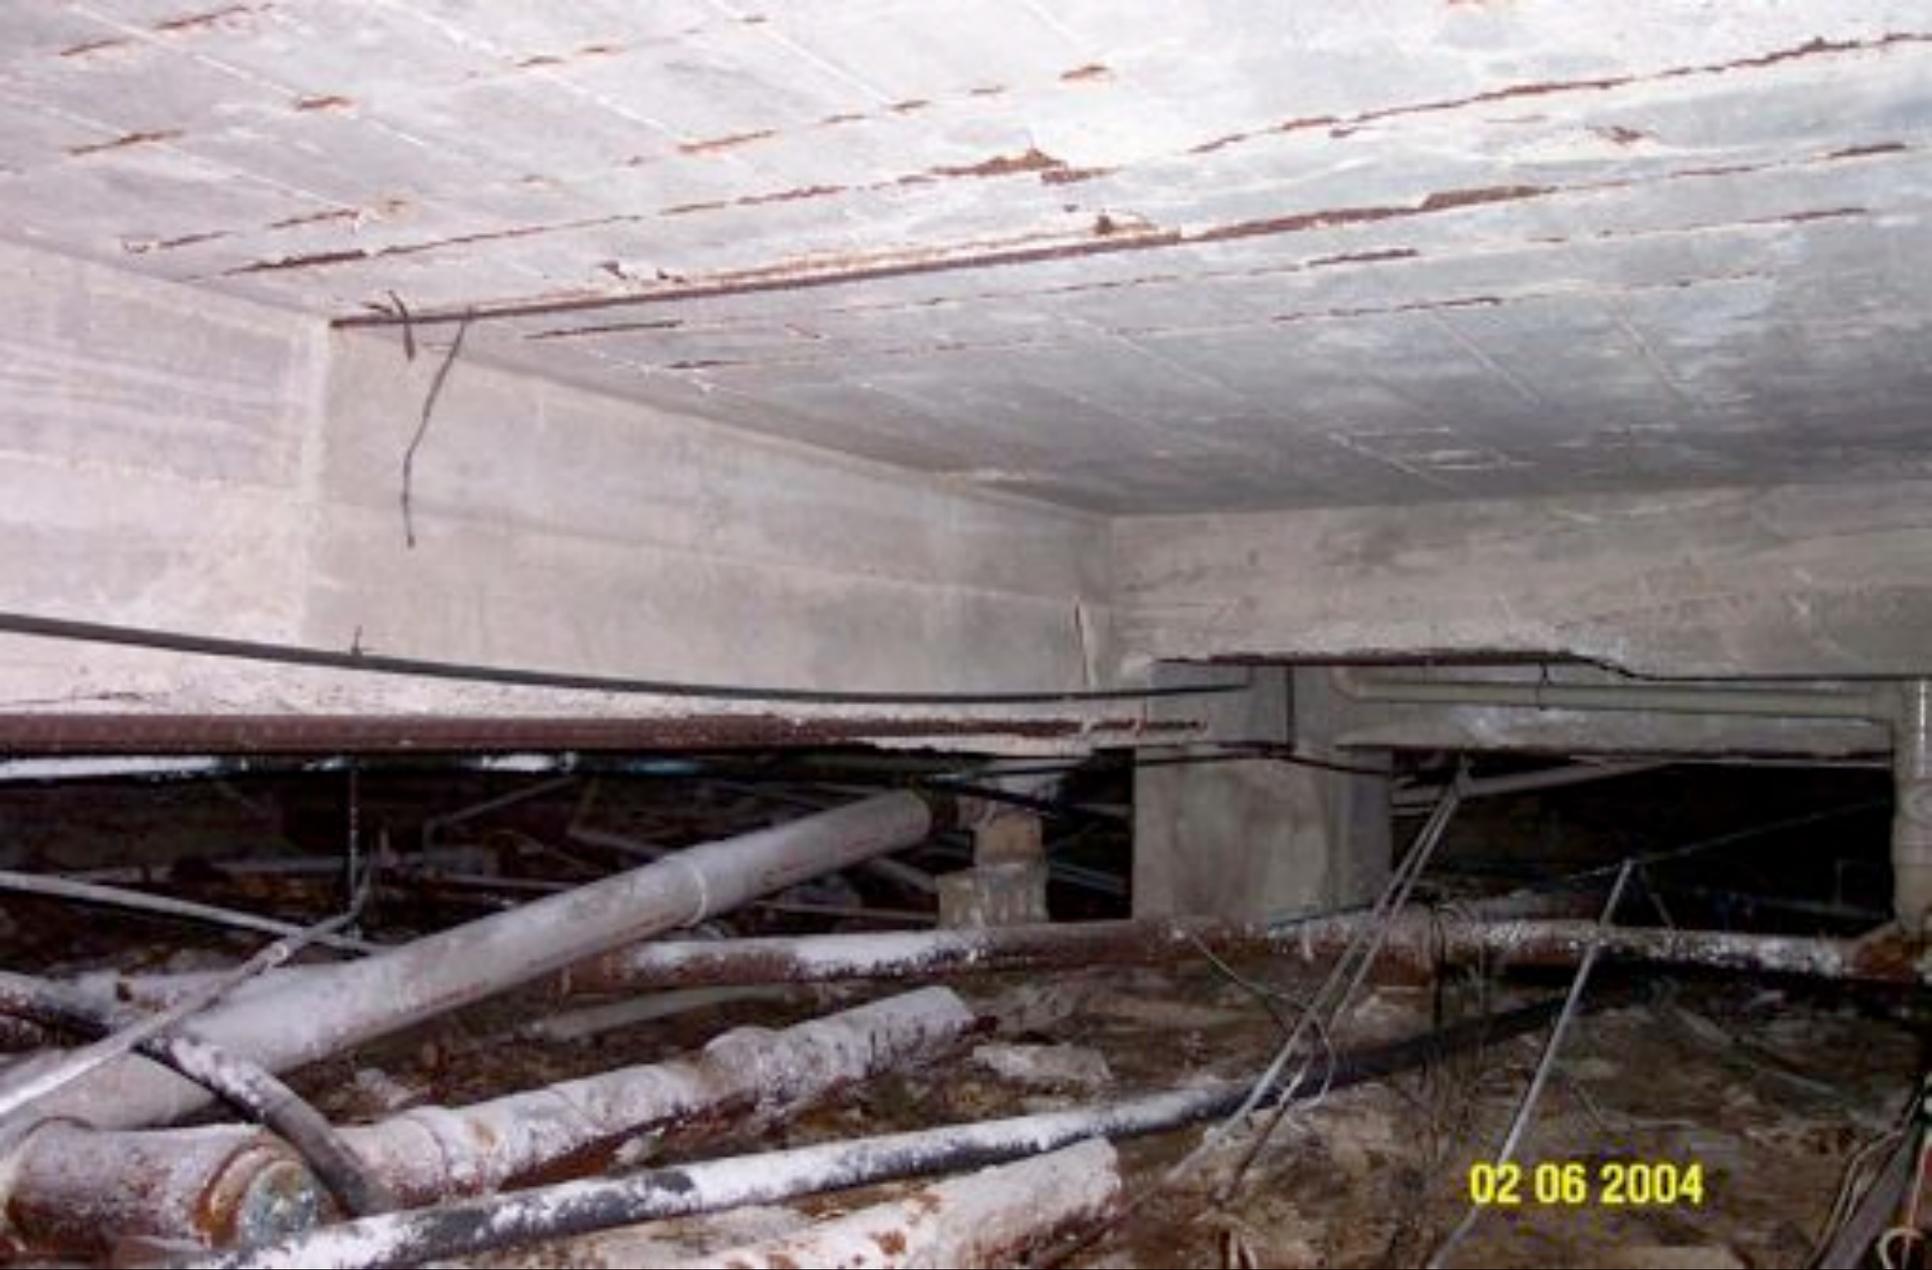
Concrete

- Corrosion of reinforcing
- Loss of section
