The Forces that Destroy Historic Structures

The SC Historic Preservation Conference

Craig M. Bennett, Jr., PE

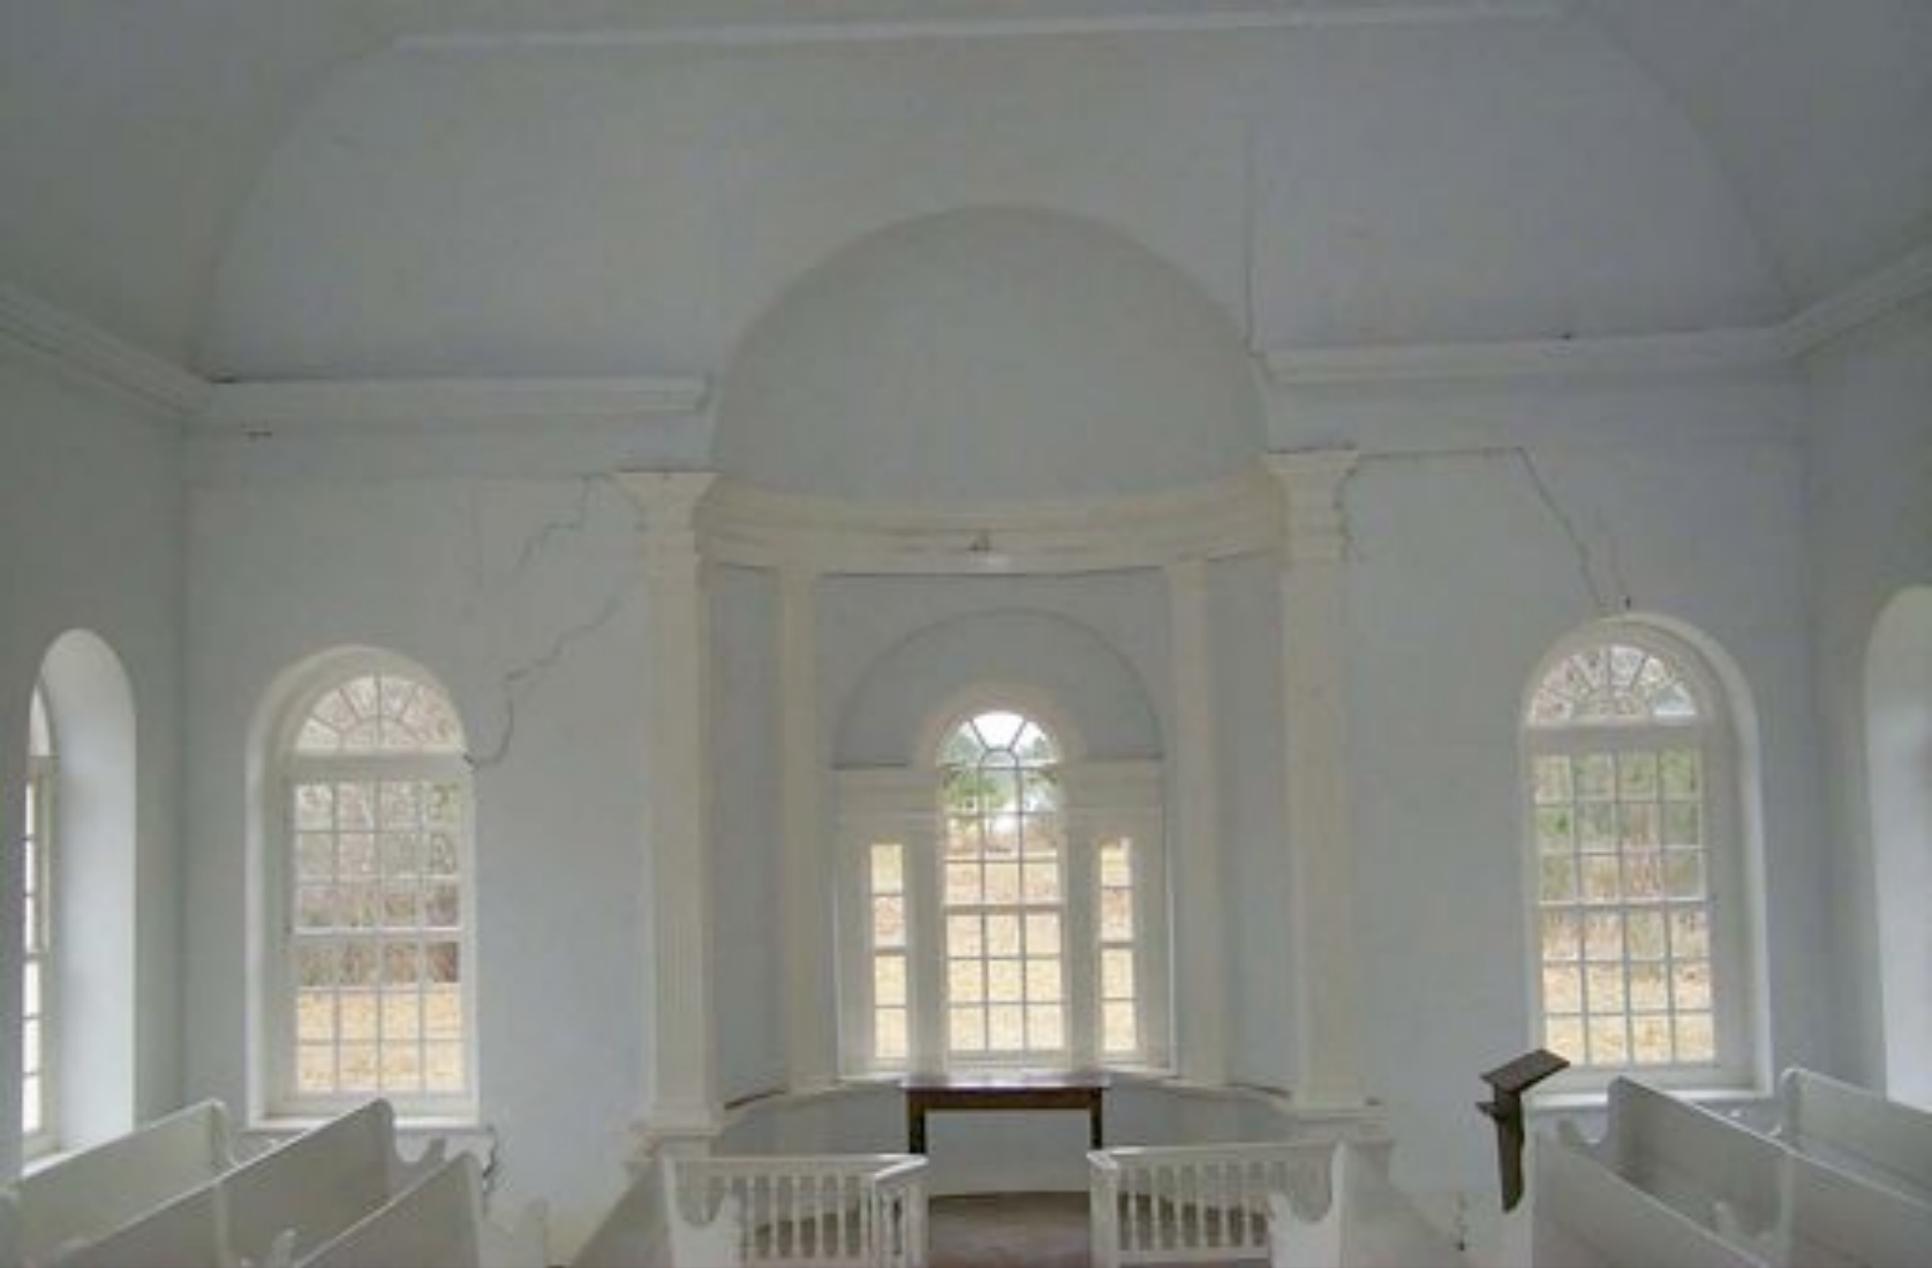
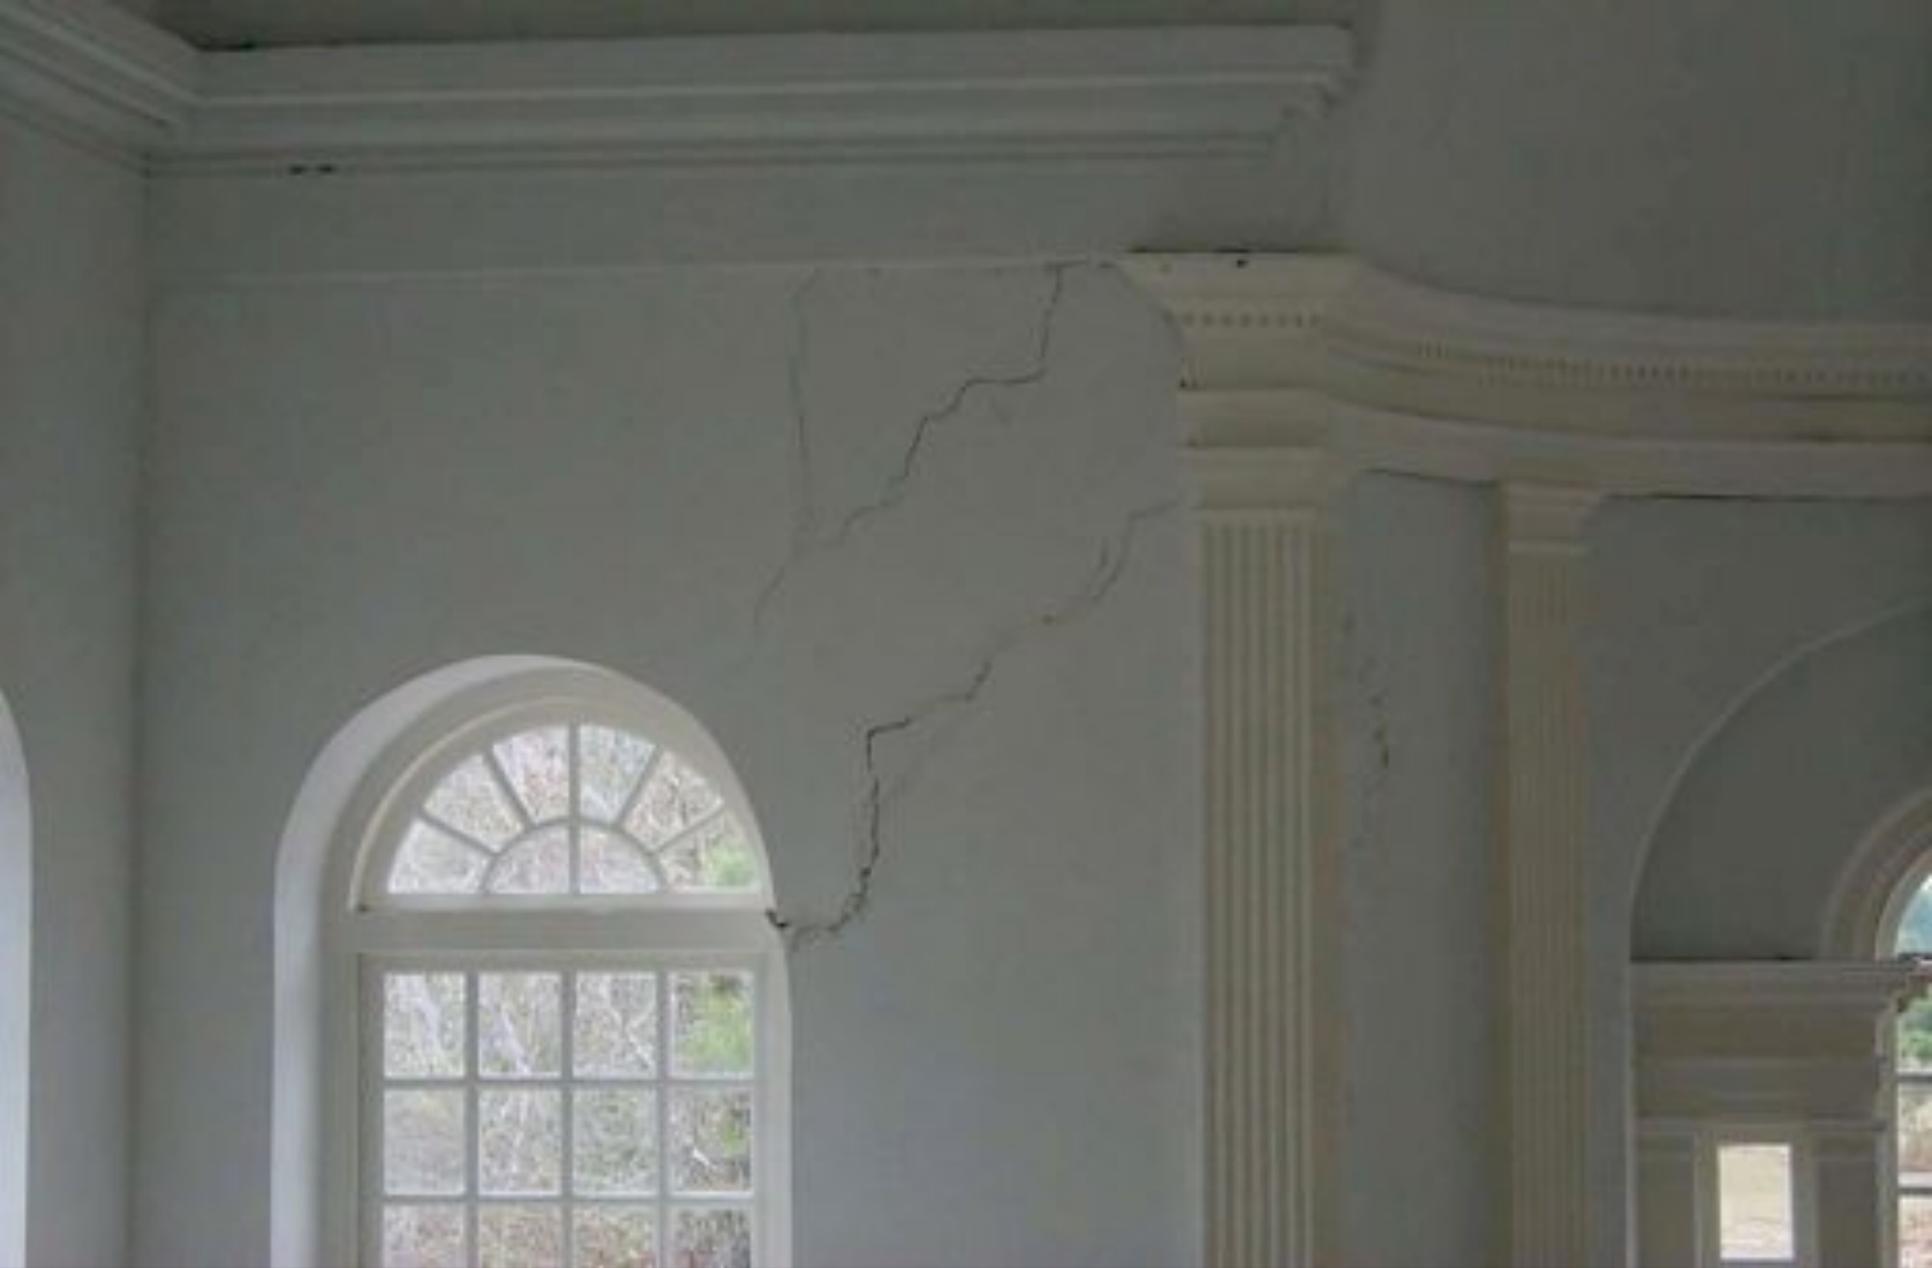
Soil

- Overstress
 - Foundation movement and building settlement

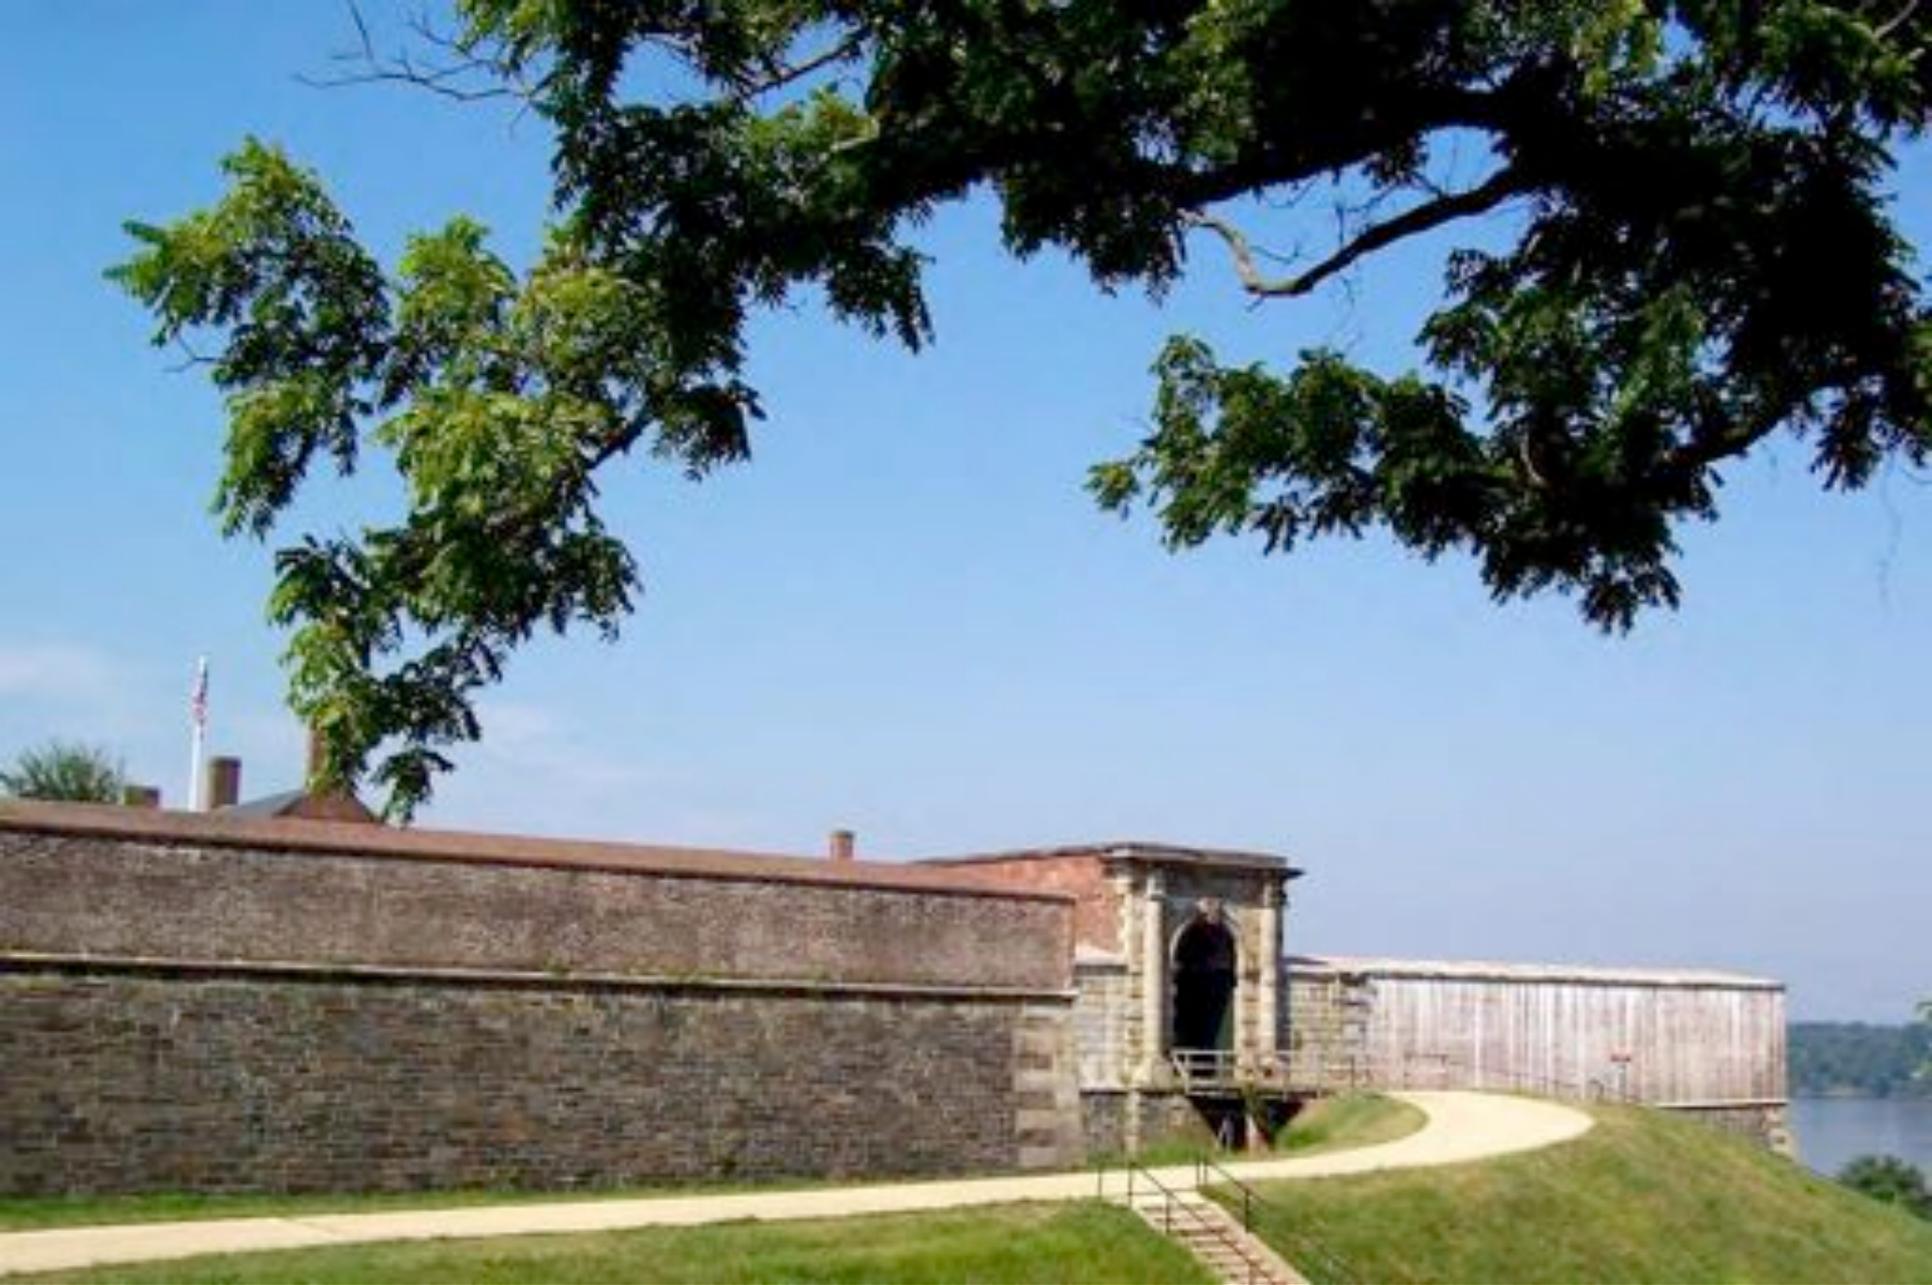
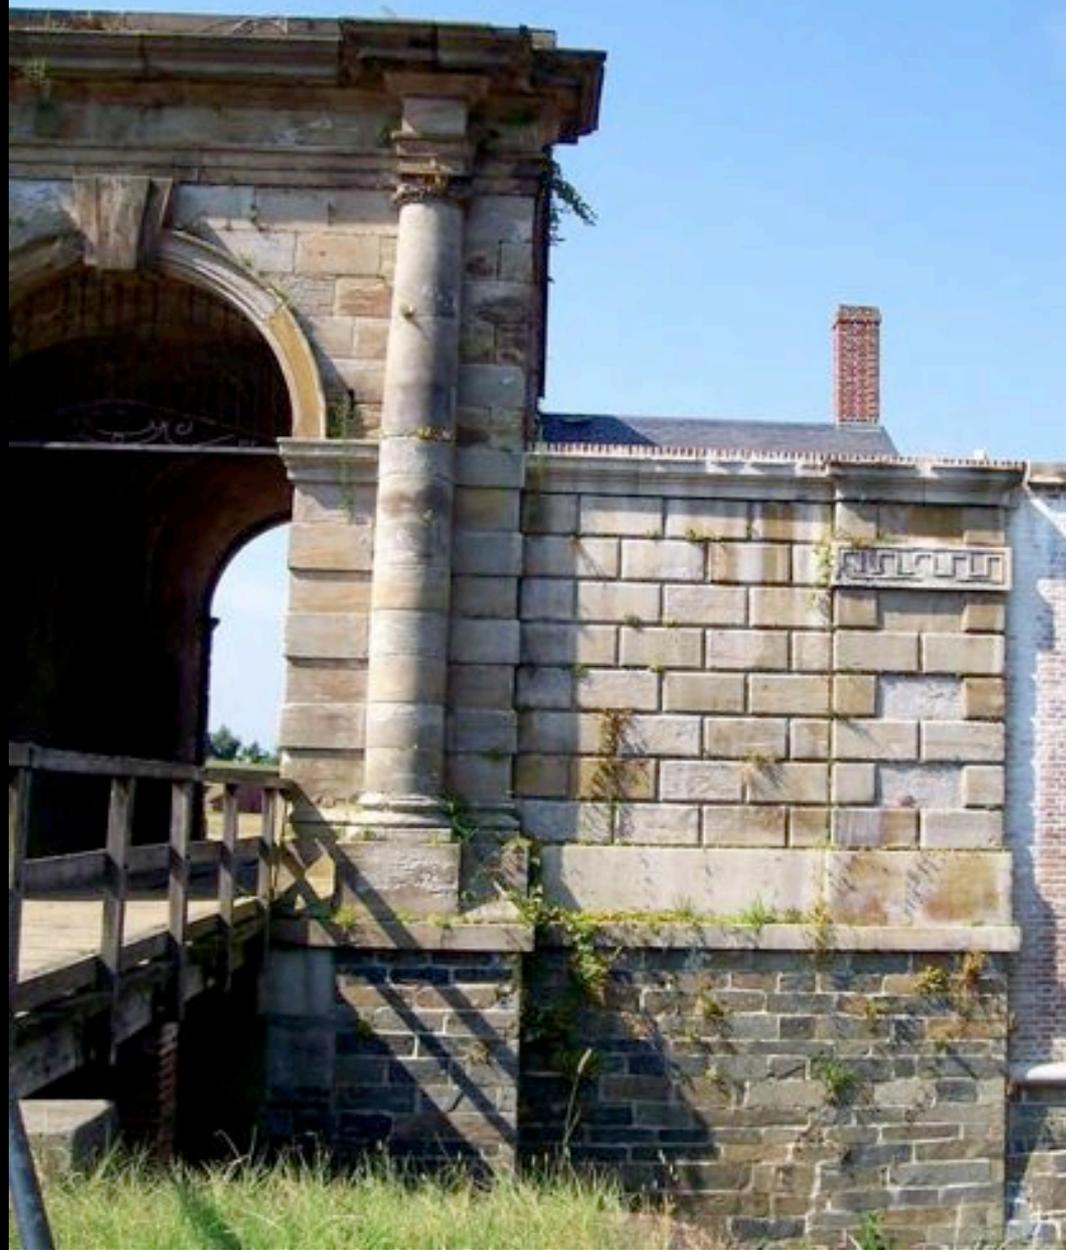
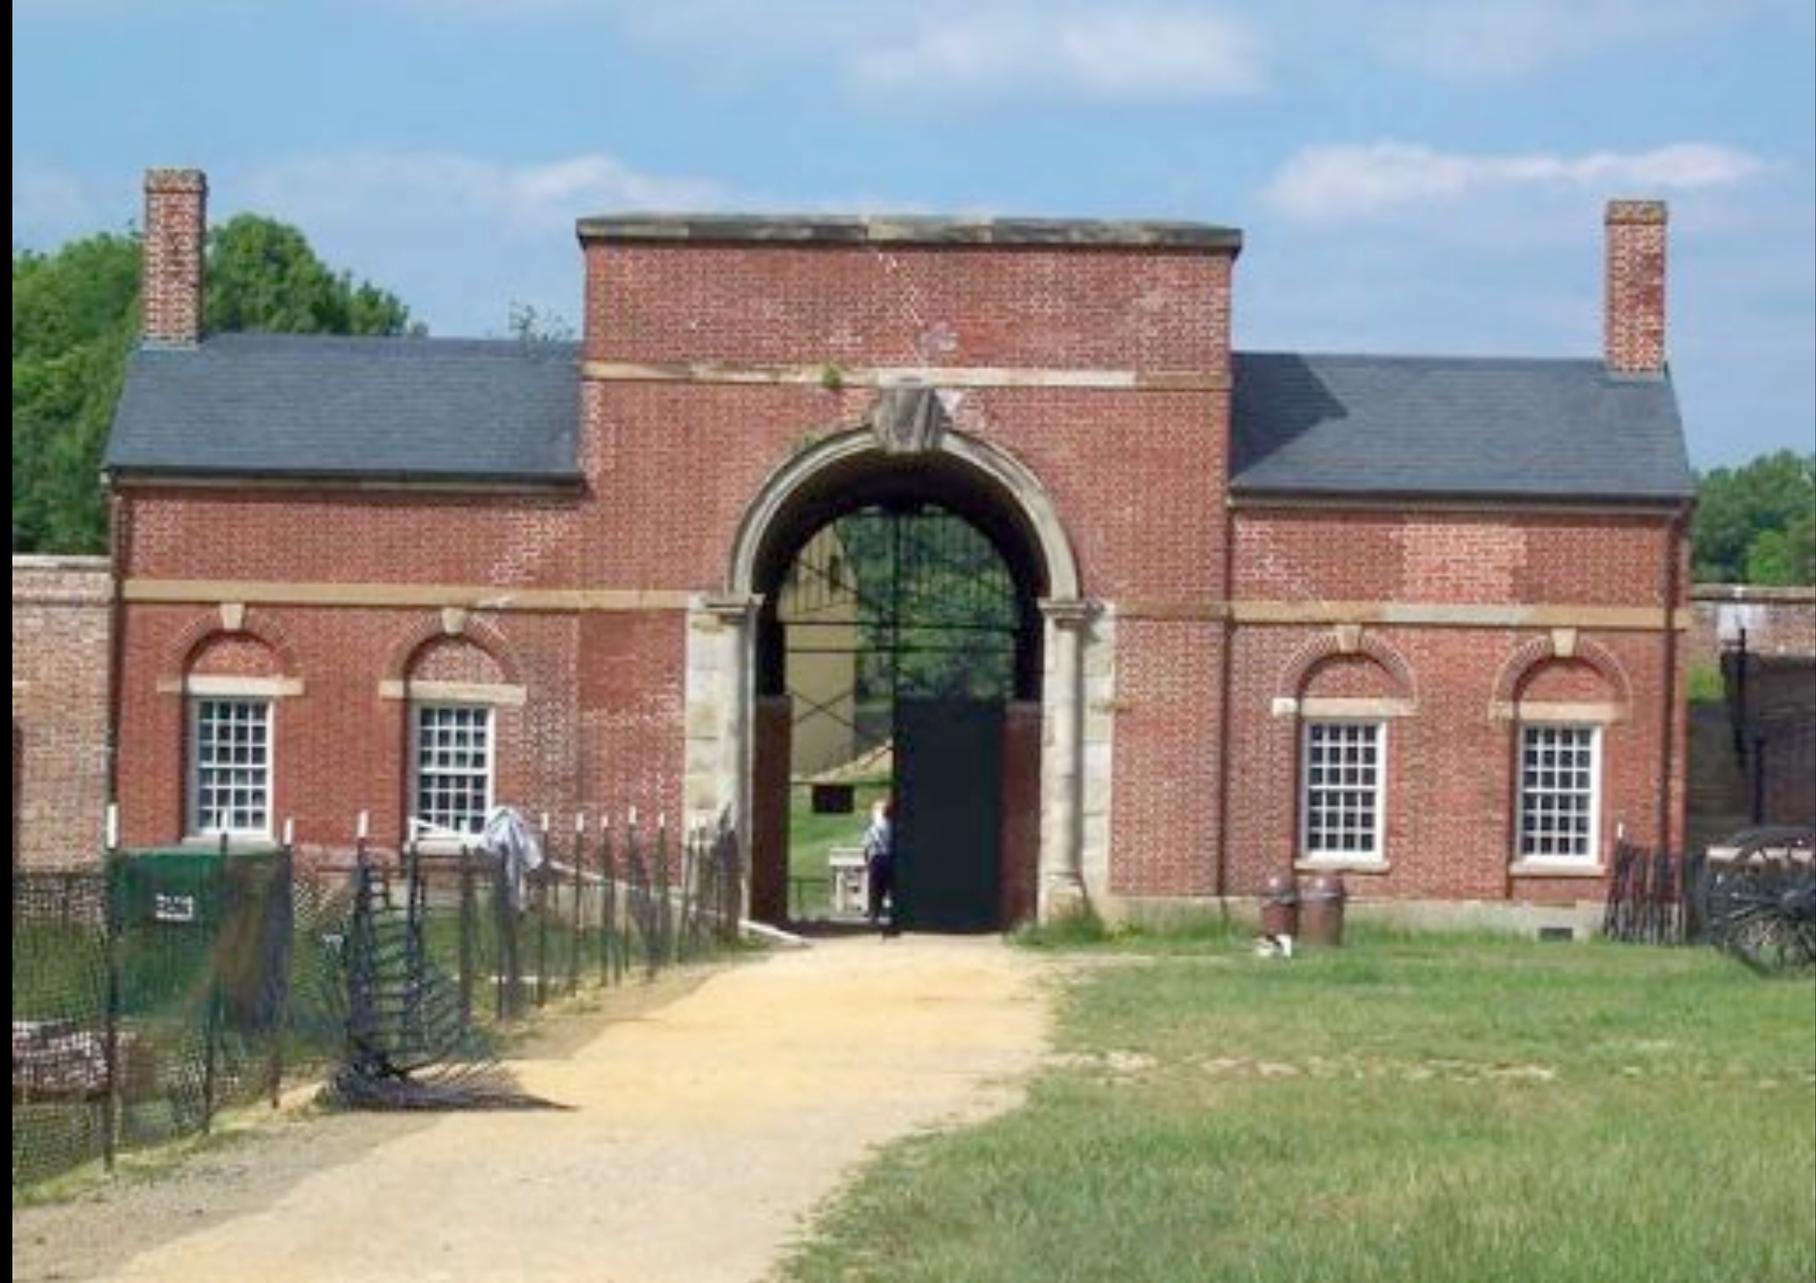
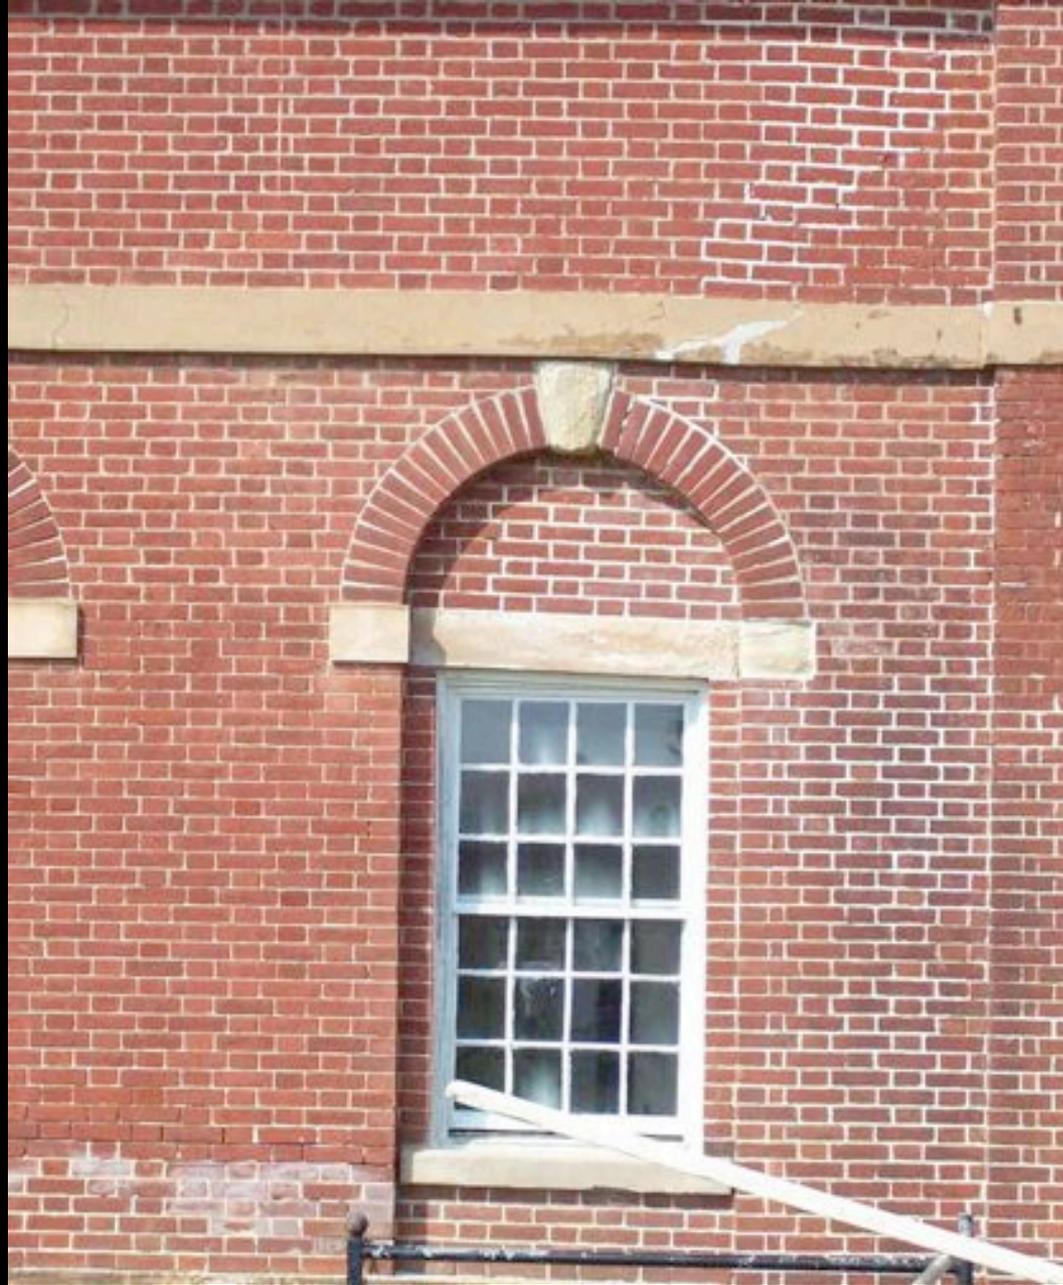
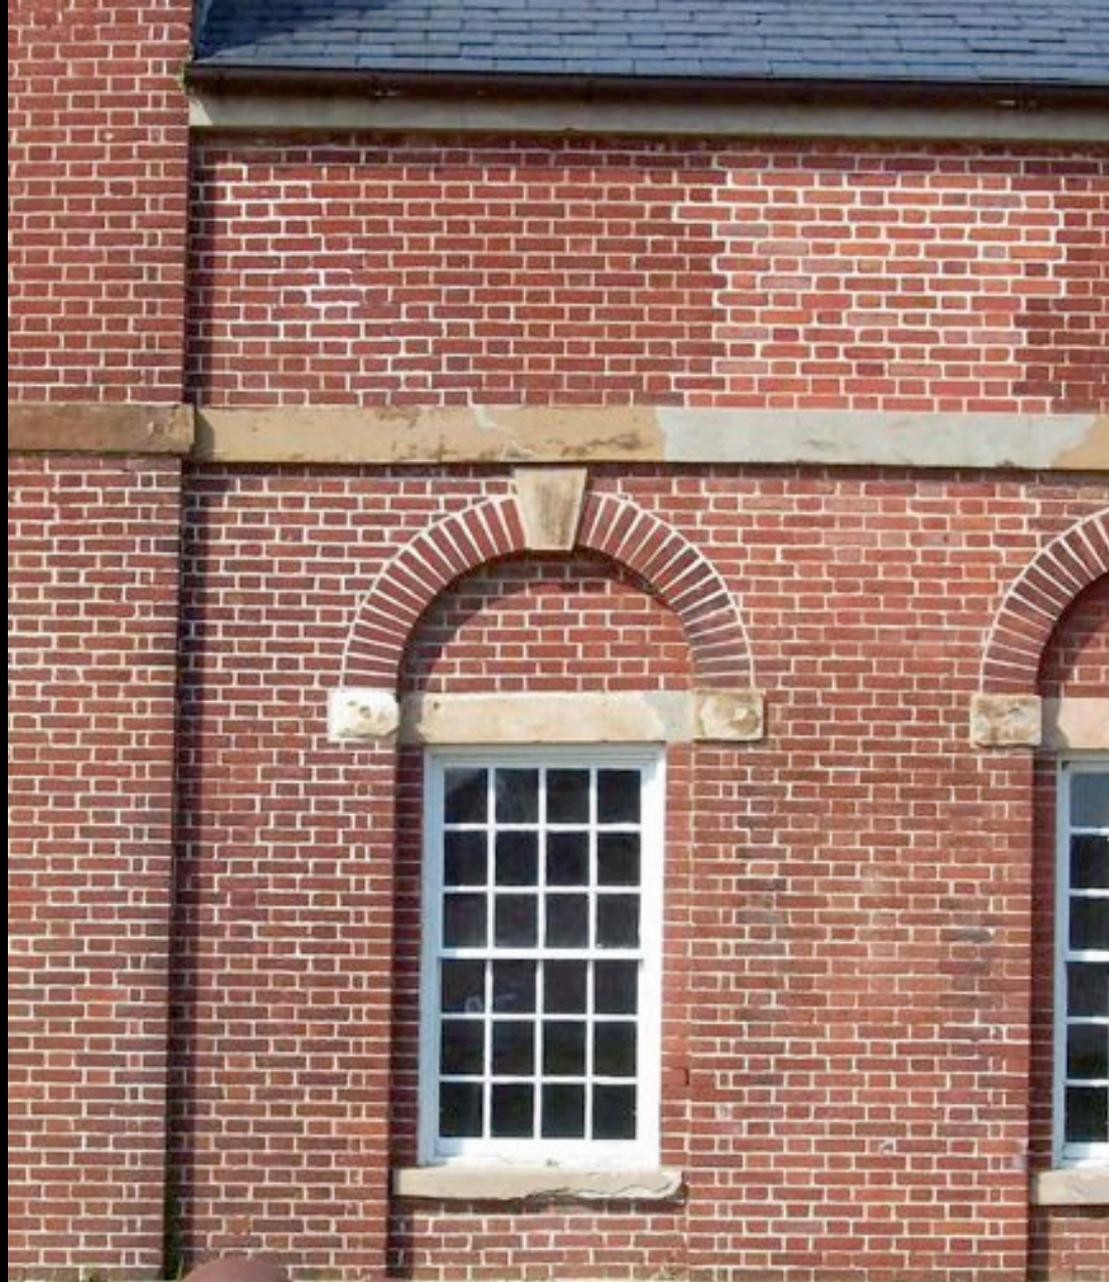
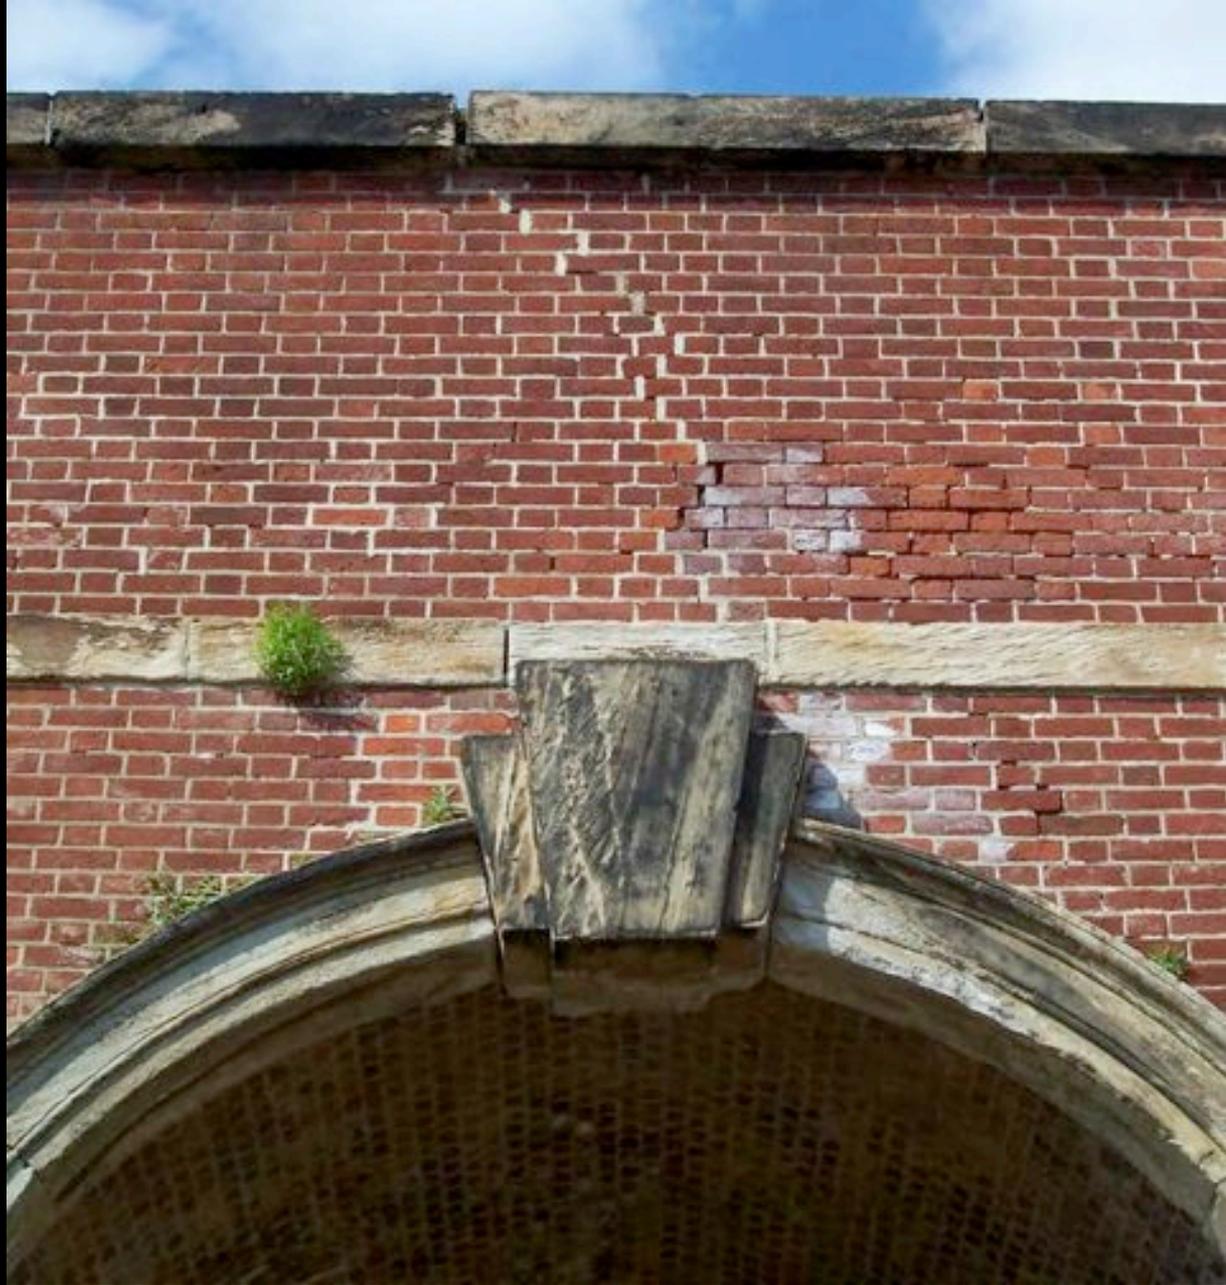
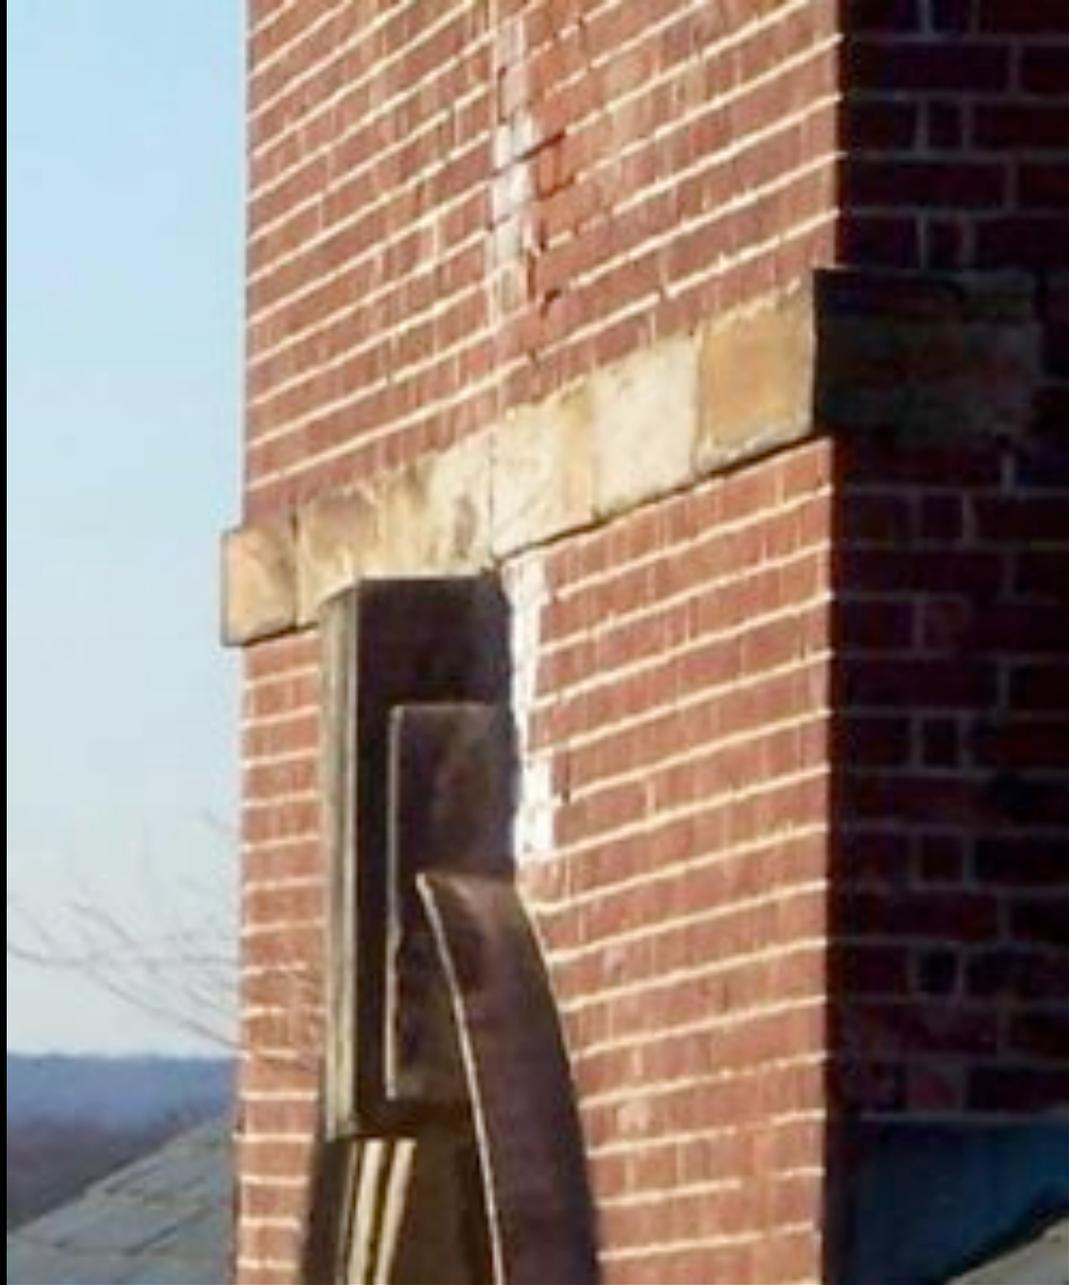
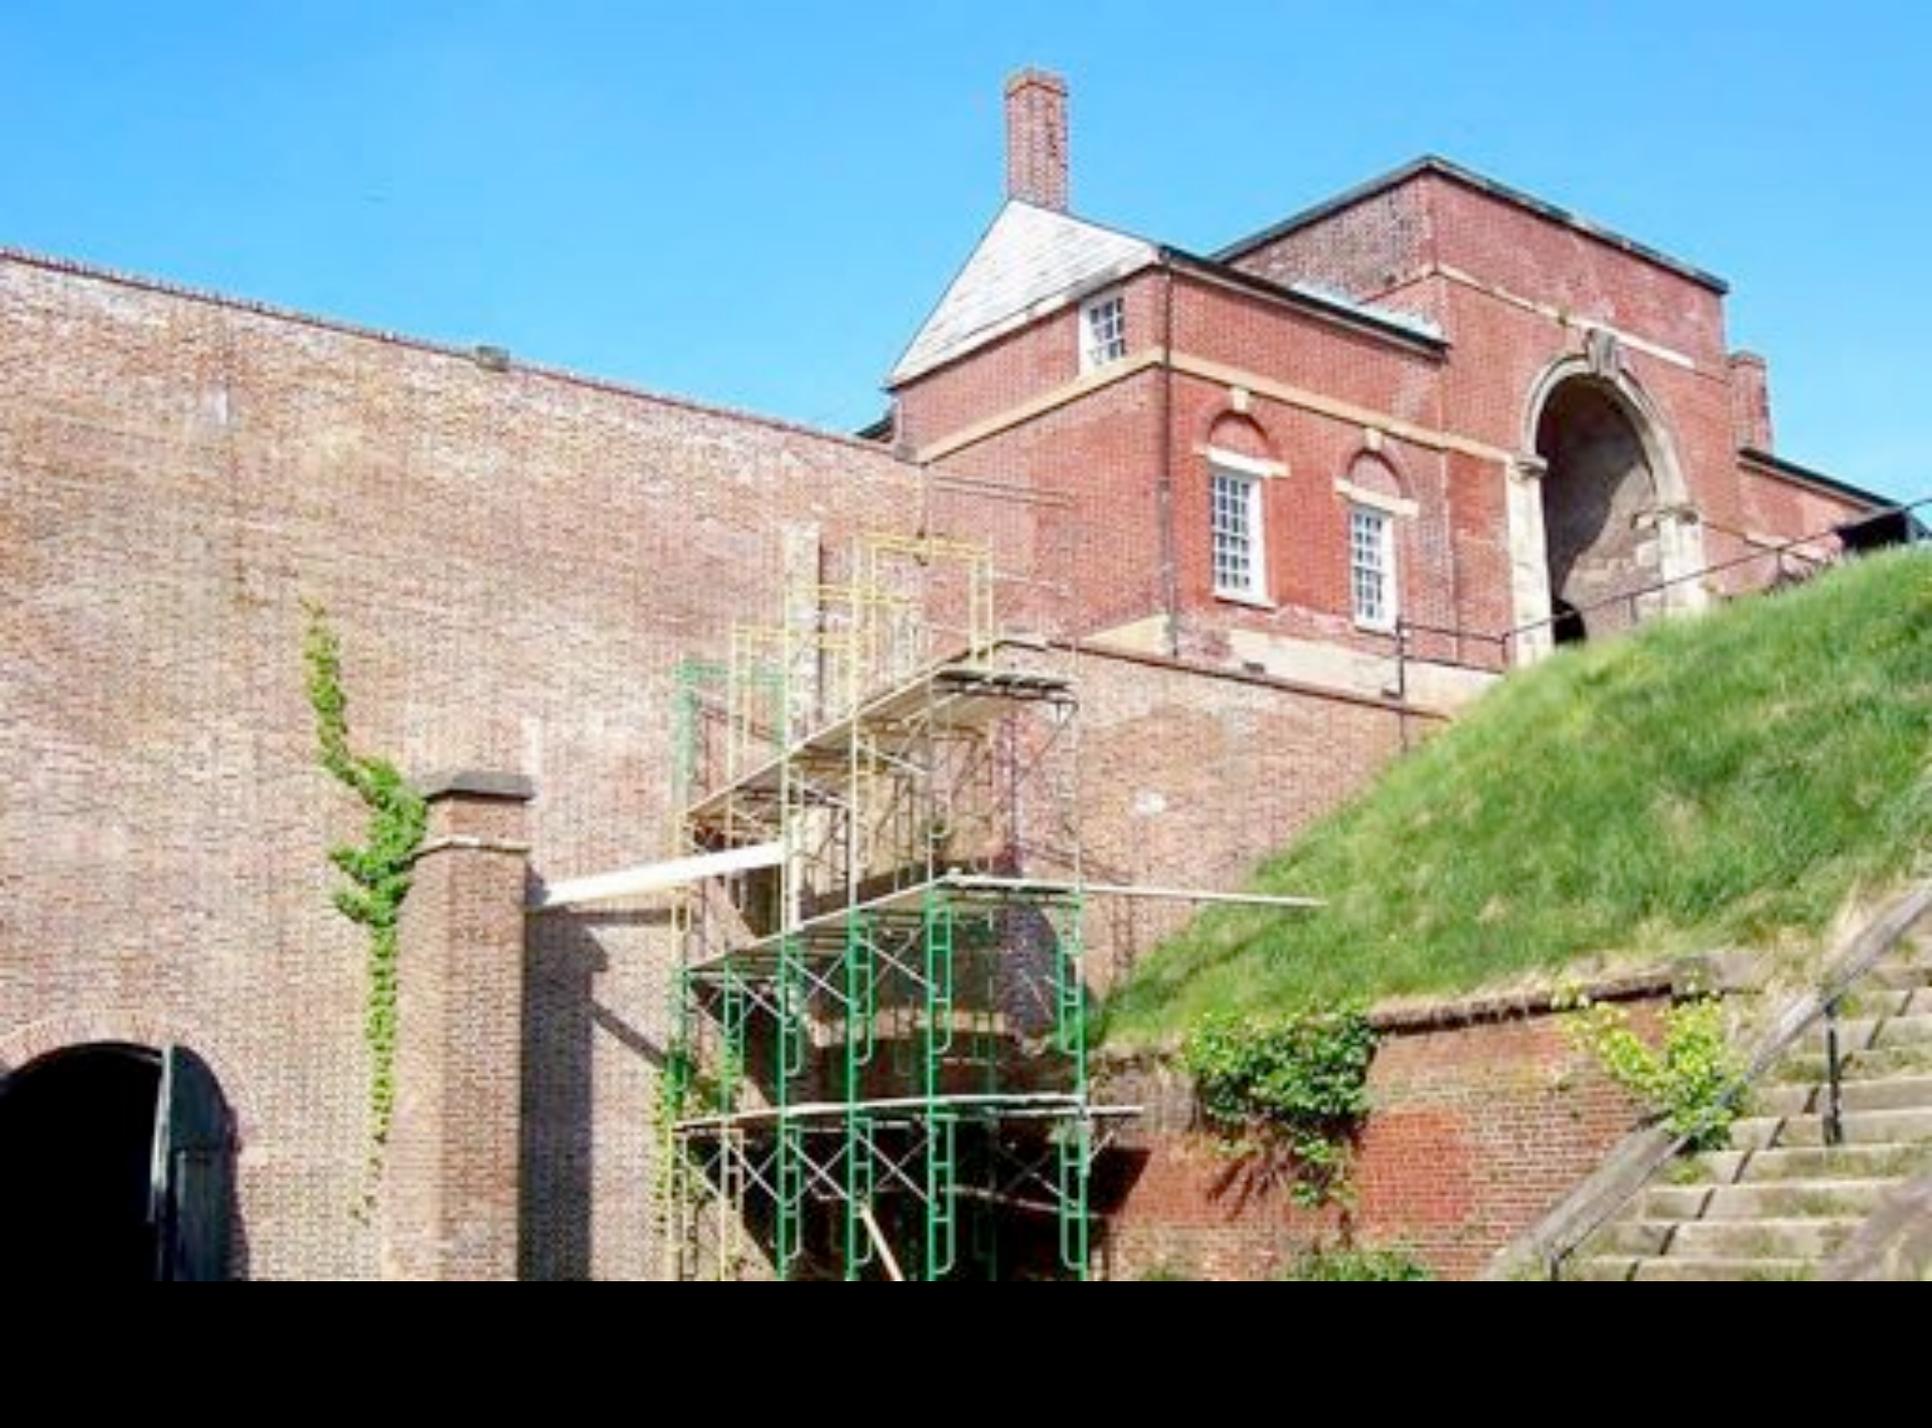
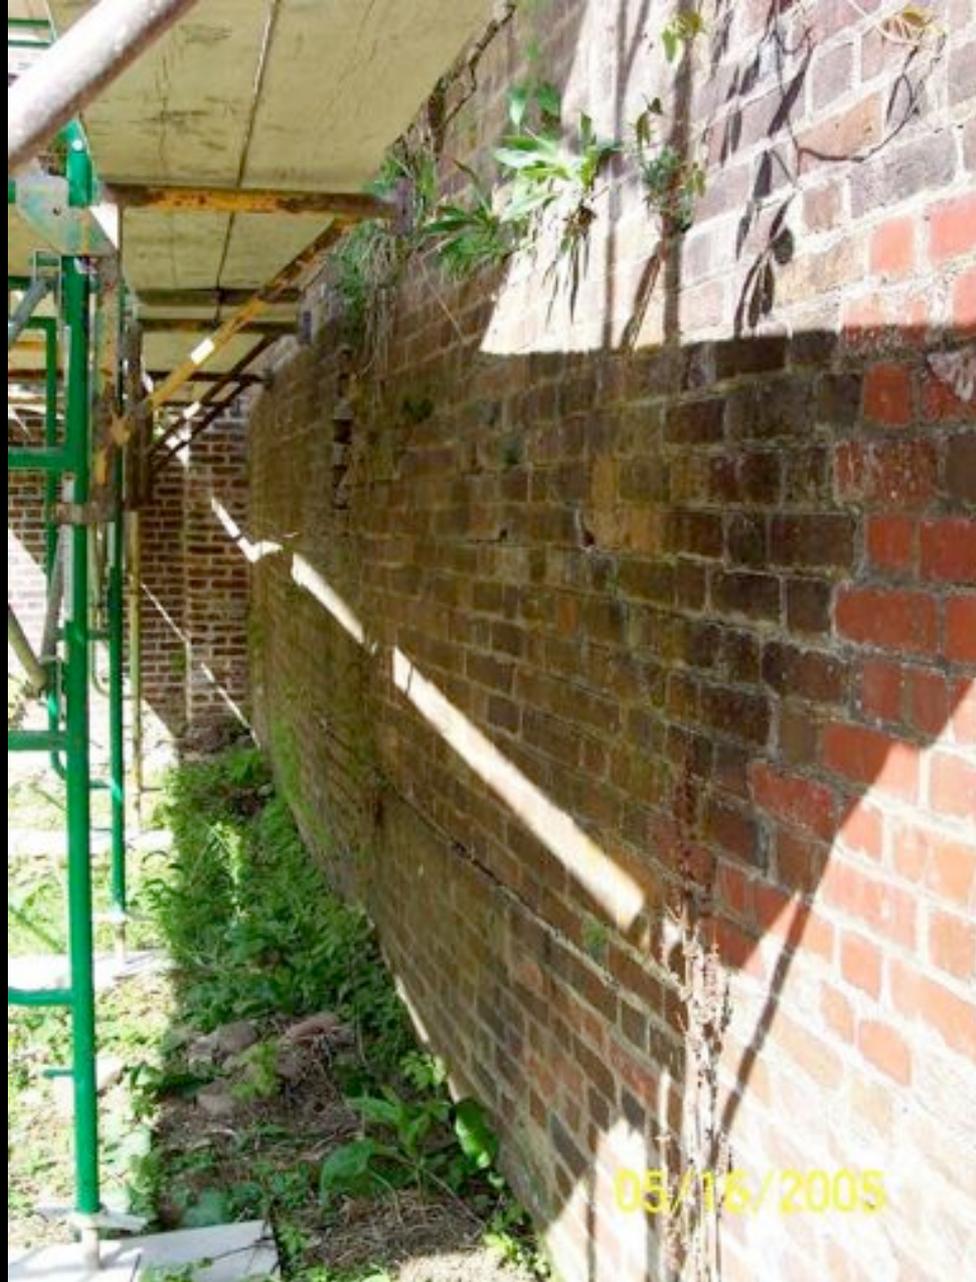
- 1820 Fort Washington, Maryland
 - Major structural issues due to water migration

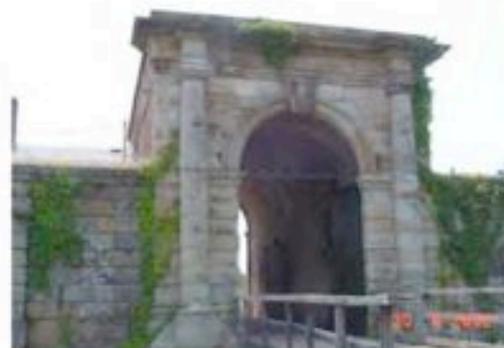
Main Gate – North Elevation

The thermal anomalies in this image highlight areas affected by solar gain. These all tend to relate to areas below the parapet wall. This would suggest that the fill below the paved areas on the roof of the Sally Port has absorbed high levels of solar radiation. This occurs where the fill material has a high moisture content increasing the rate at which solar gain is absorbed.

The migration of heat down to the lower levels of the masonry would suggest that moisture is also draining down through the building fabric.

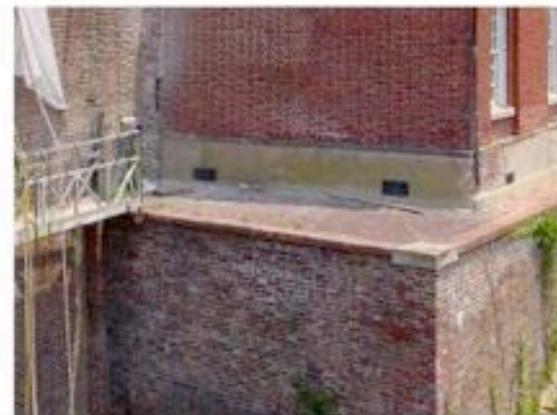
West Elevation – Gatehouse, guardhouse

The anomaly highlighted here, is an extension of the anomaly shown in thermogram 4 and connects with the anomaly below the first floor stringcourse.
