The Forces that Destroy Historic Structures

The SC Historic Preservation Conference

Craig M. Bennett, Jr., PE

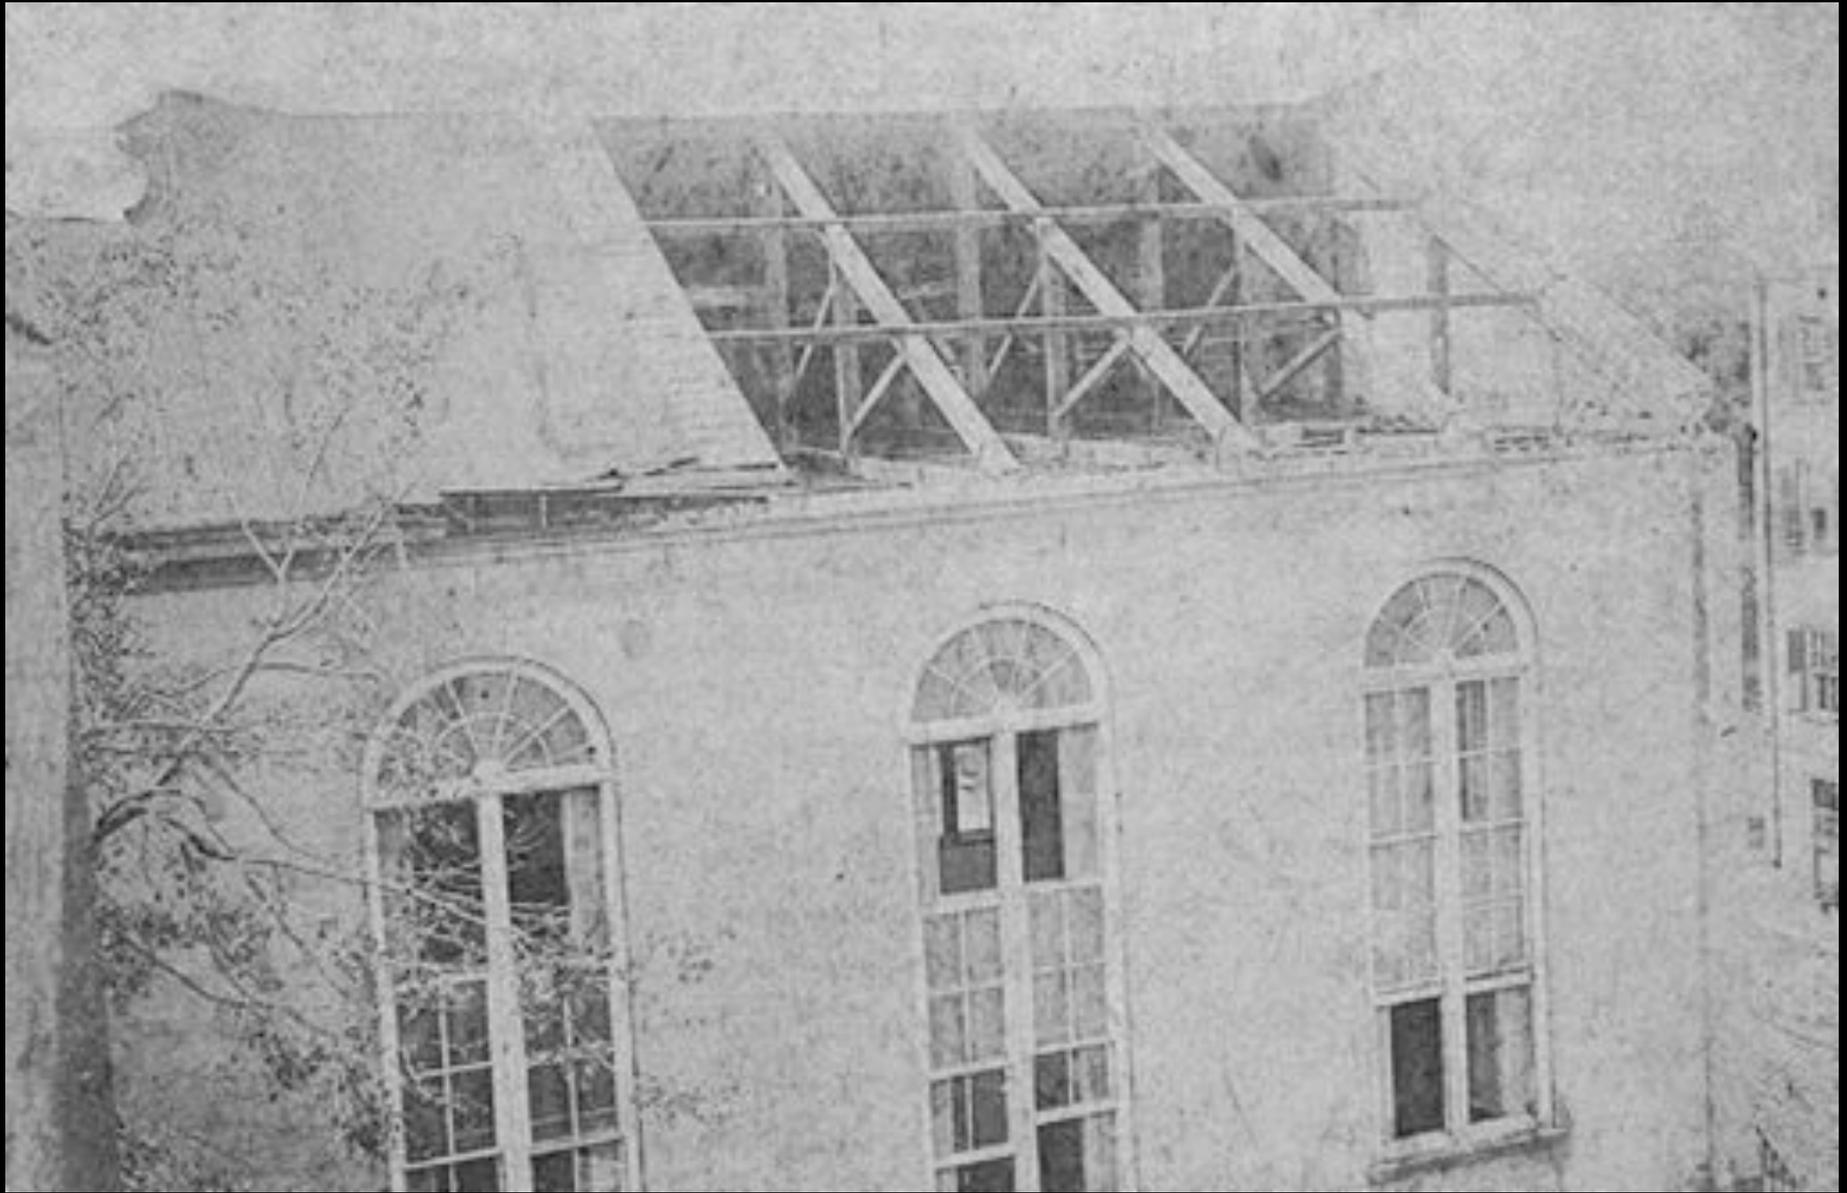
1897 Hurricane Damage

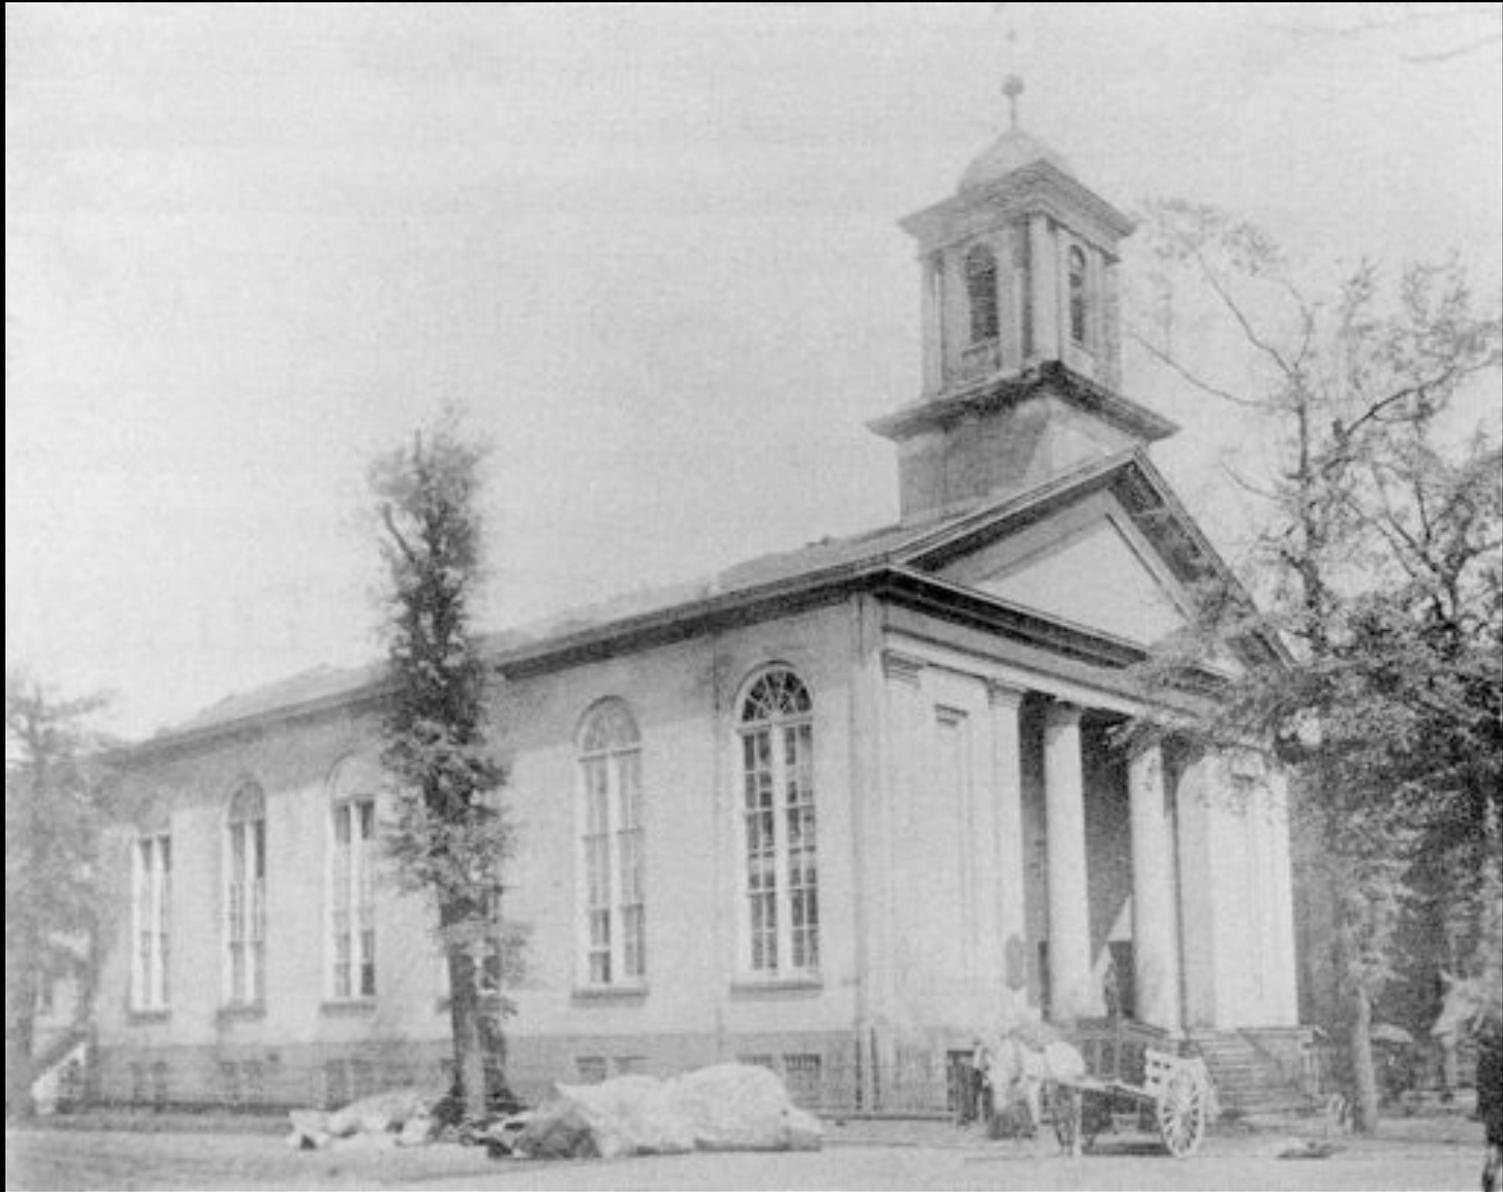
1897 Hurricane Damage

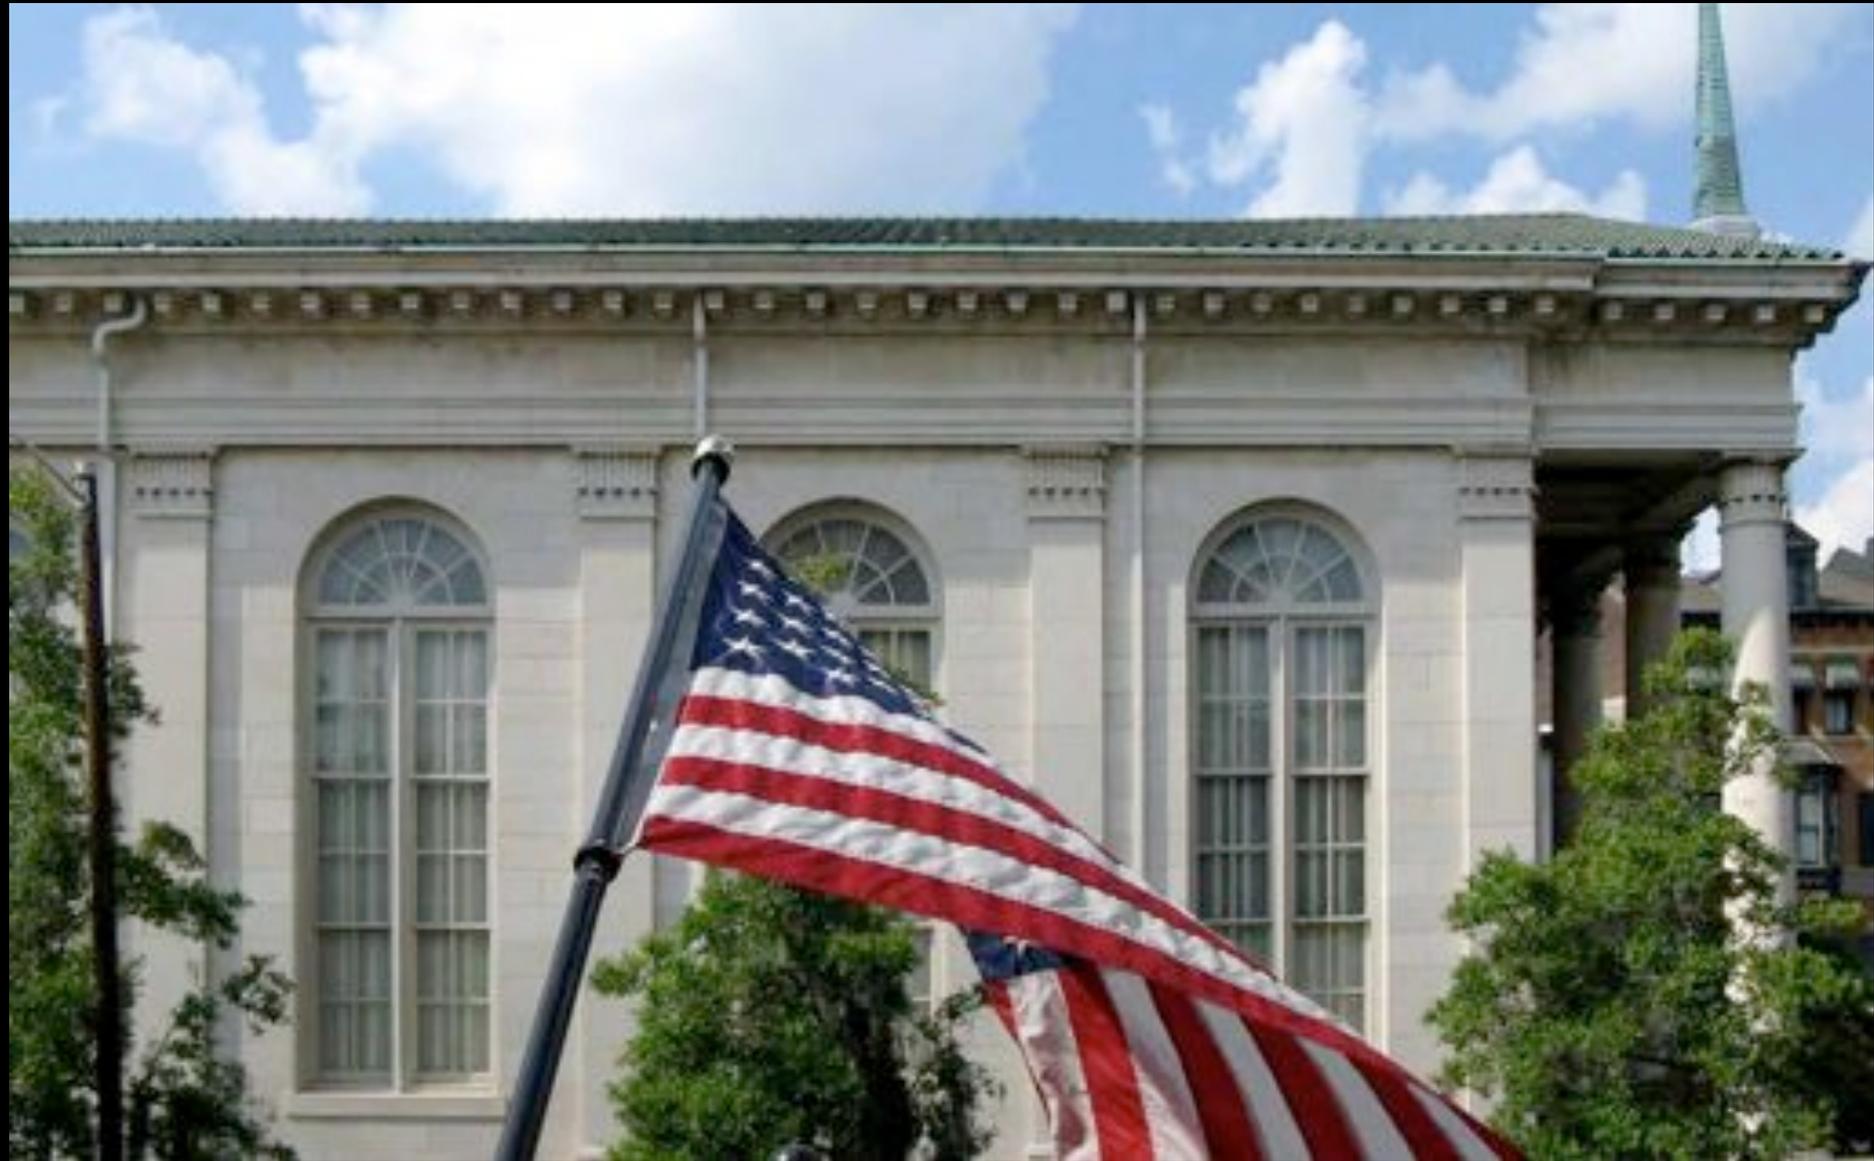
Roof line Deformation

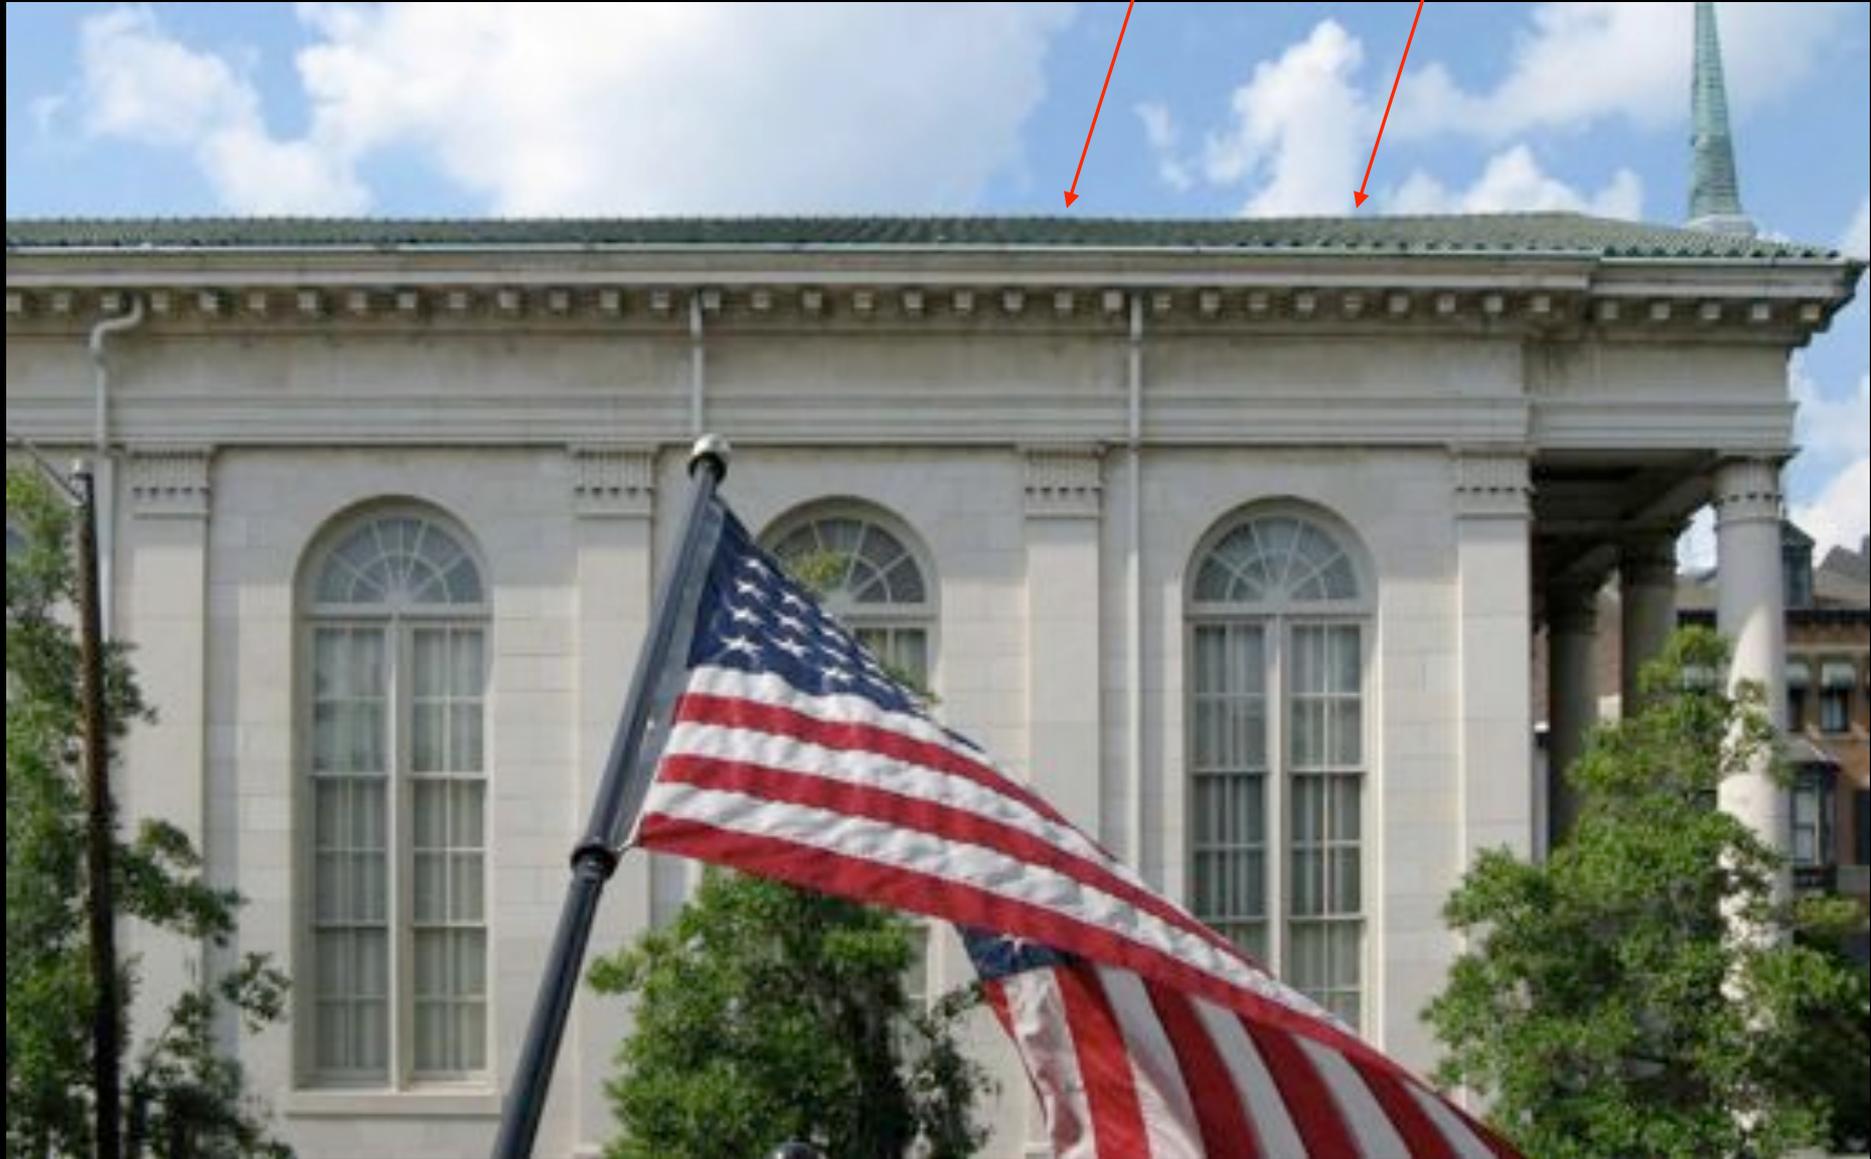
Roof line Deformation

Truss 2

Truss 1

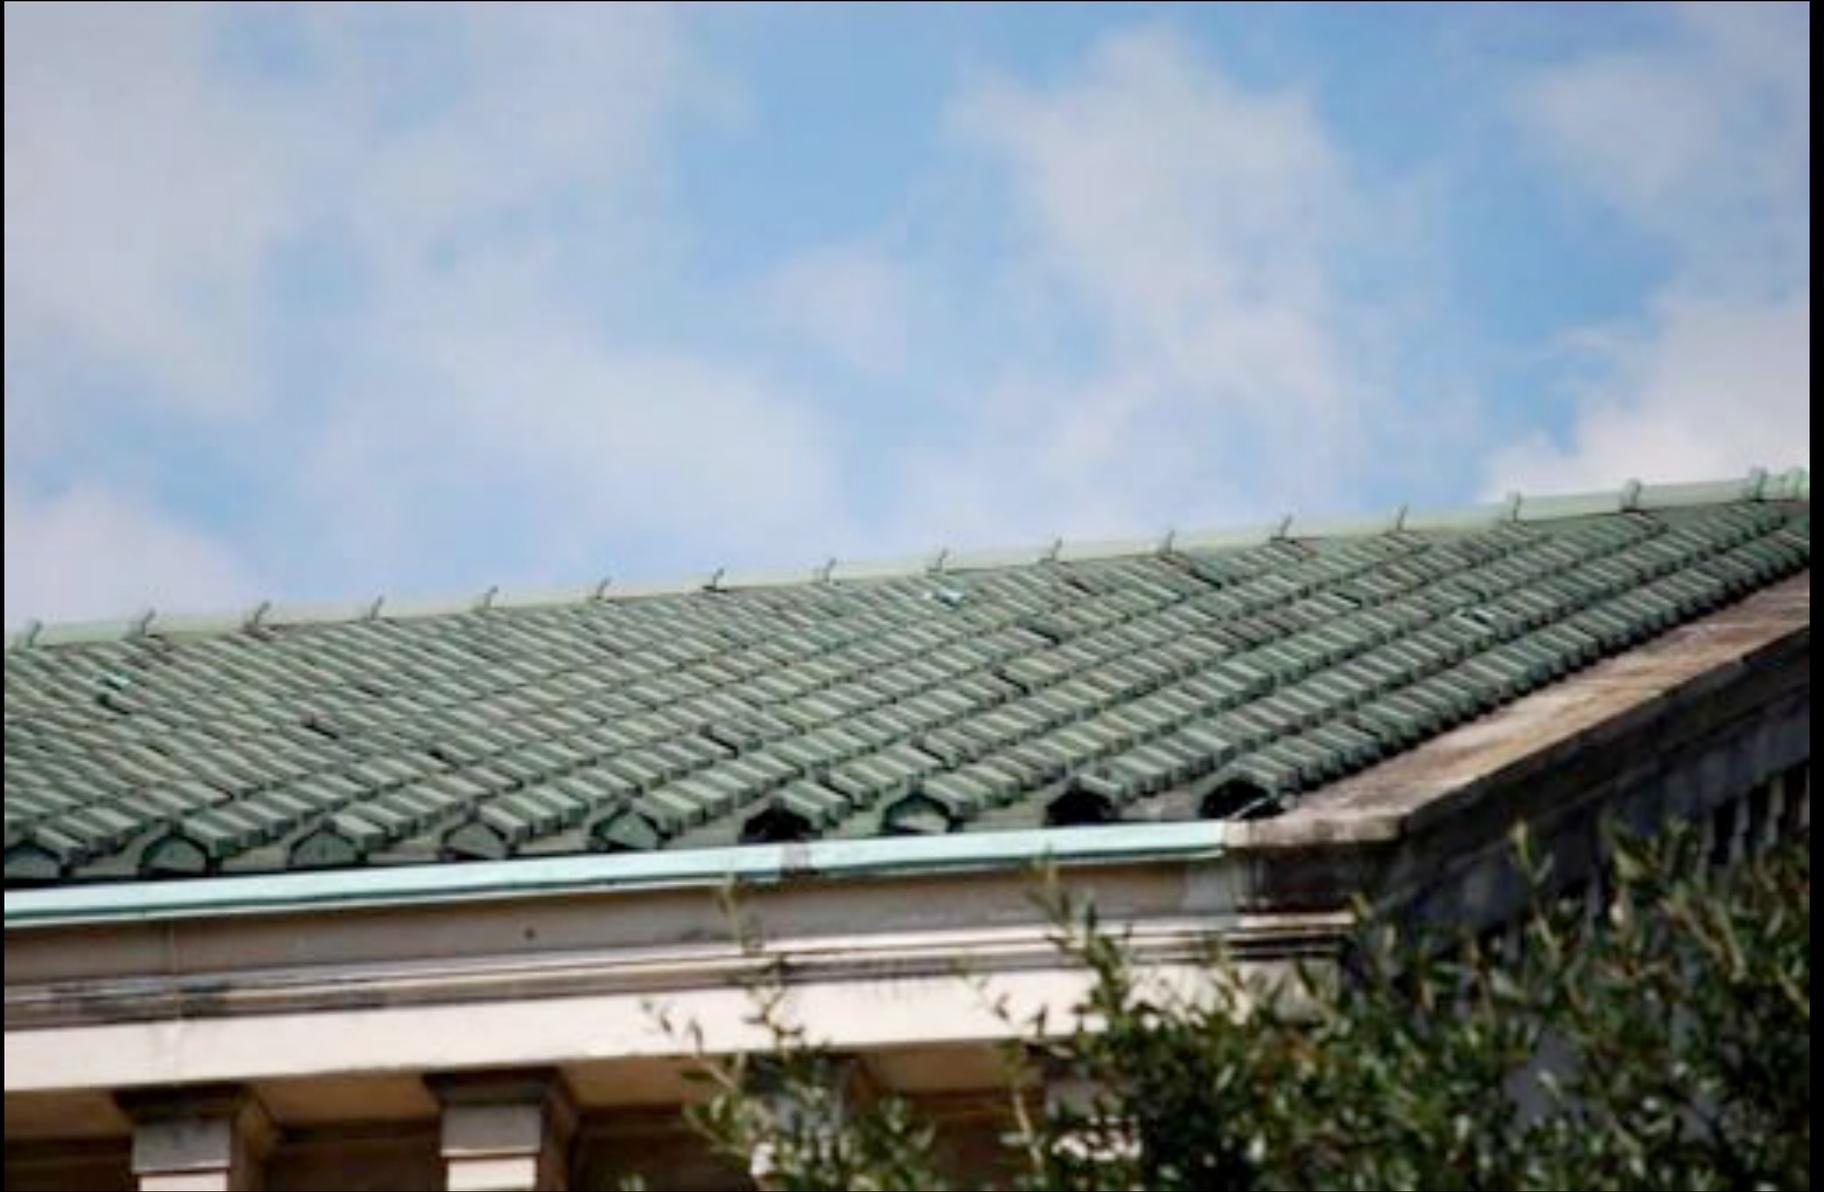
Significant Truss Loads: Roof Loads

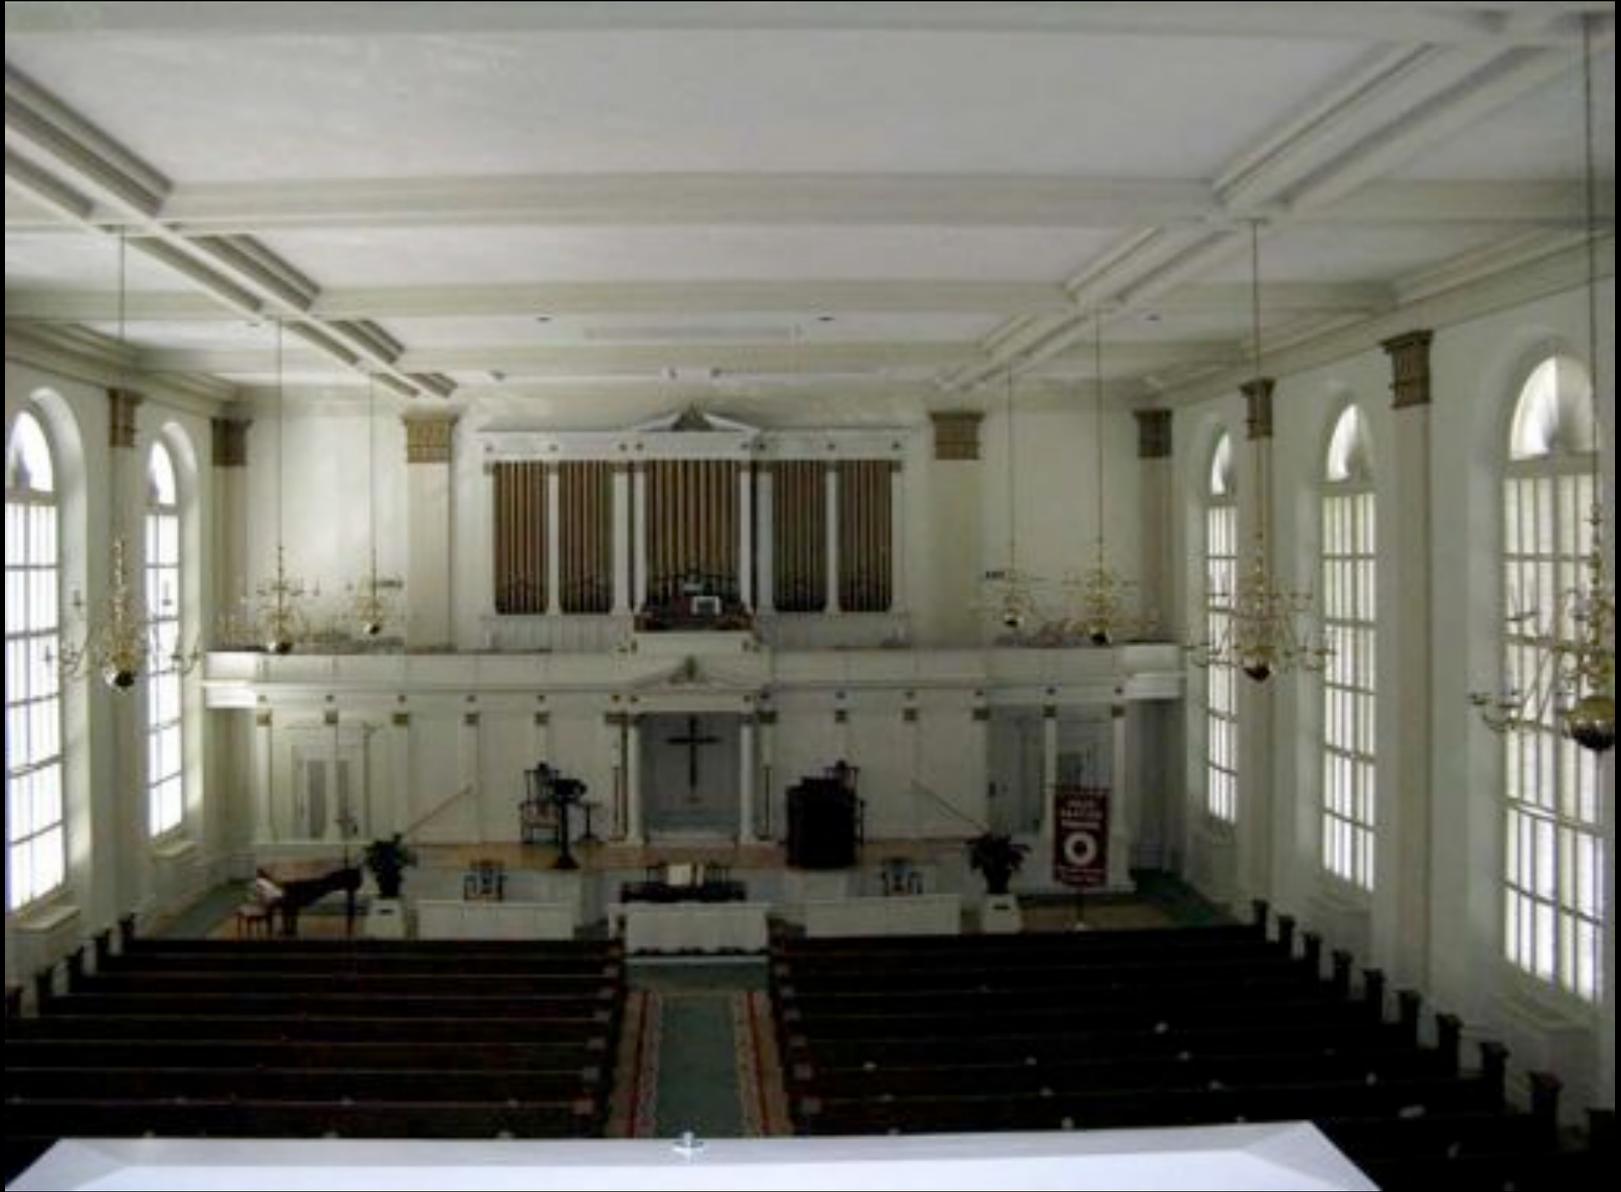
Significant Truss Loads: Ceiling Plaster

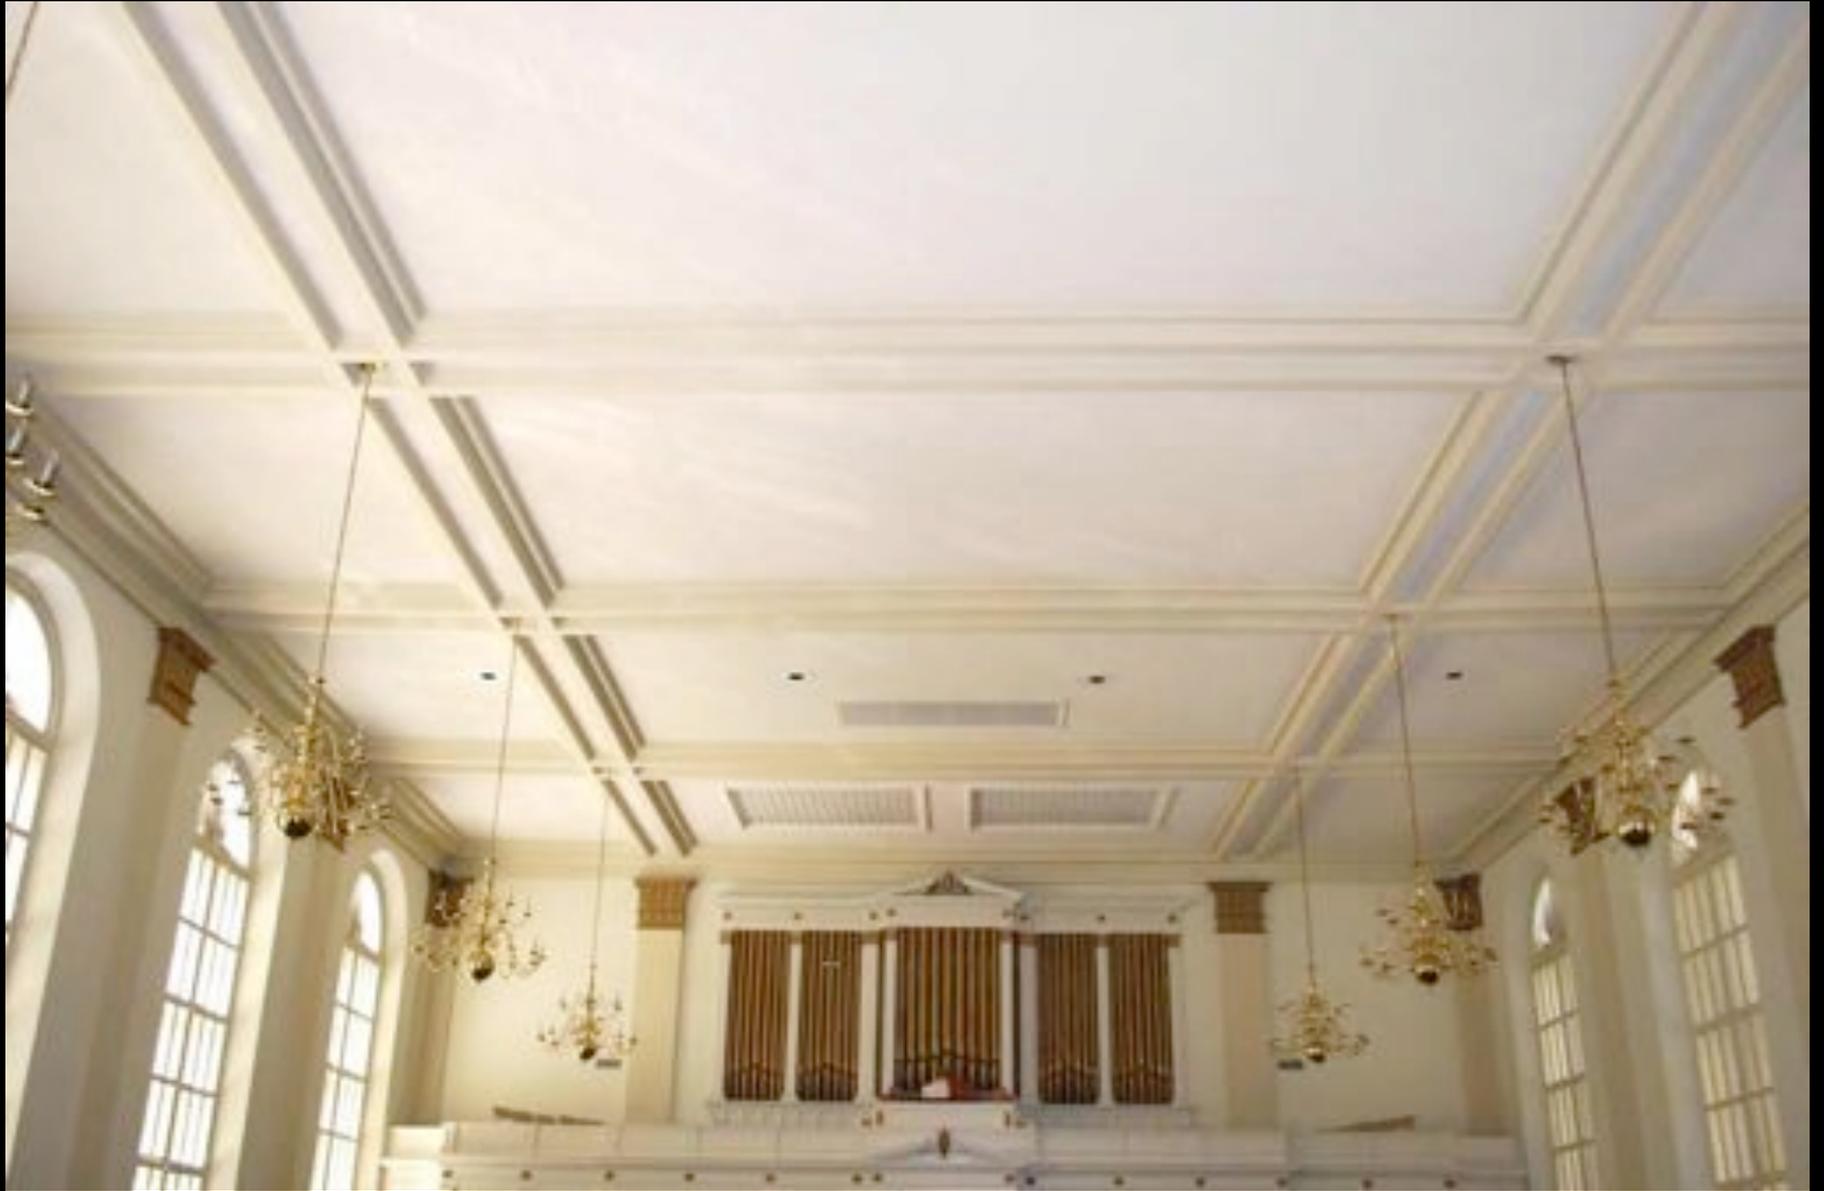
Ceiling Deflection: Sanctuary

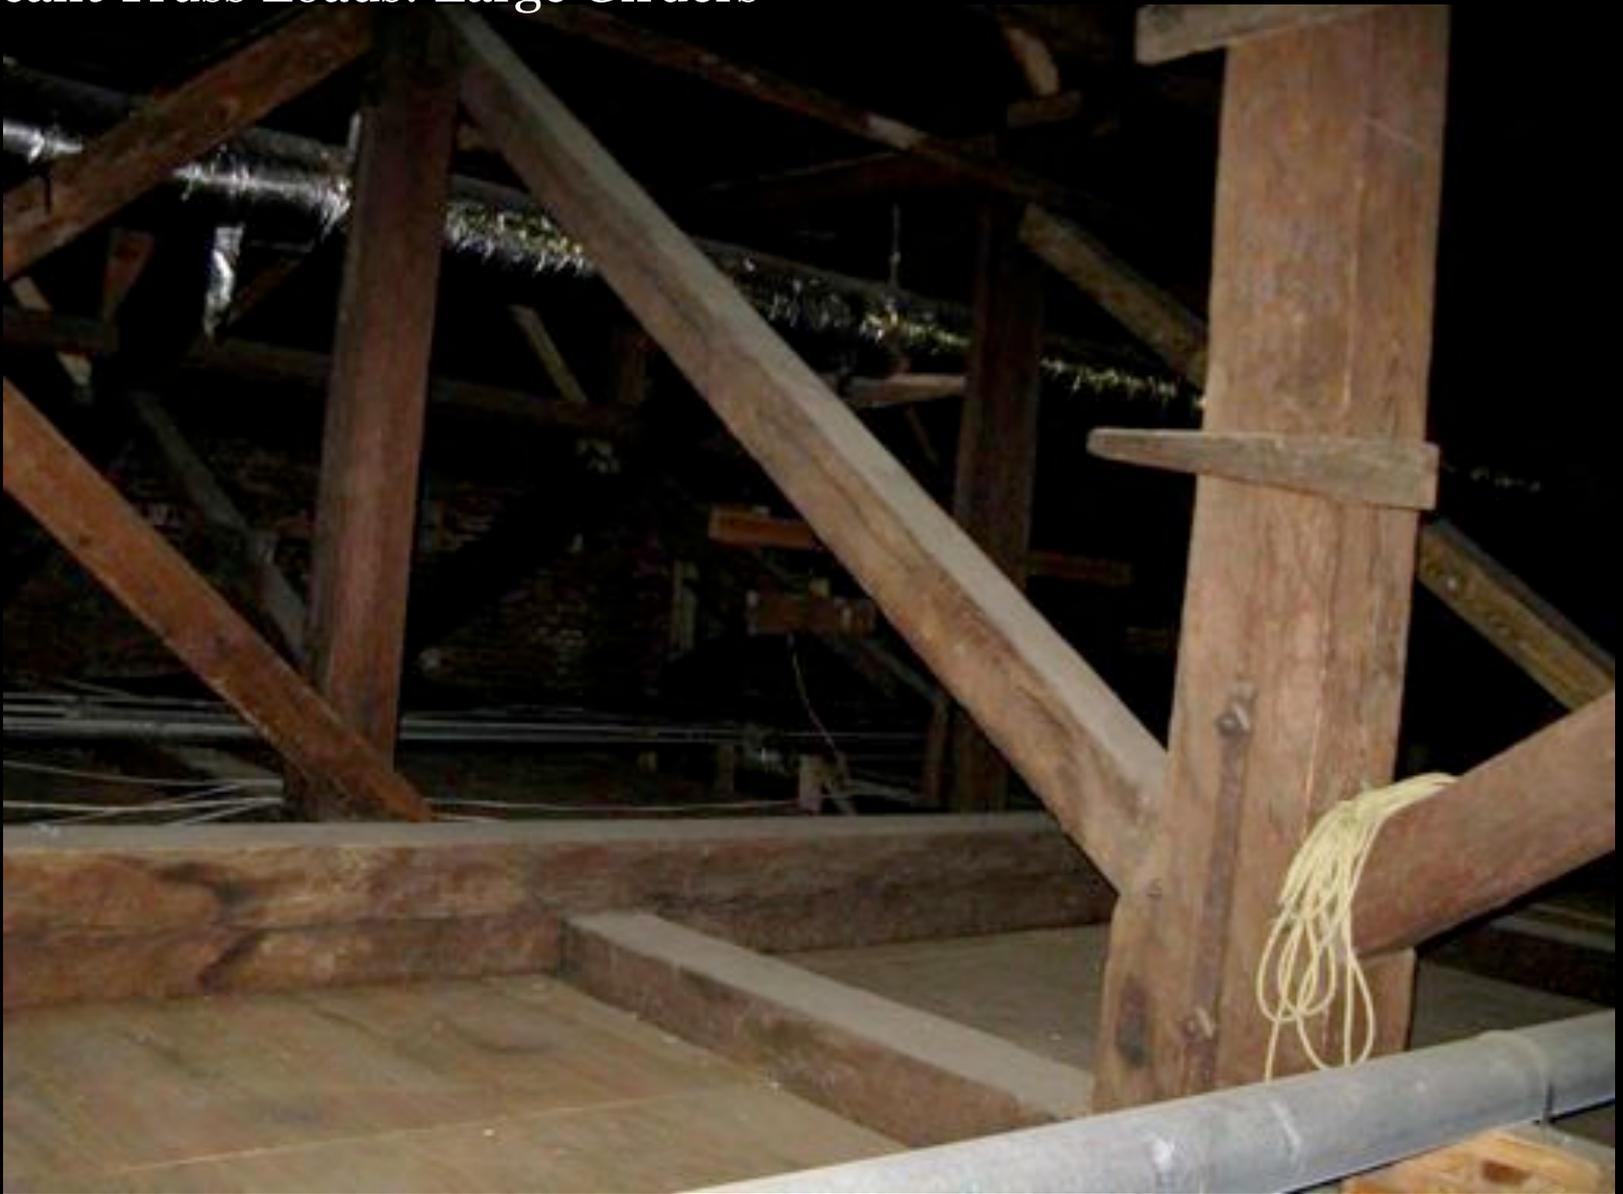
Significant Truss Loads: Large Girders

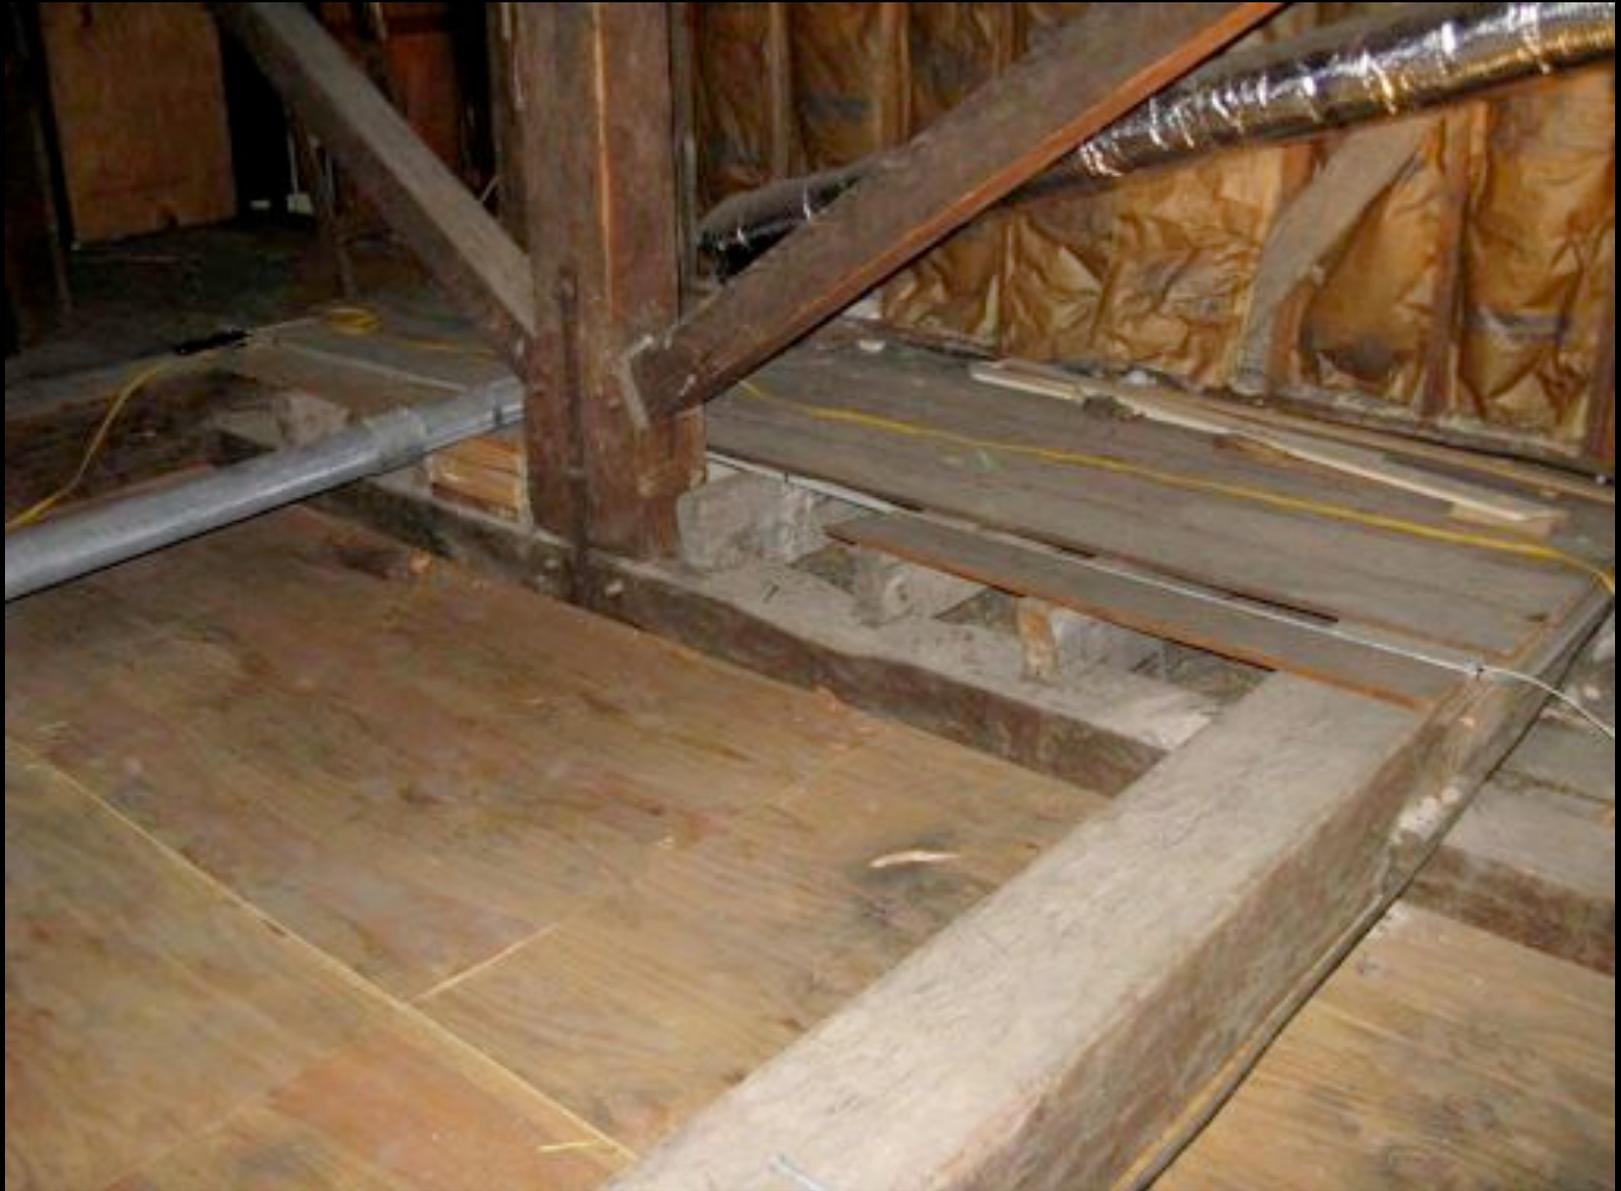
Significant Truss Loads: Large Girders

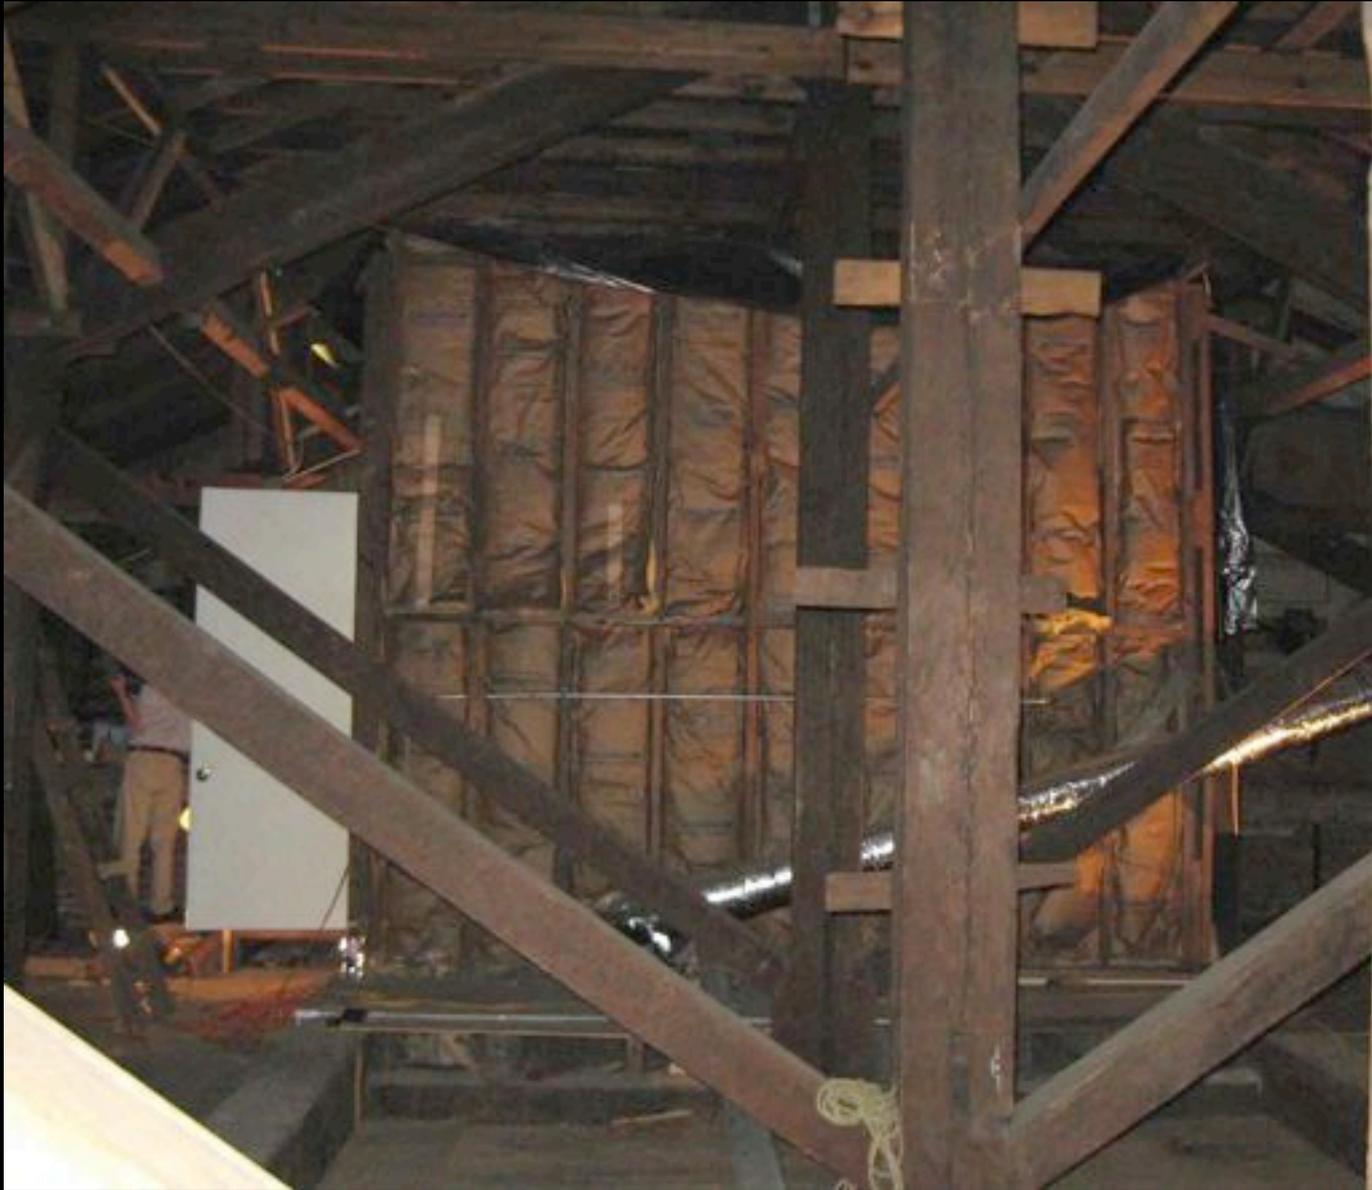
Significant Truss Loads: Organ Room

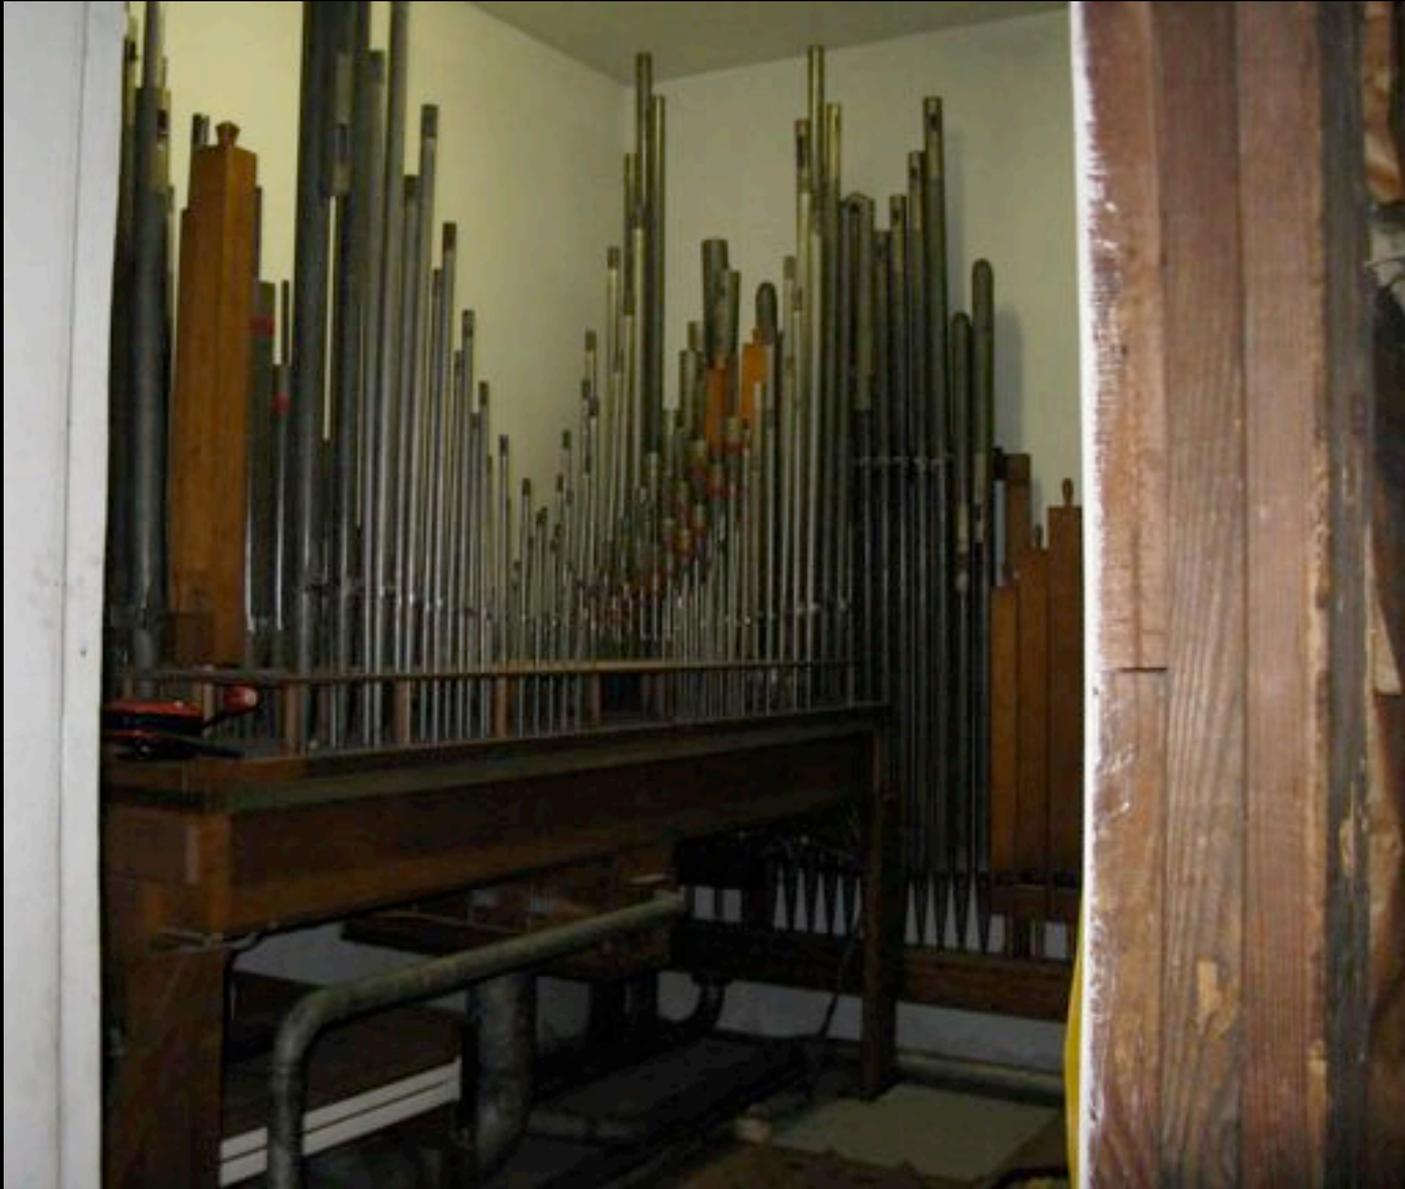
Significant Truss Loads: Organ Room
