The Forces that Destroy Historic Structures

The SC Historic Preservation Conference

Craig M. Bennett, Jr., PE

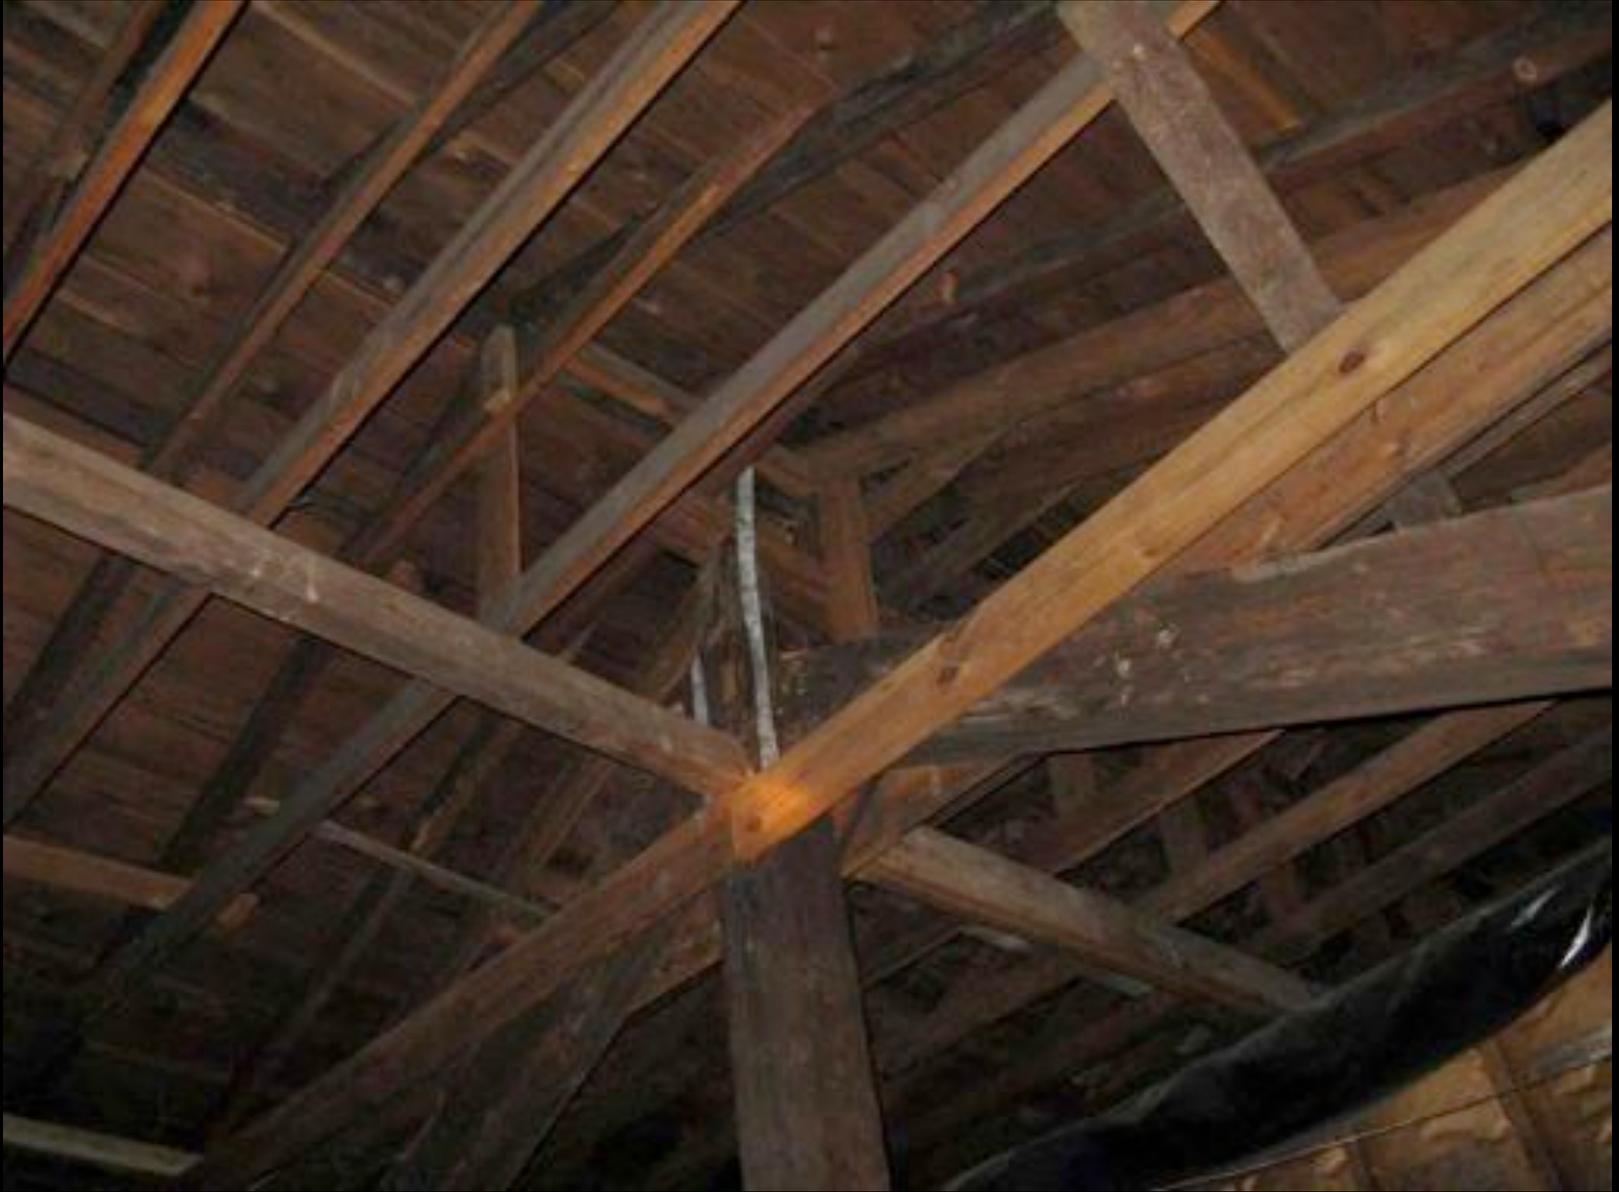
Significant Truss Loads: Additional Roof Framing

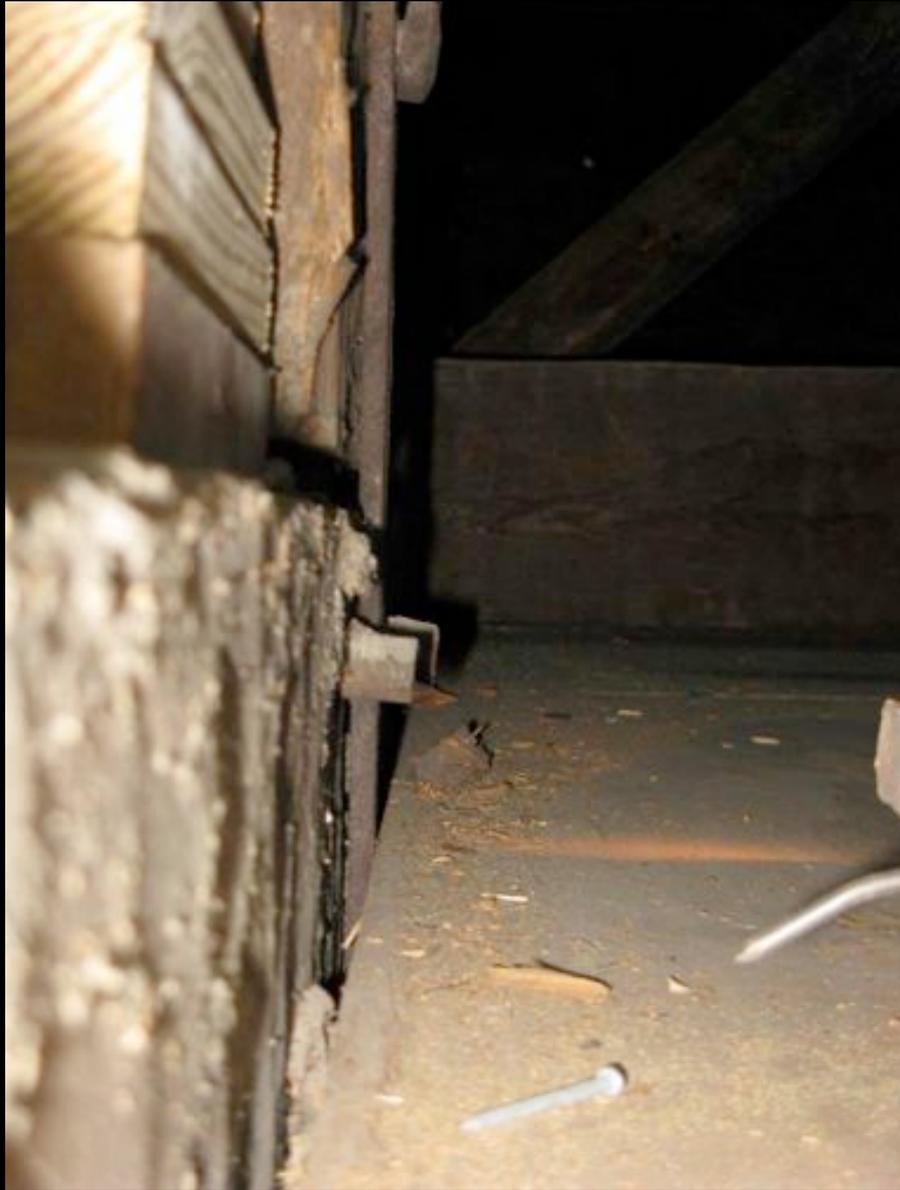
Bending of Bolts and Wooden Dowels

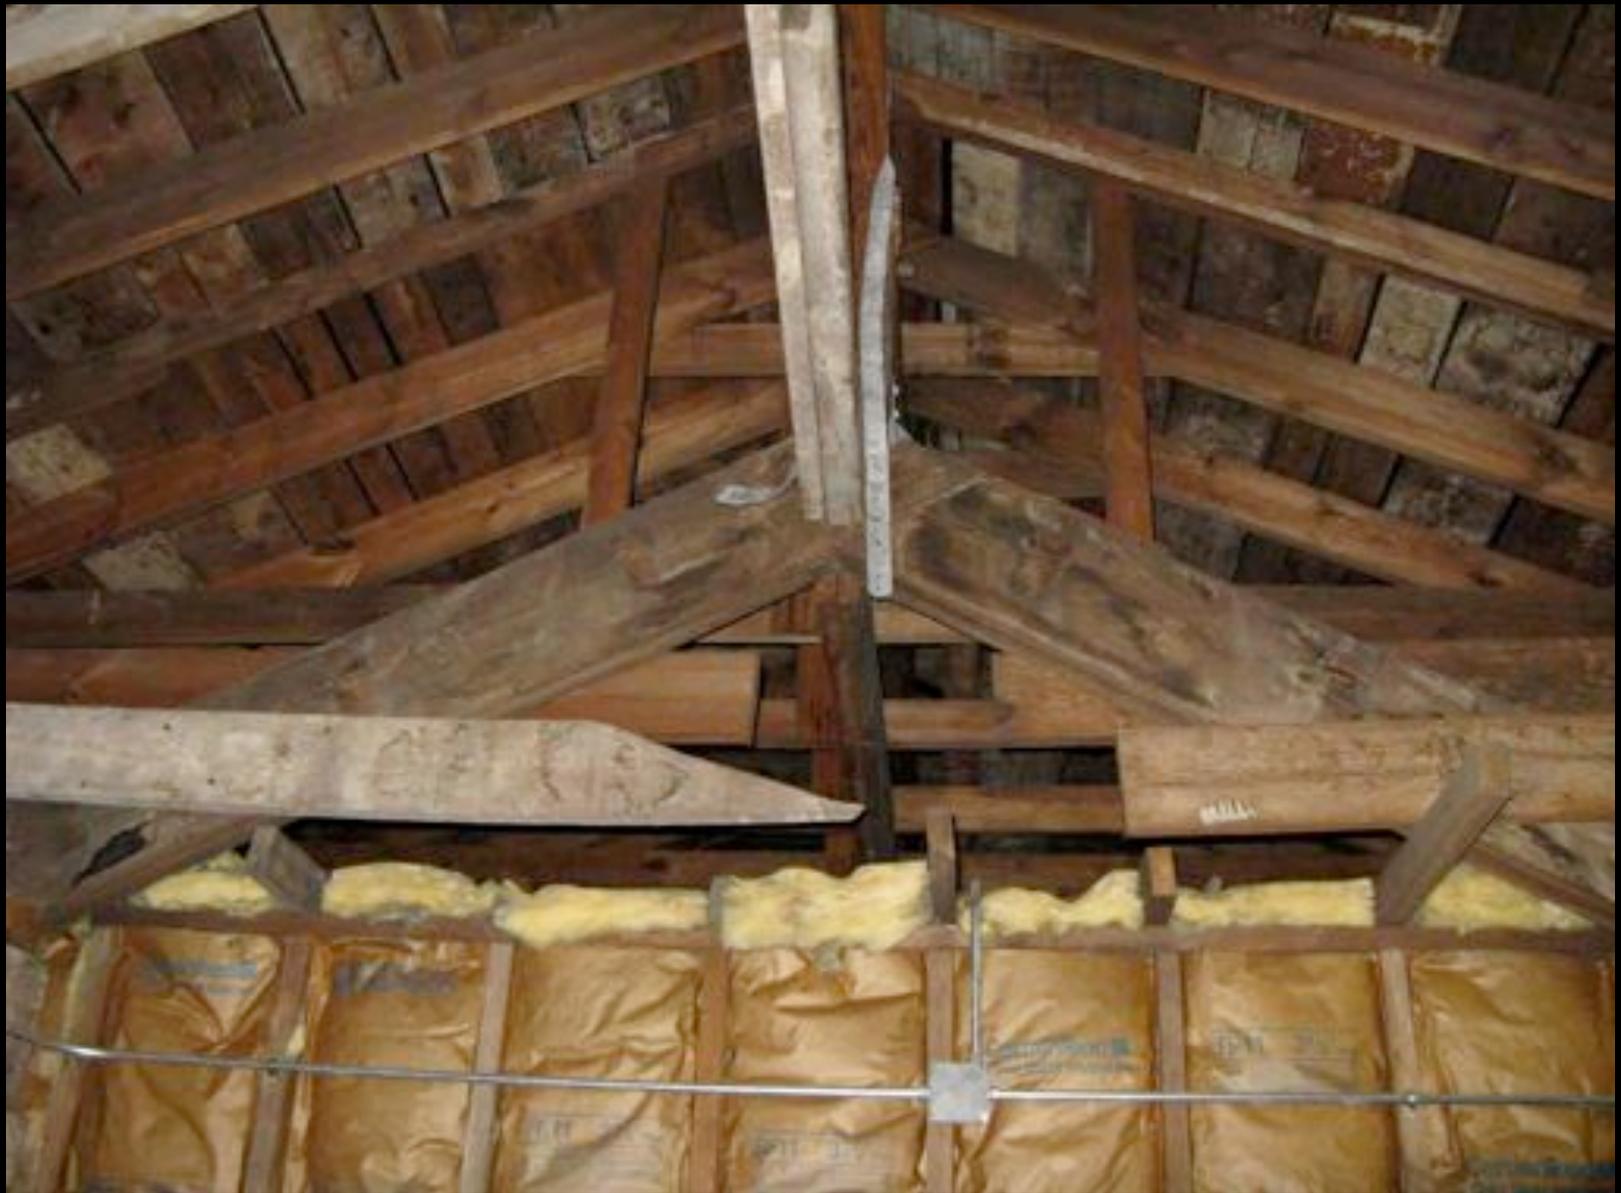
Lightly Structured Truss 1

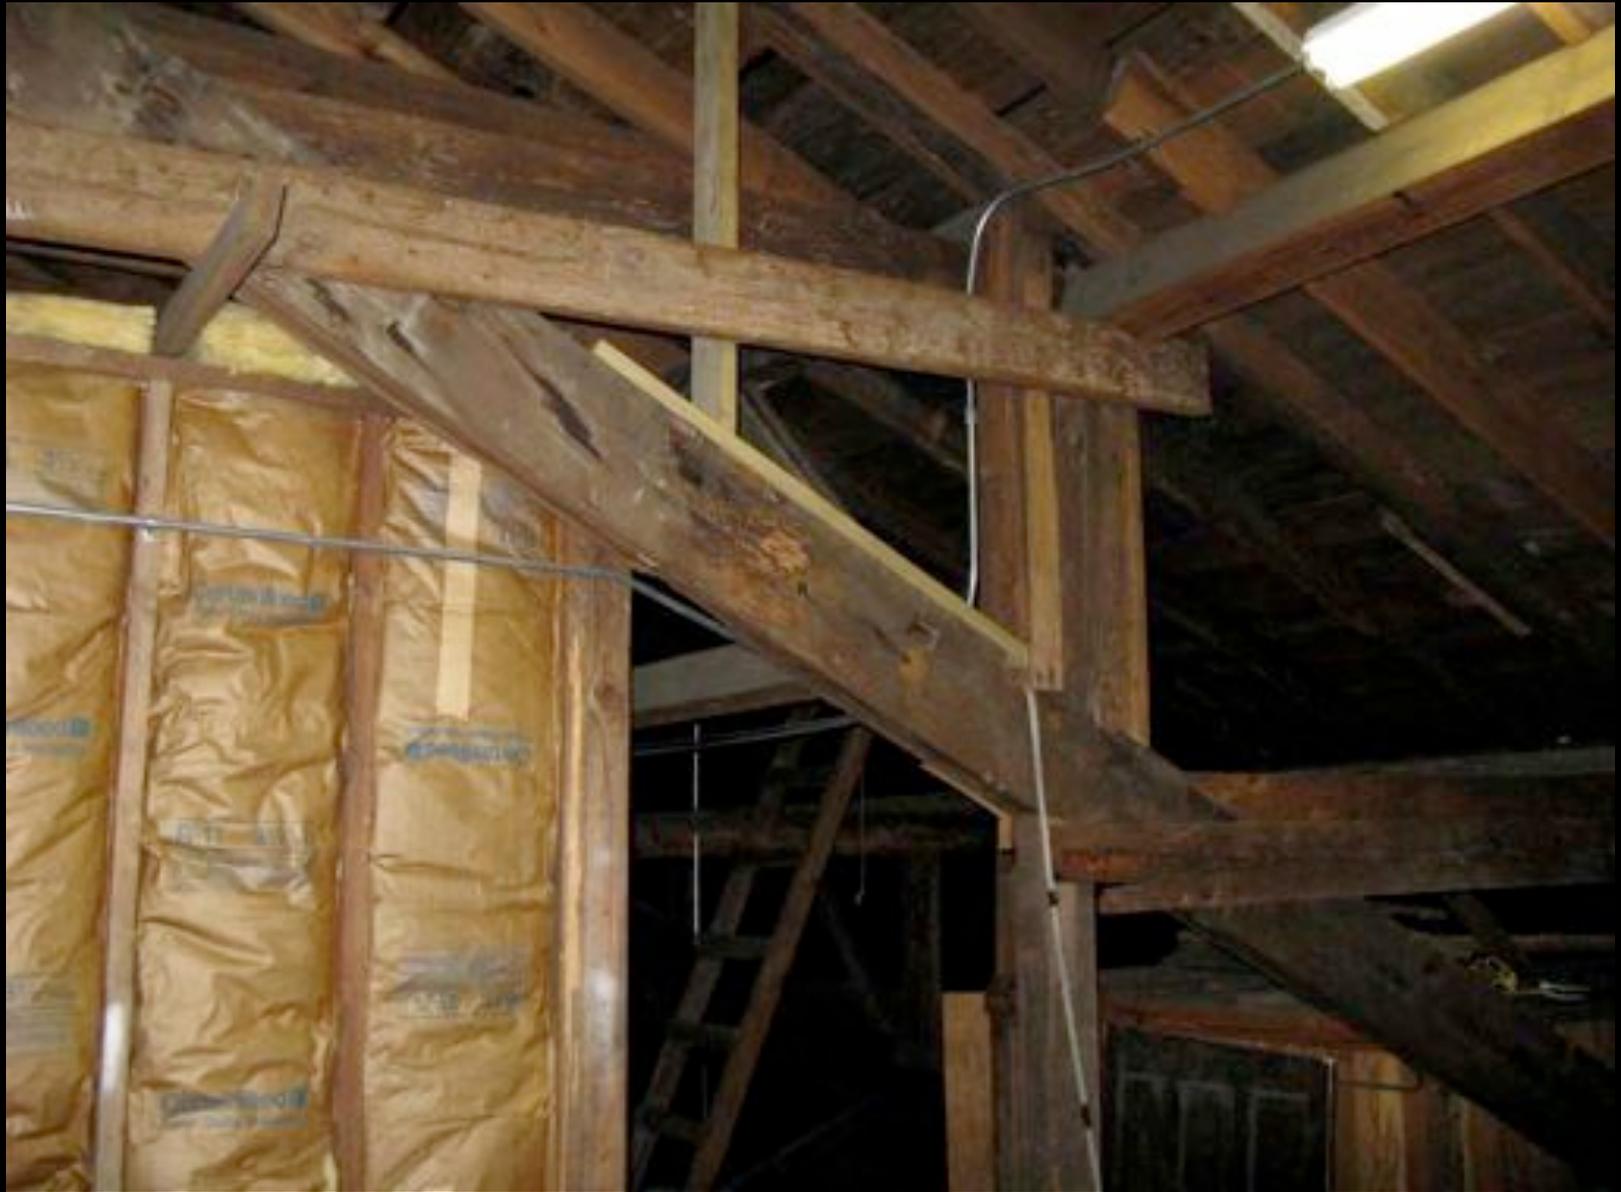
Lightly Structured Truss 1

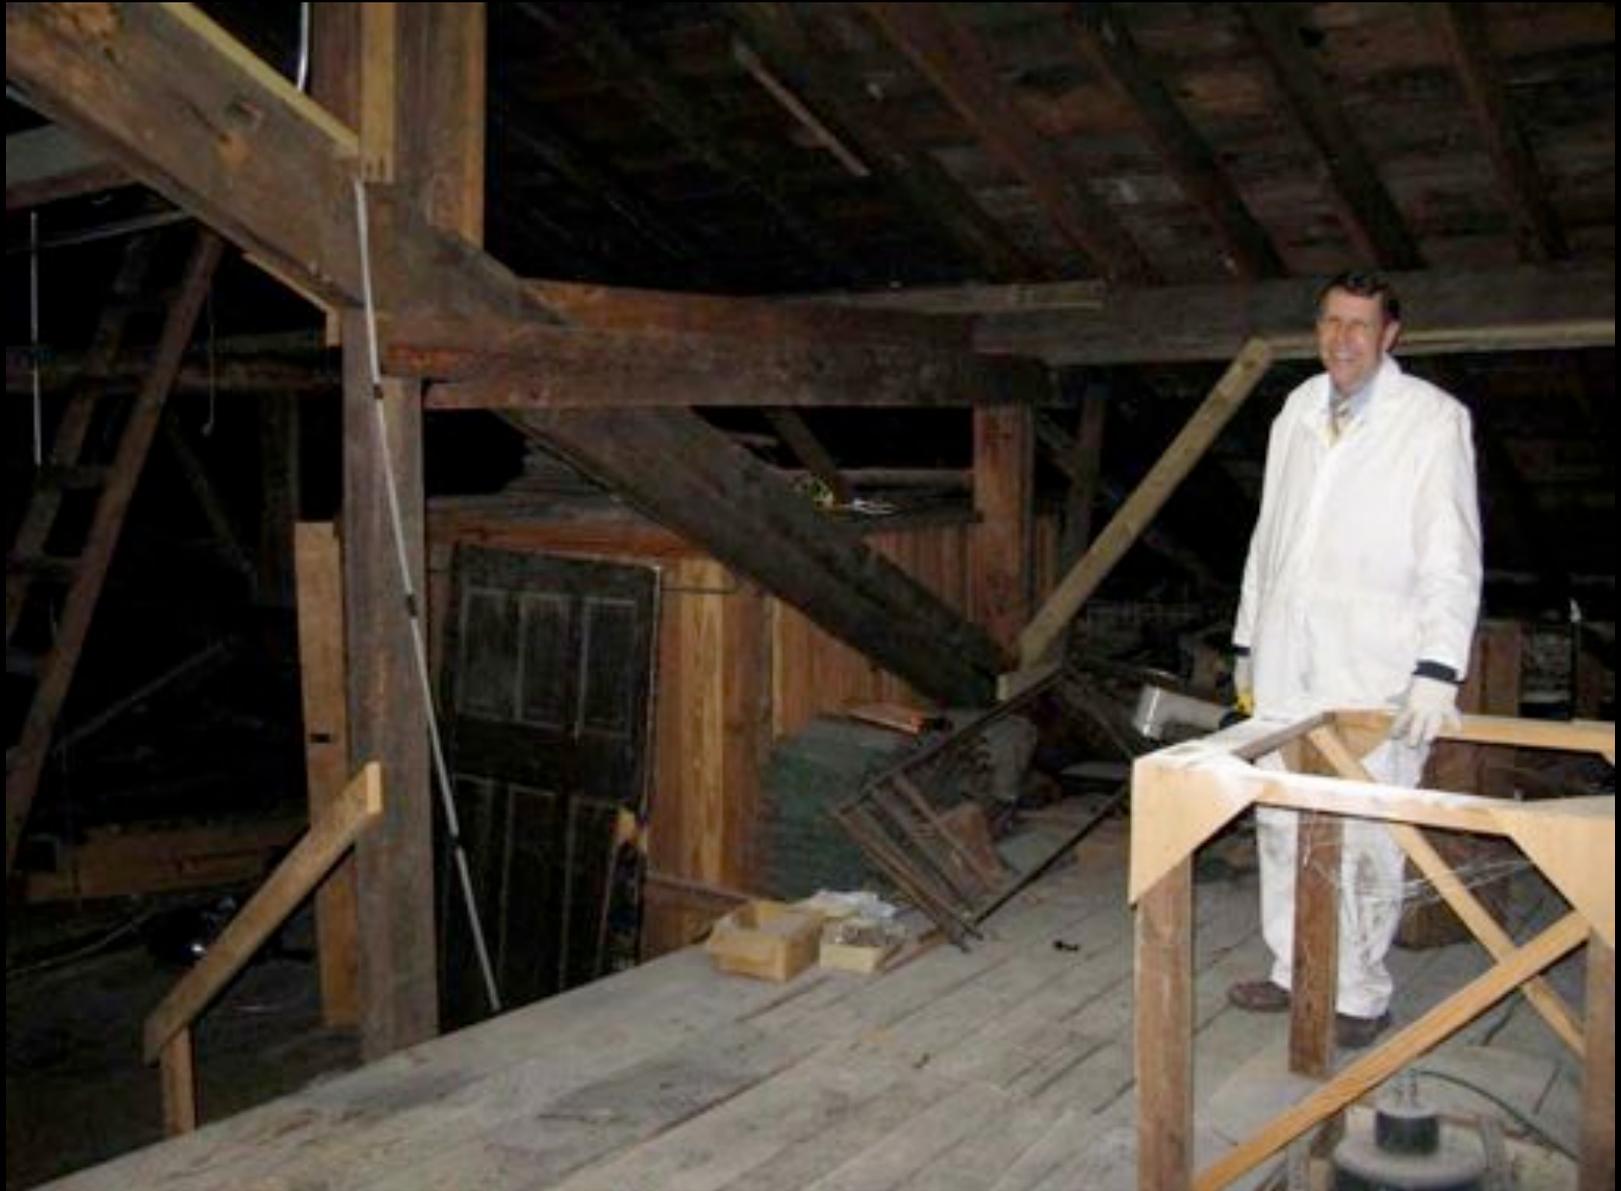
Lightly Structured Truss 1

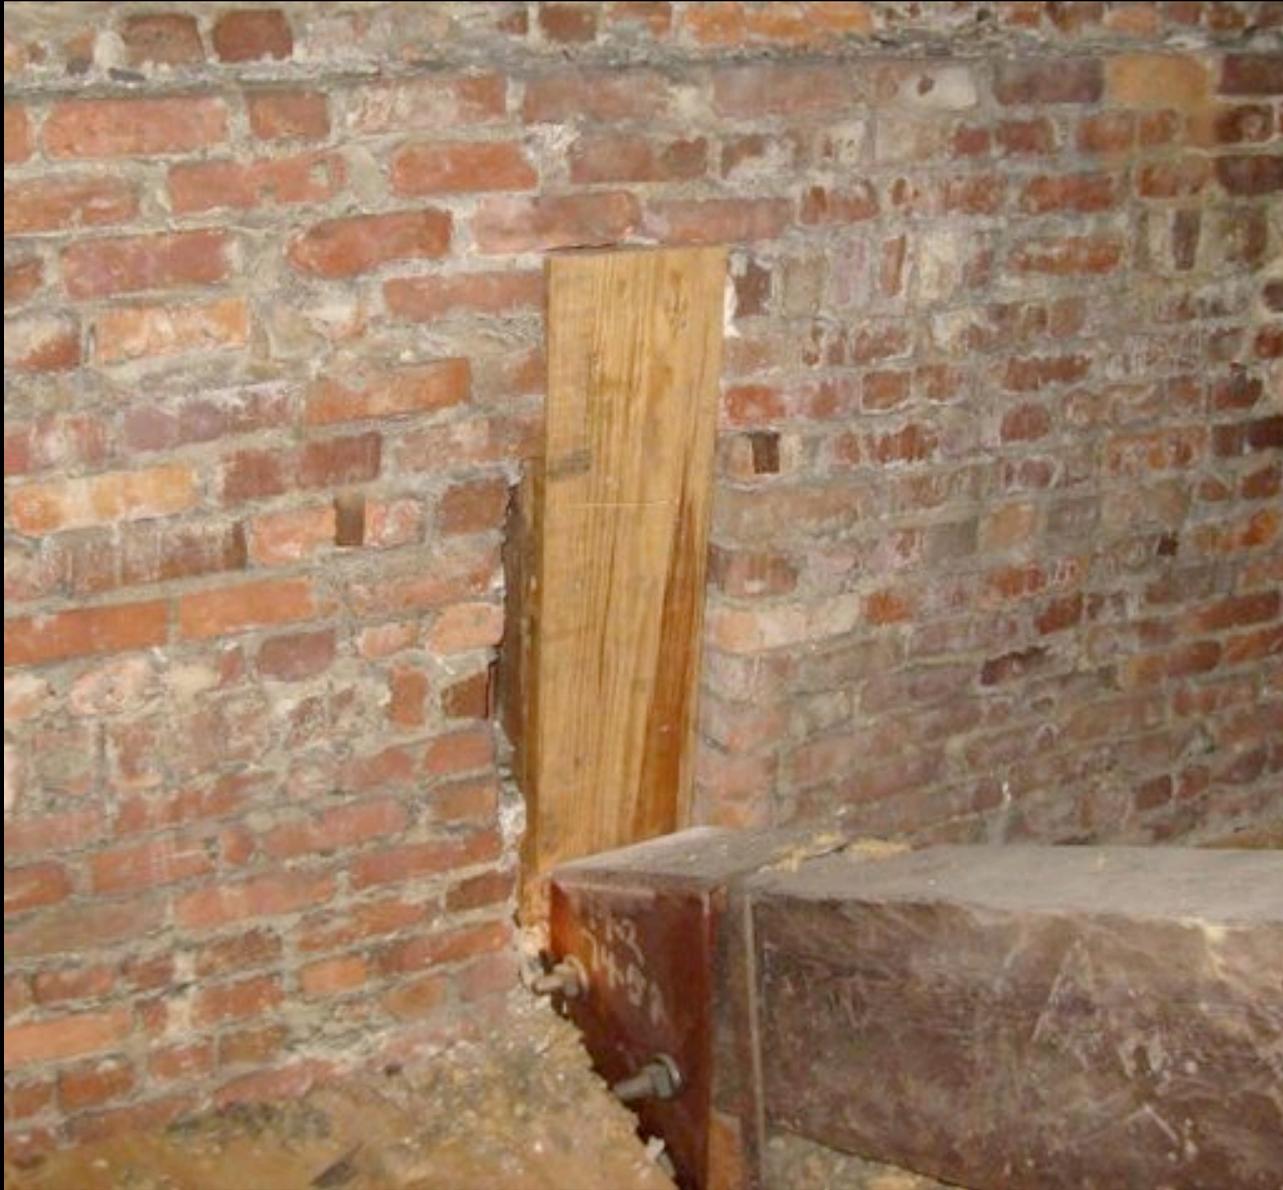
Sealed Truss Ends

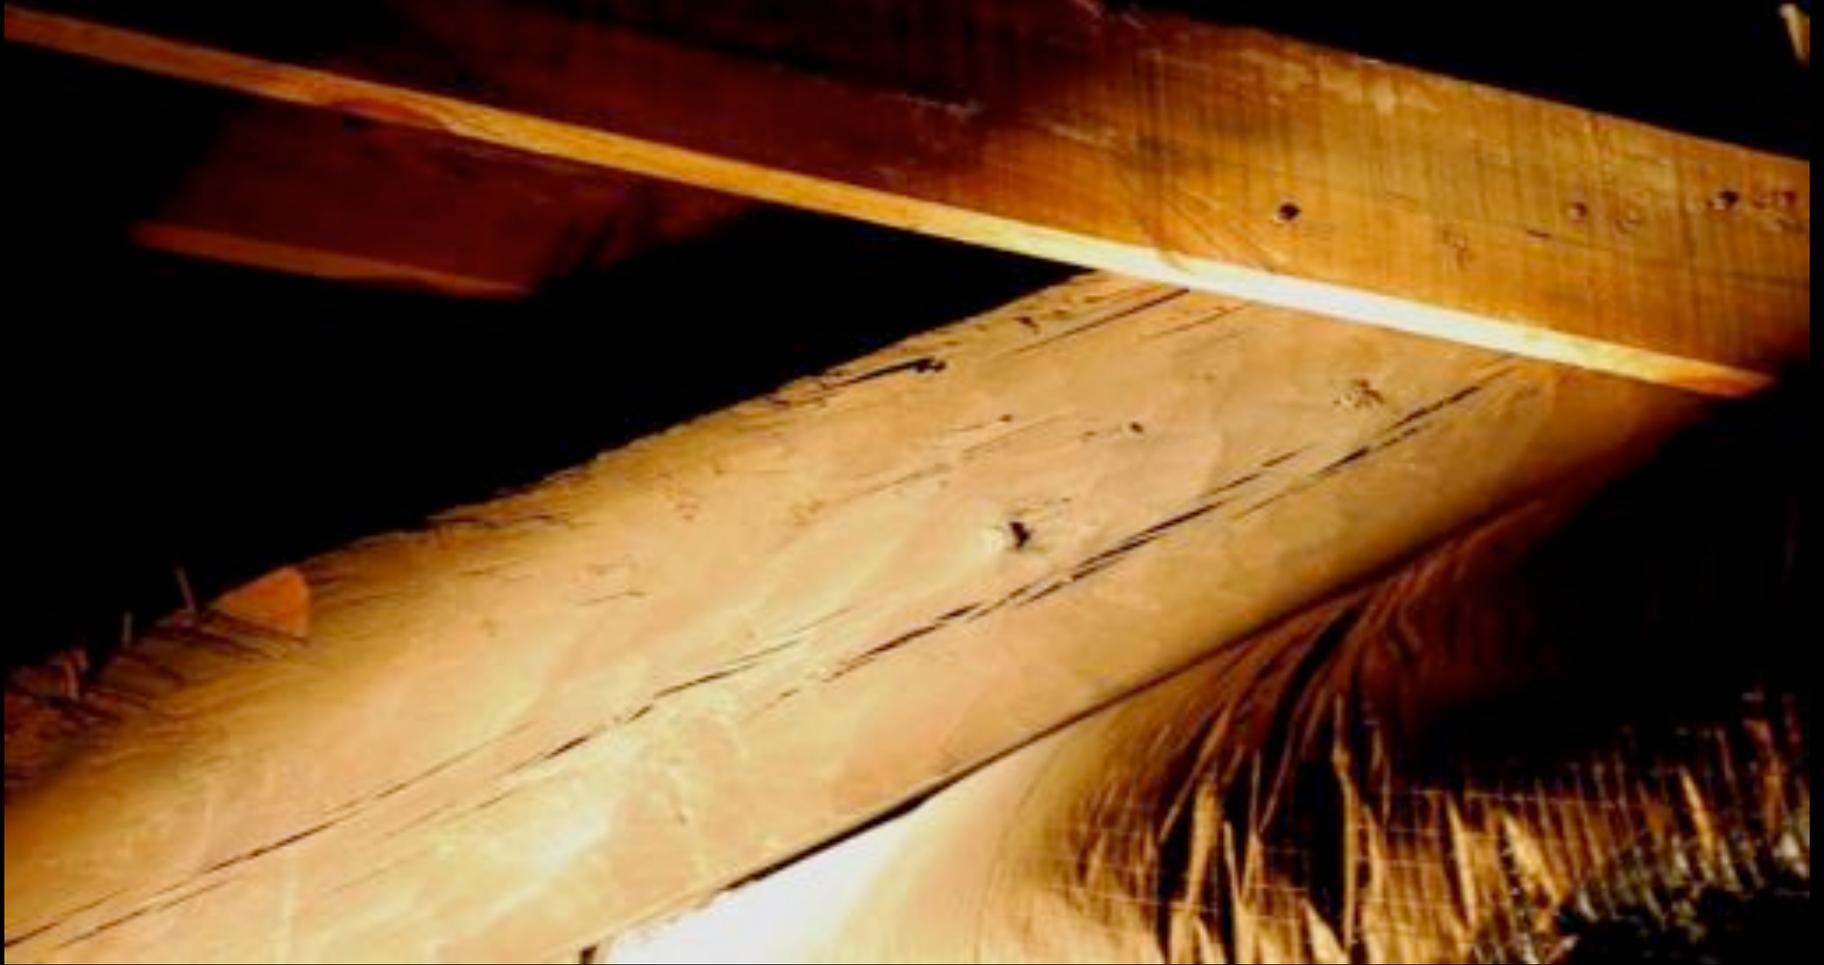
Checking of Truss Members

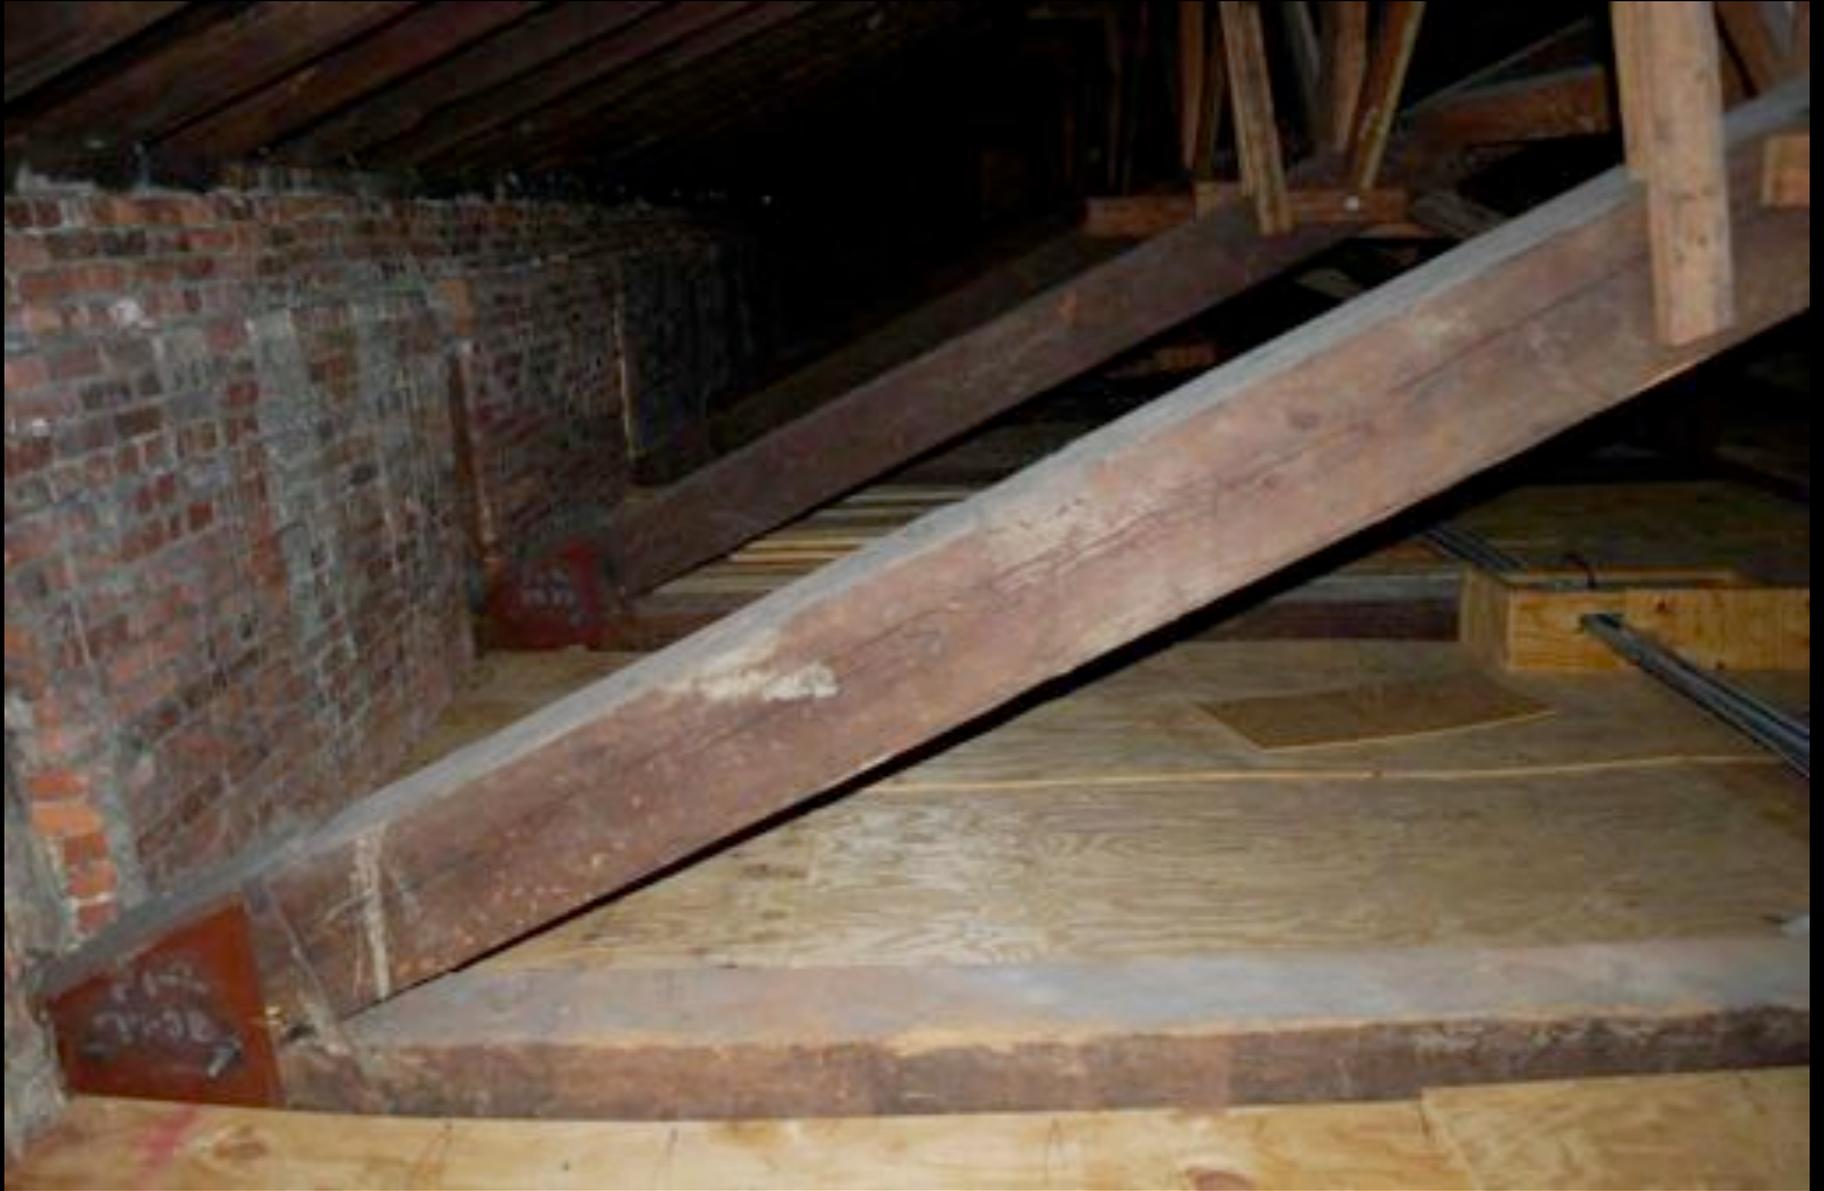
Checking of Truss Members

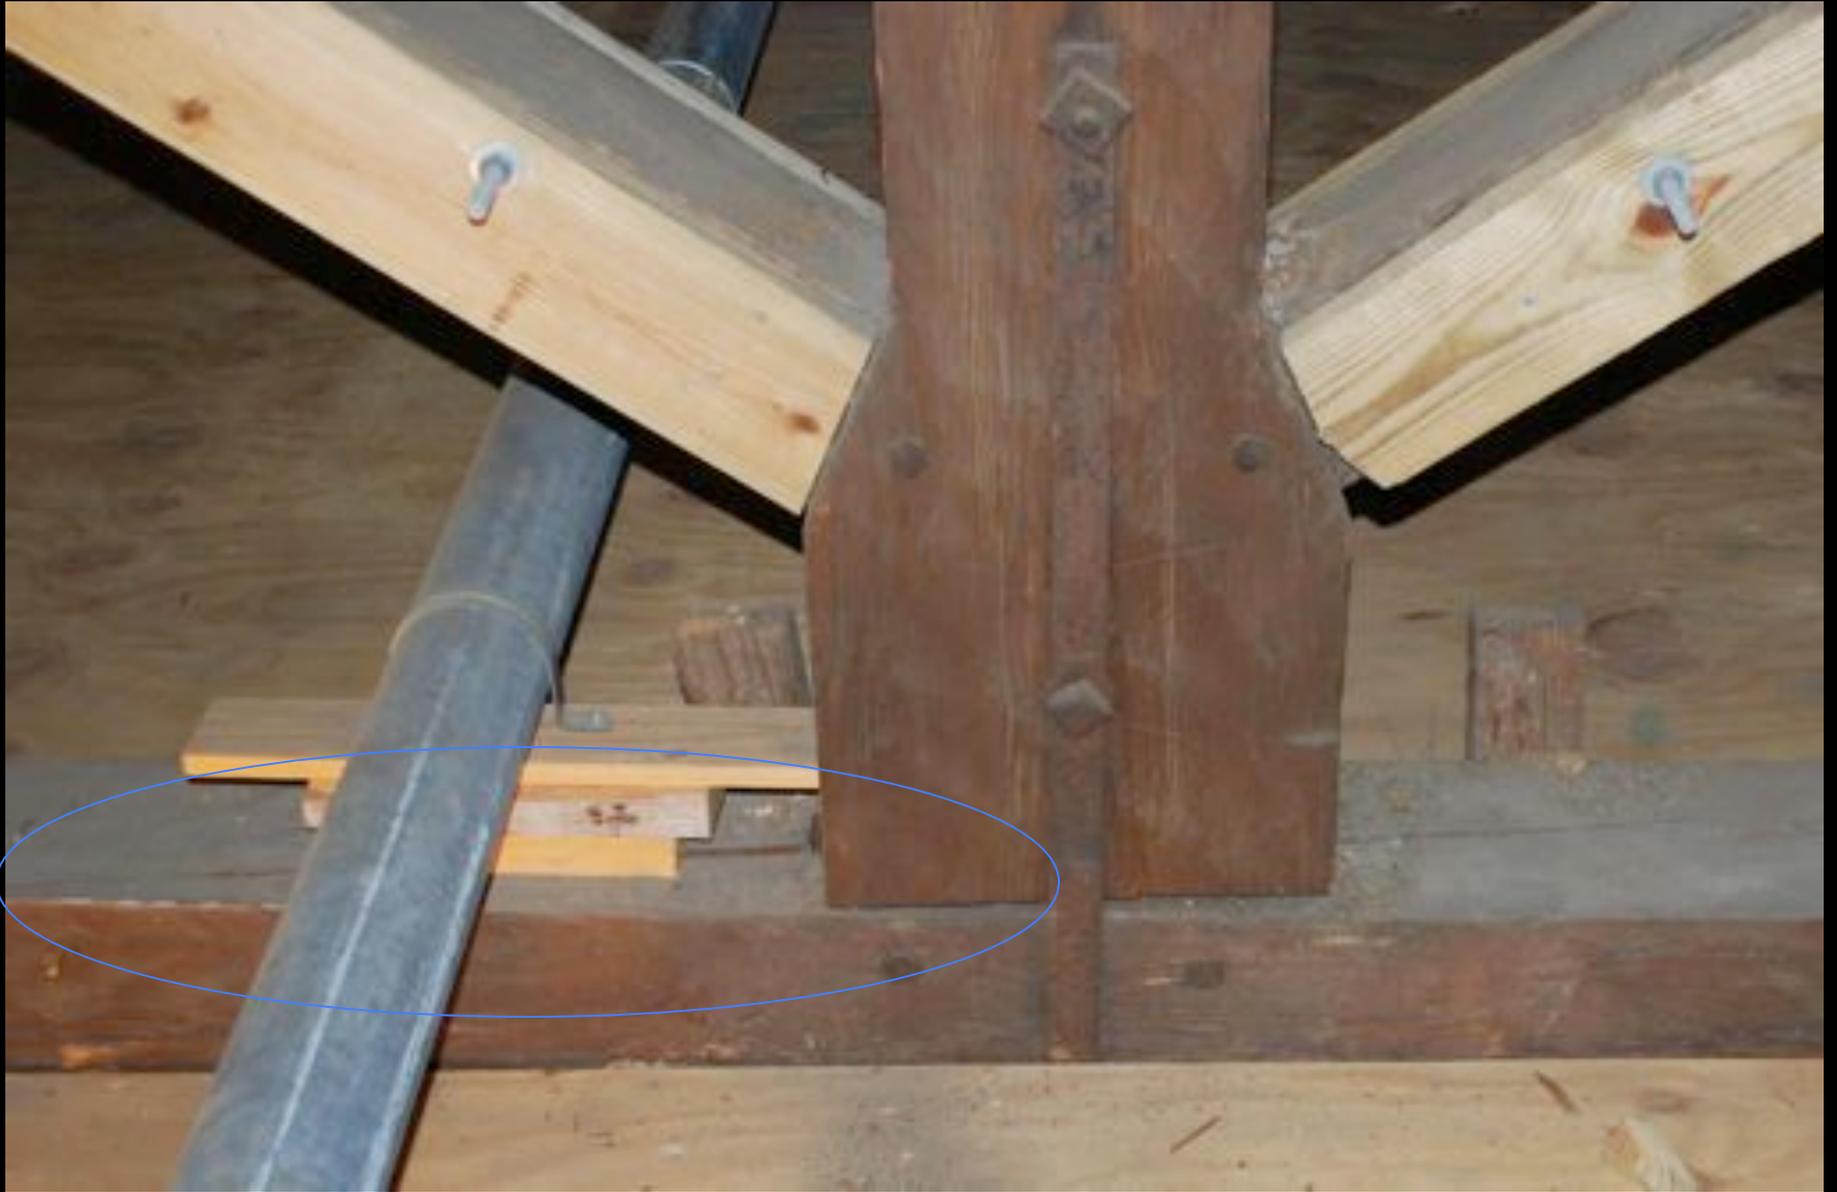
Splitting of Truss Members

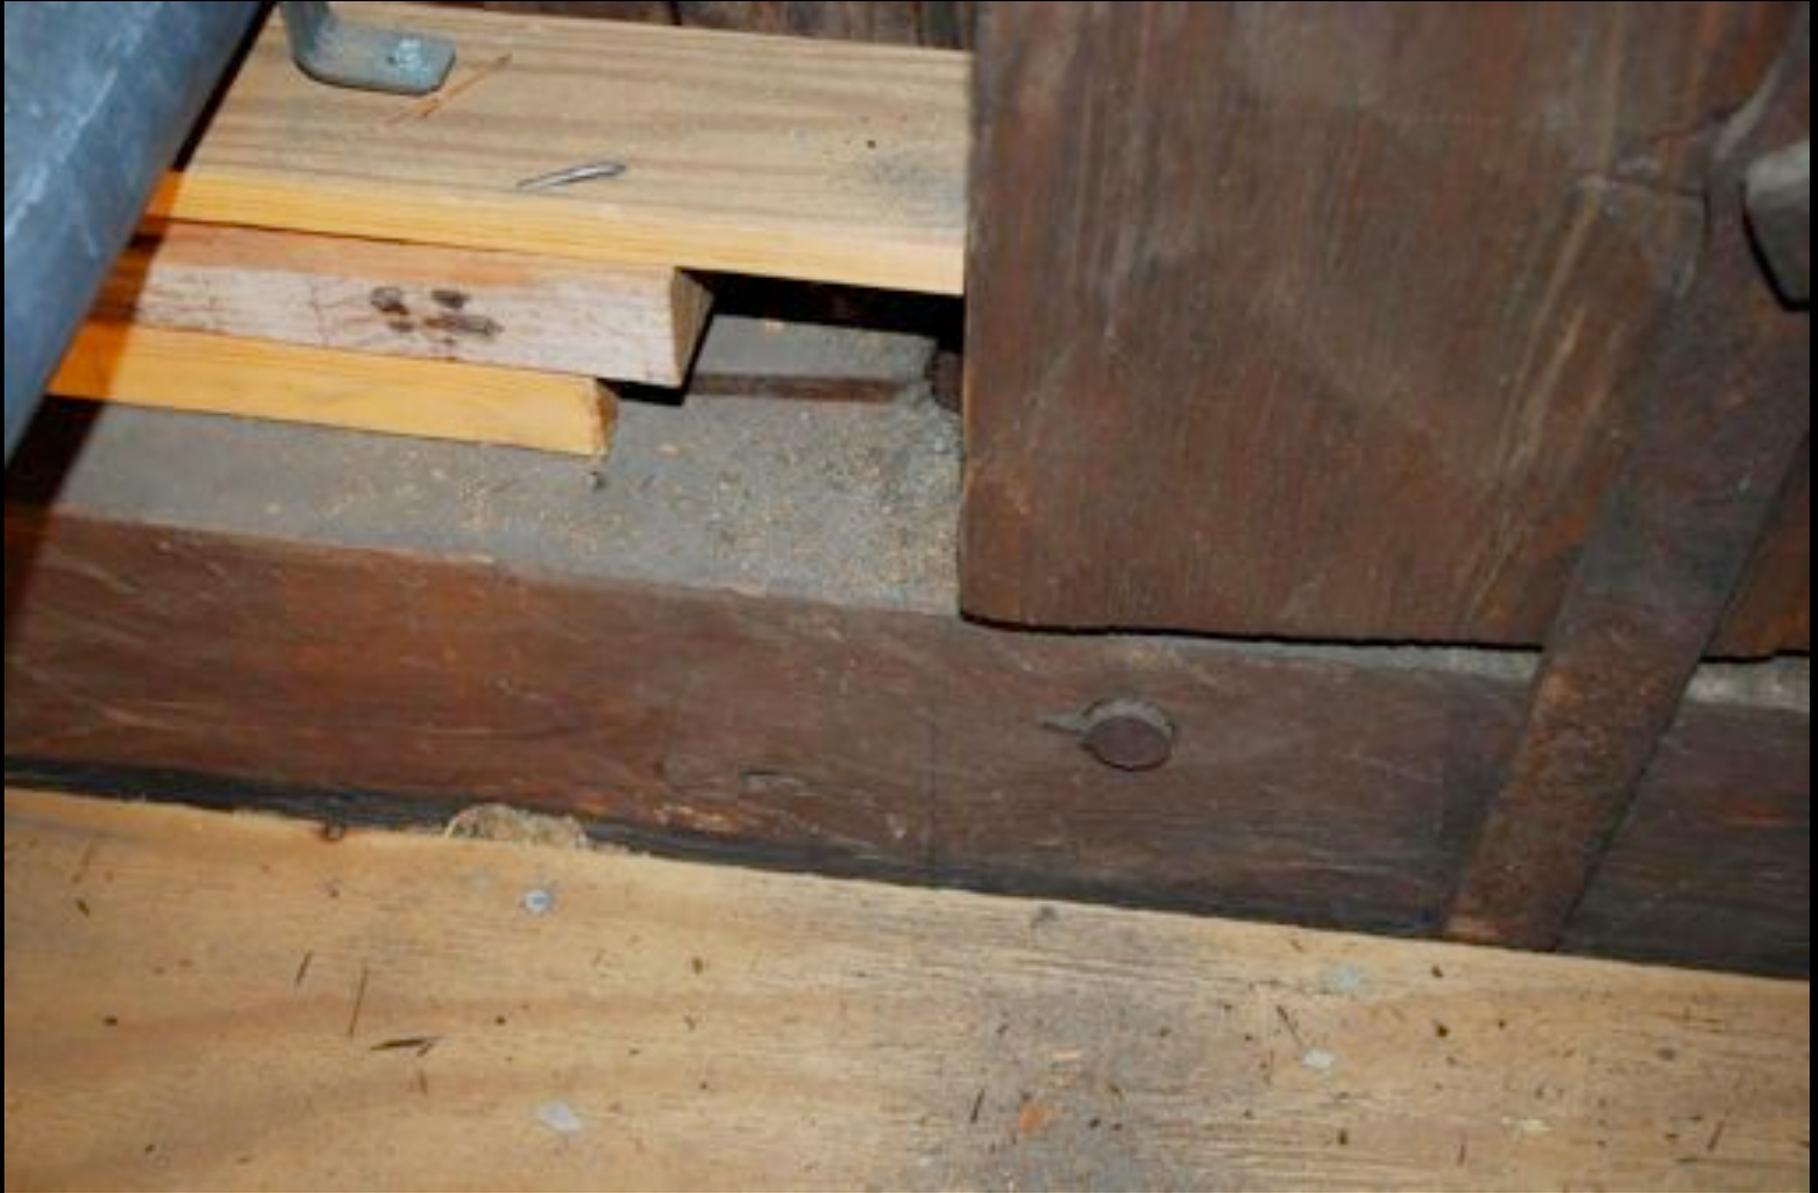
Splitting of Truss Members

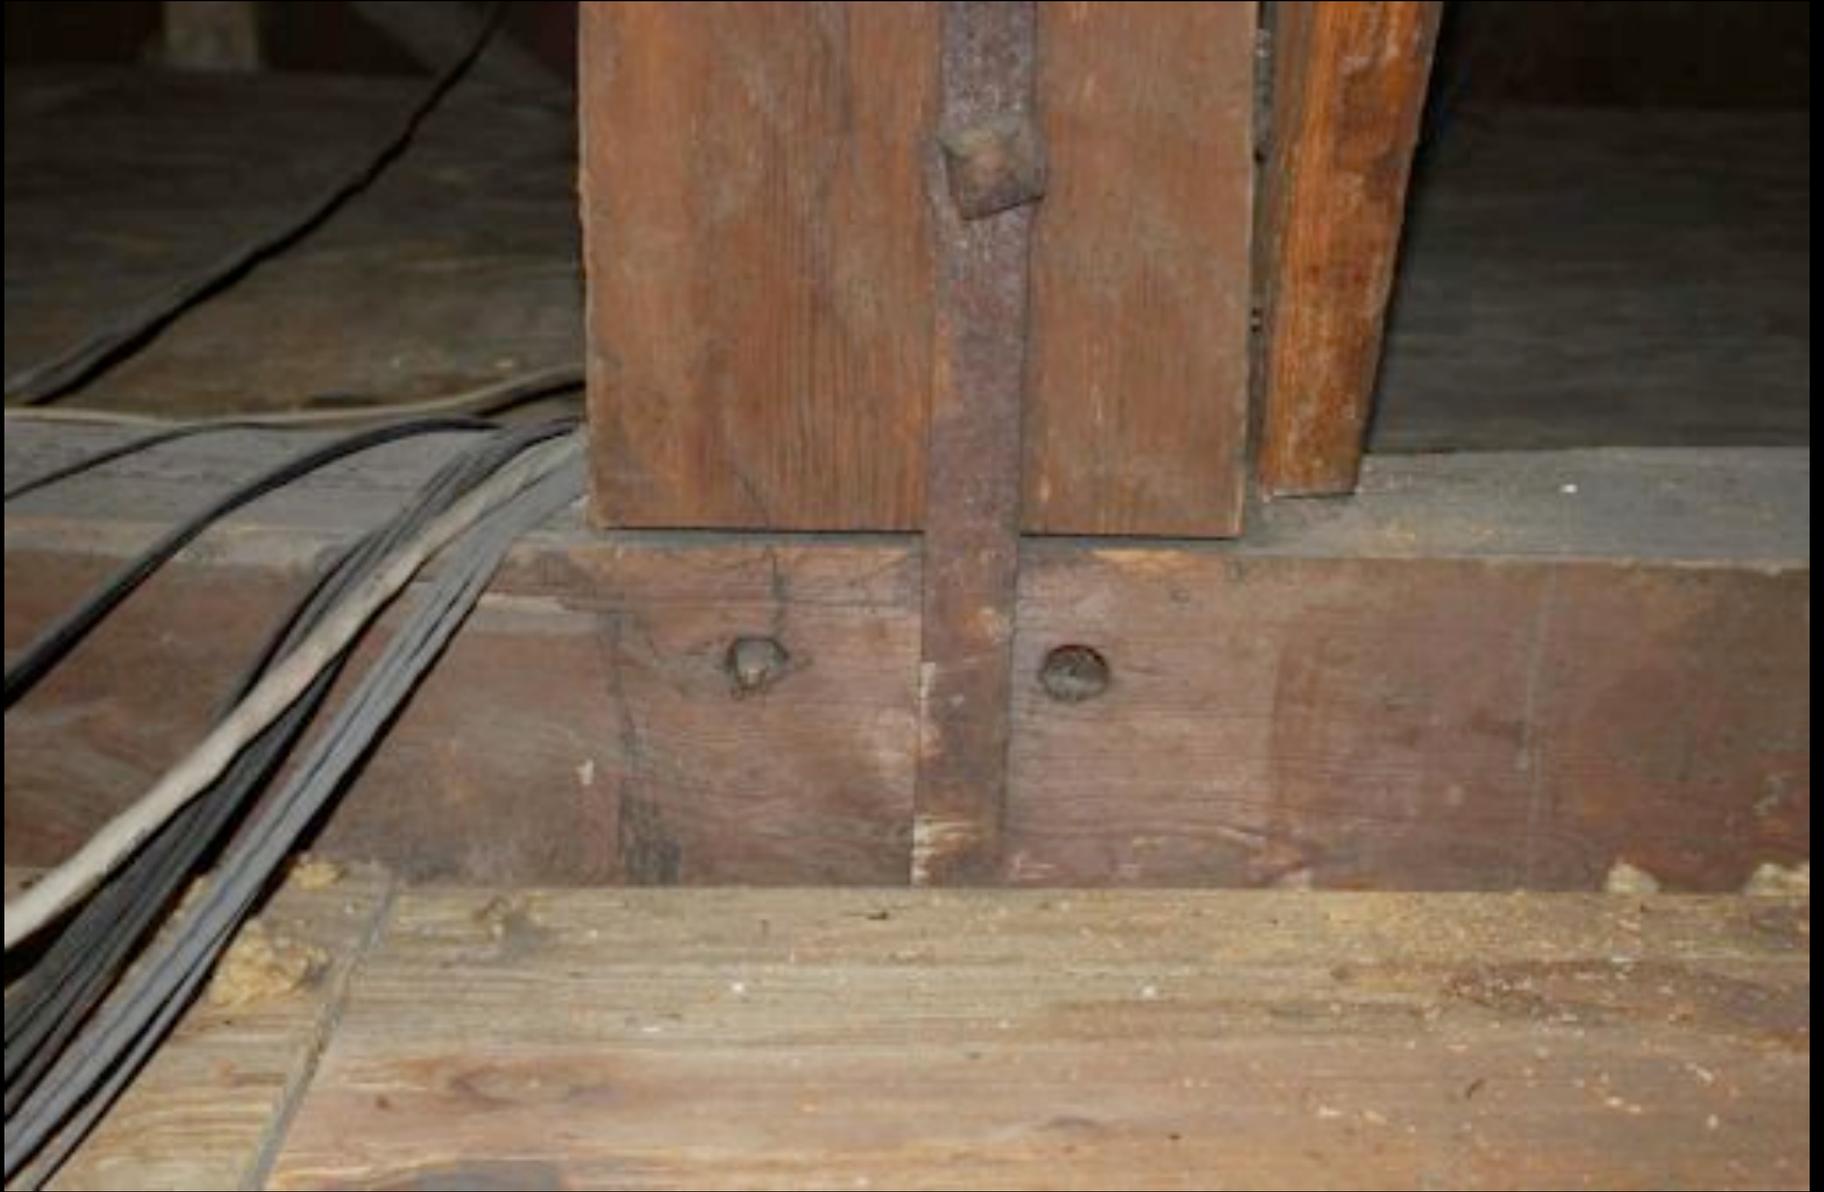
Deflection and Separation of Truss Members

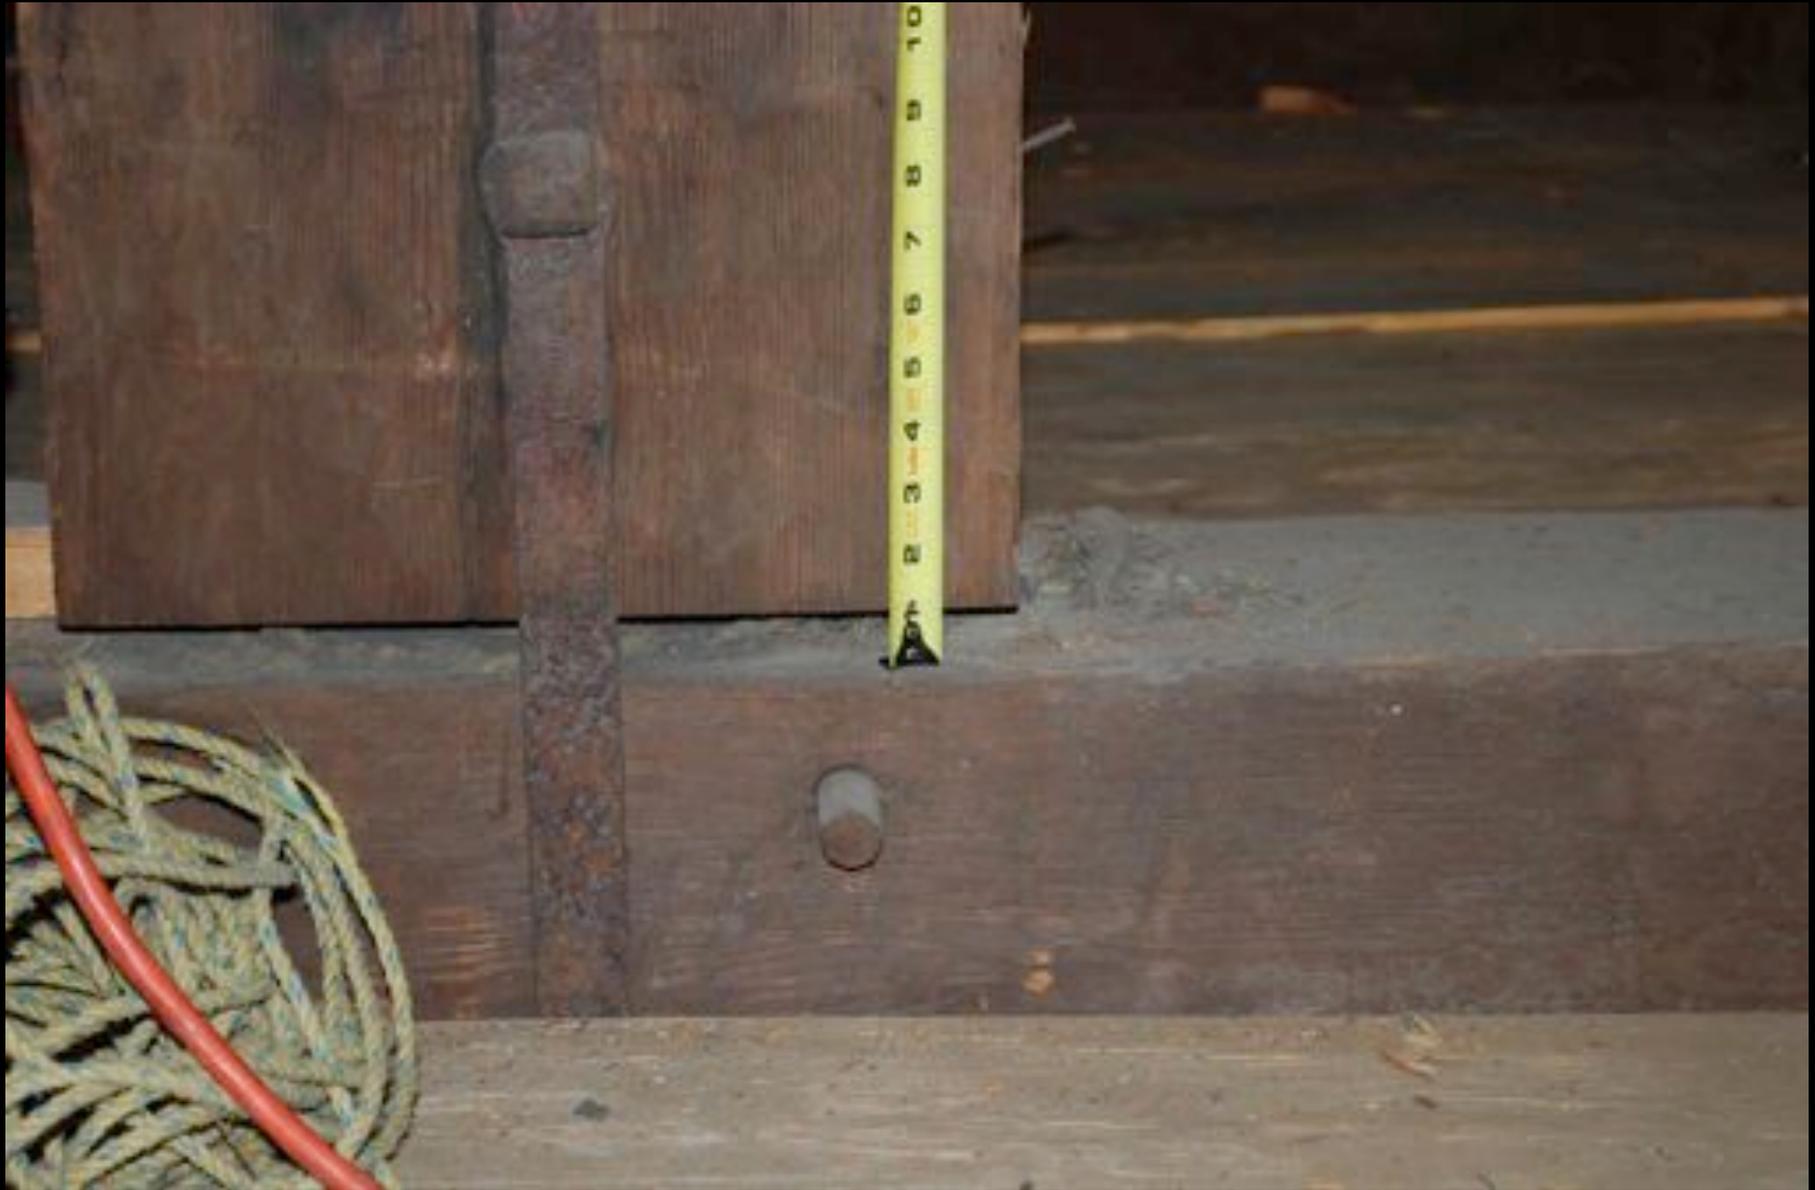
Deflection and Separation of Truss Members
