The Forces that Destroy Historic Structures

The SC Historic Preservation Conference

Craig M. Bennett, Jr., PE

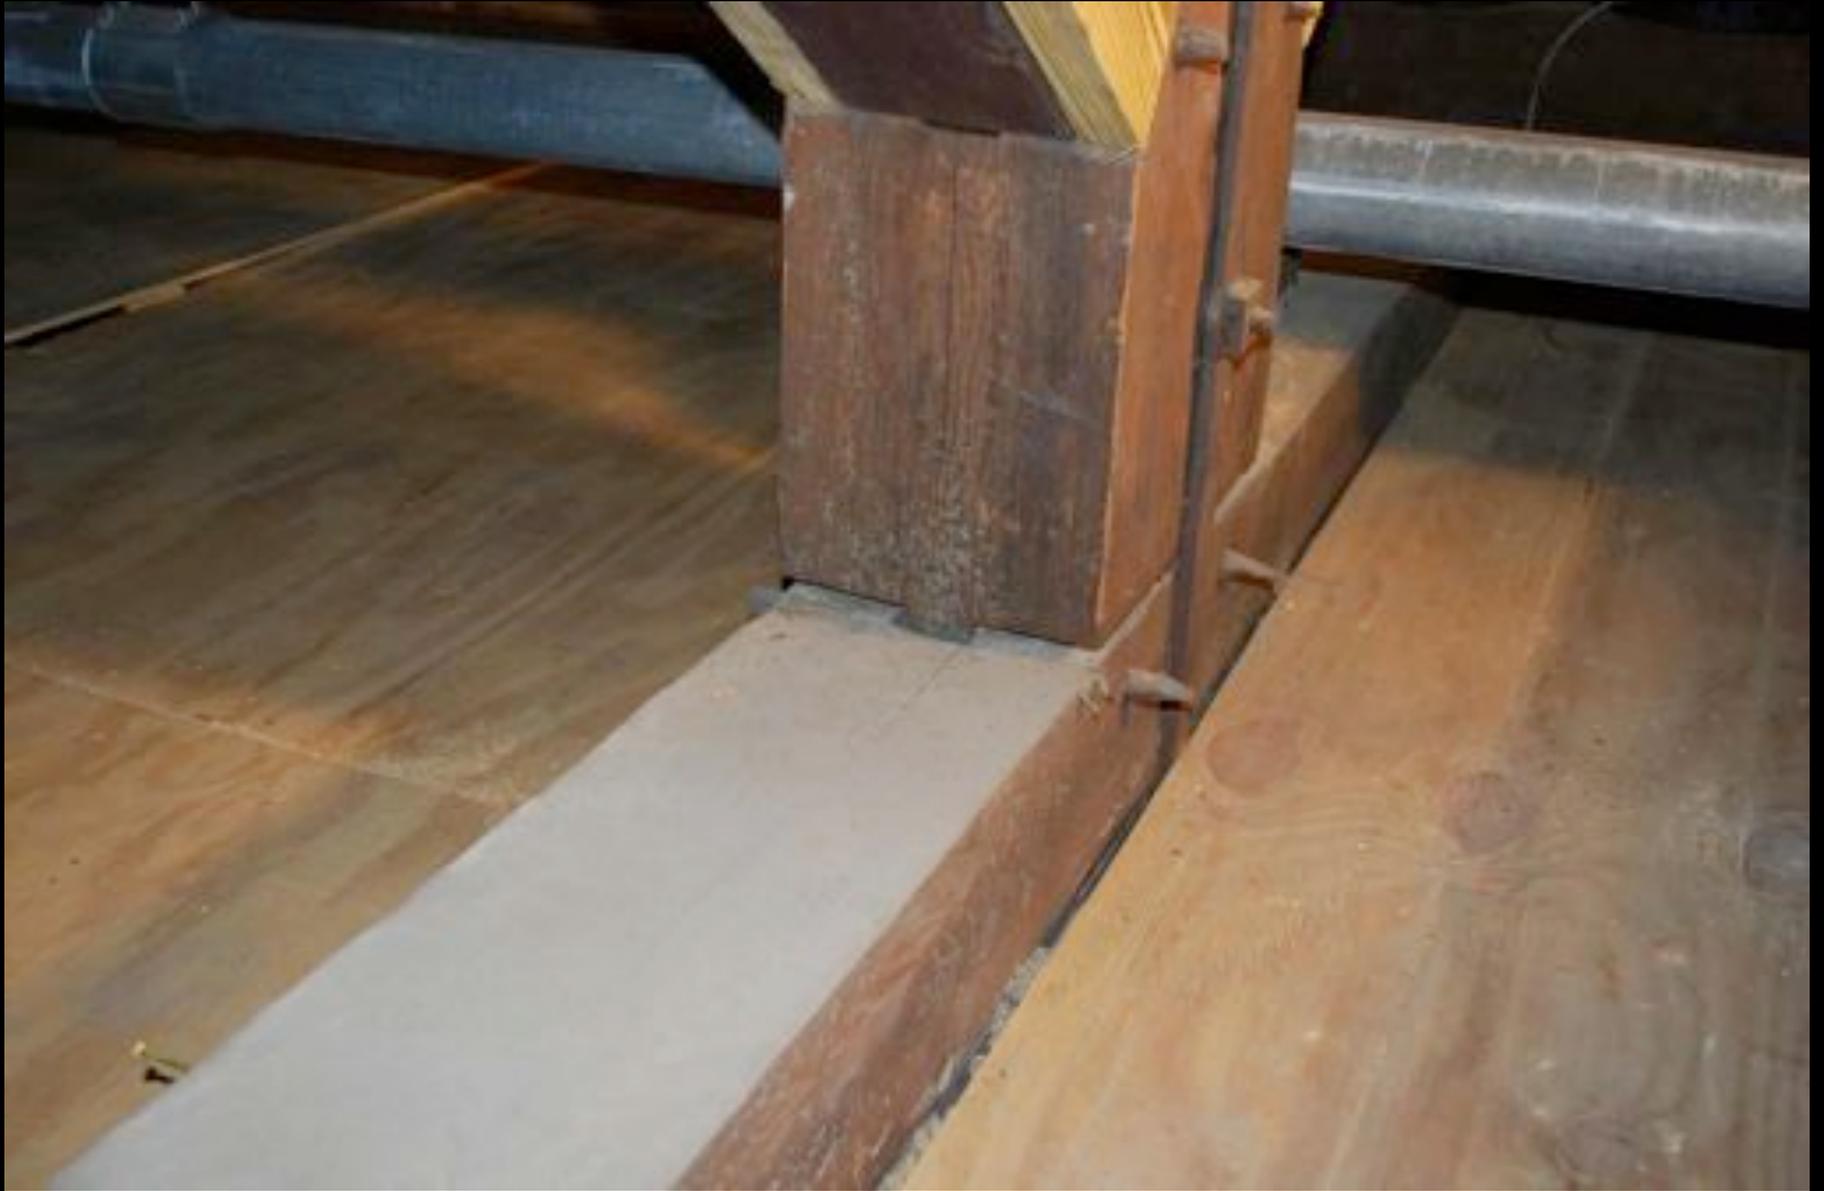
Deflection and Separation of Truss Members

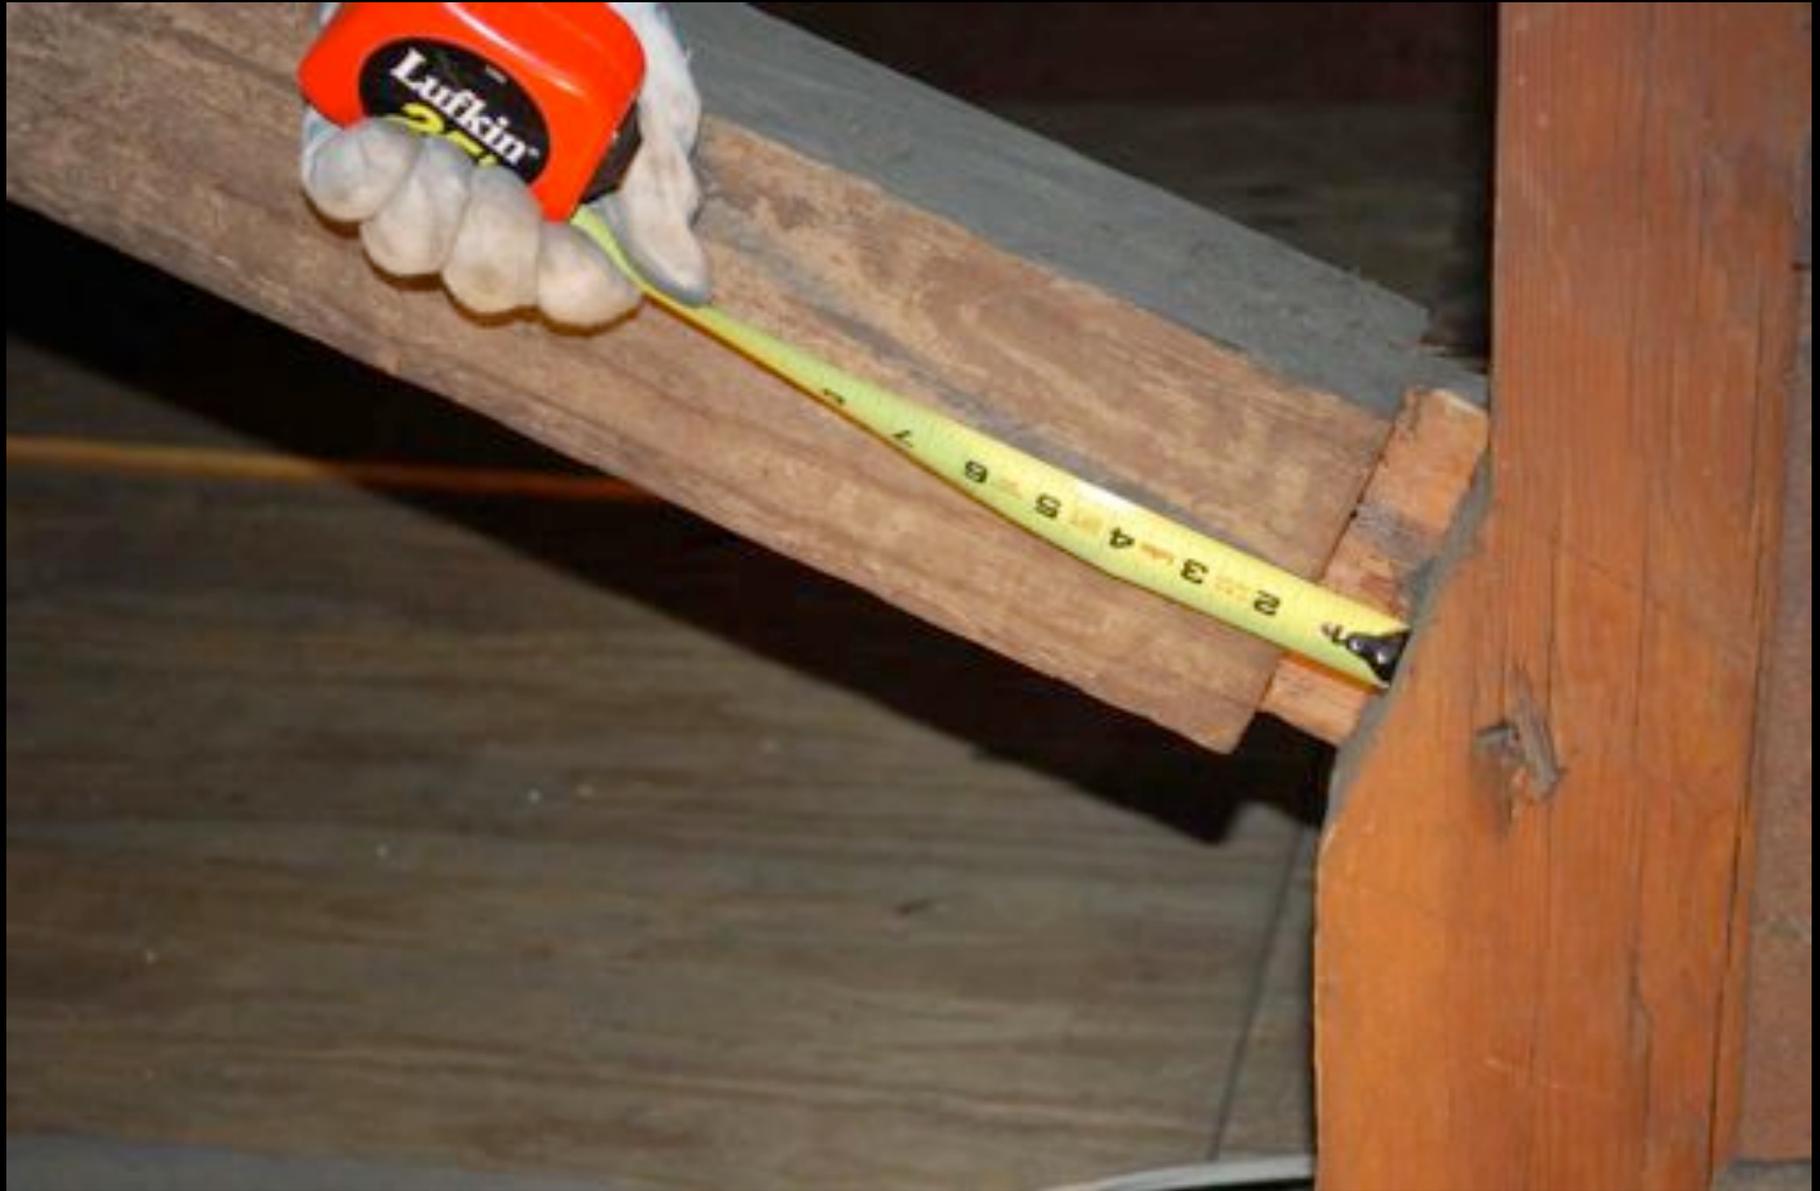
Separation of Truss Members

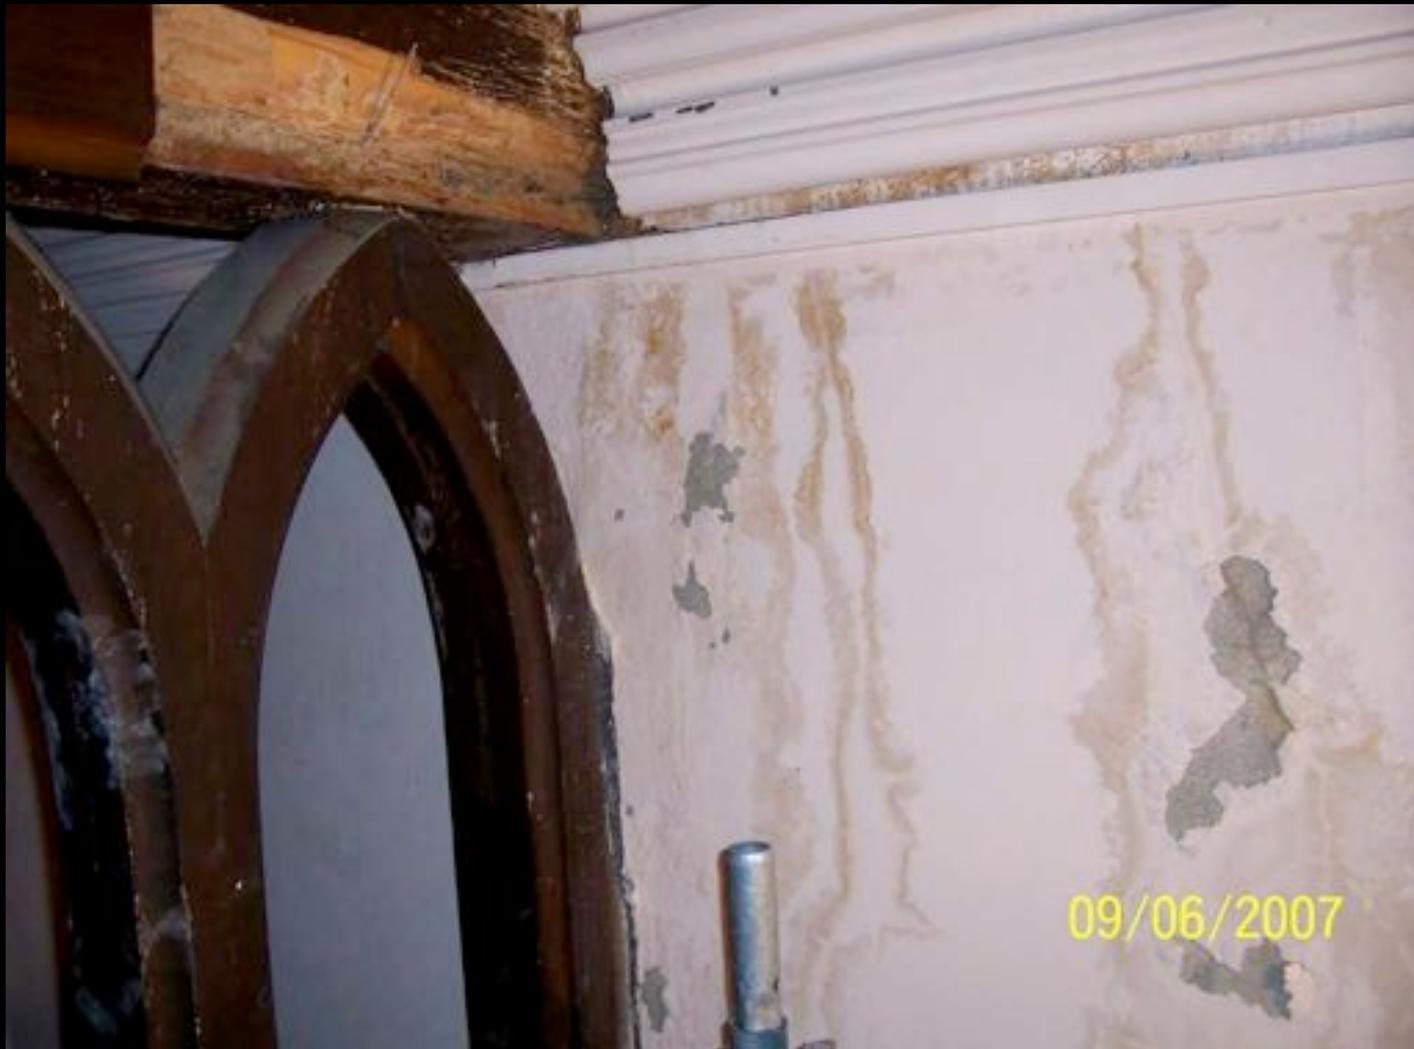
- Plaster deterioration due to water infiltration
- Separation of trusses from walls

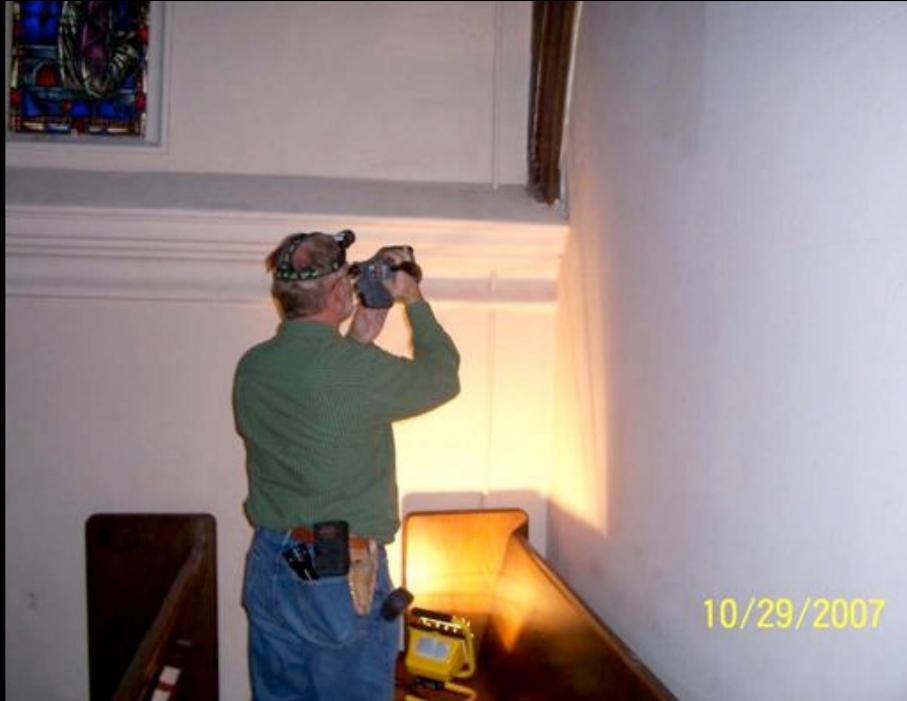
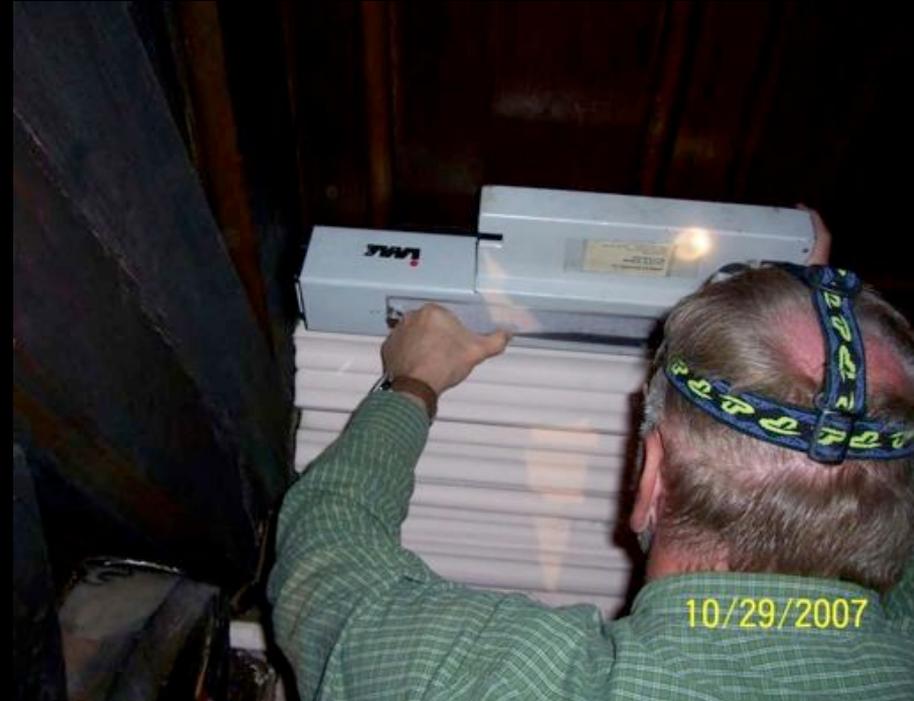
General Summary of Findings

Termite Damage

Severe wood deterioration of trusses at masonry pockets

Damage to masonry pockets

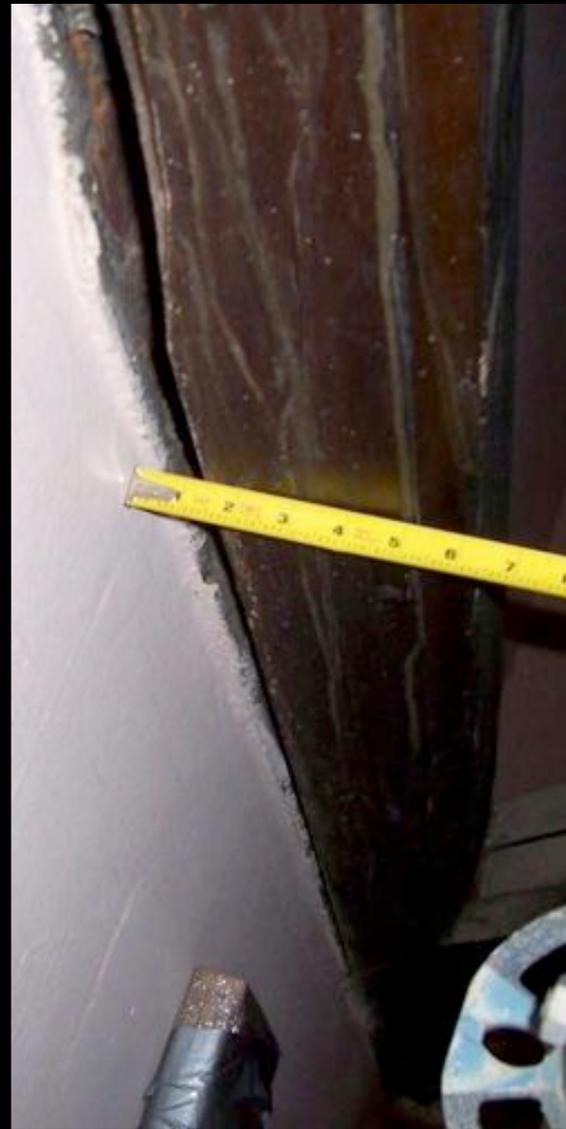
Truss separation from walls

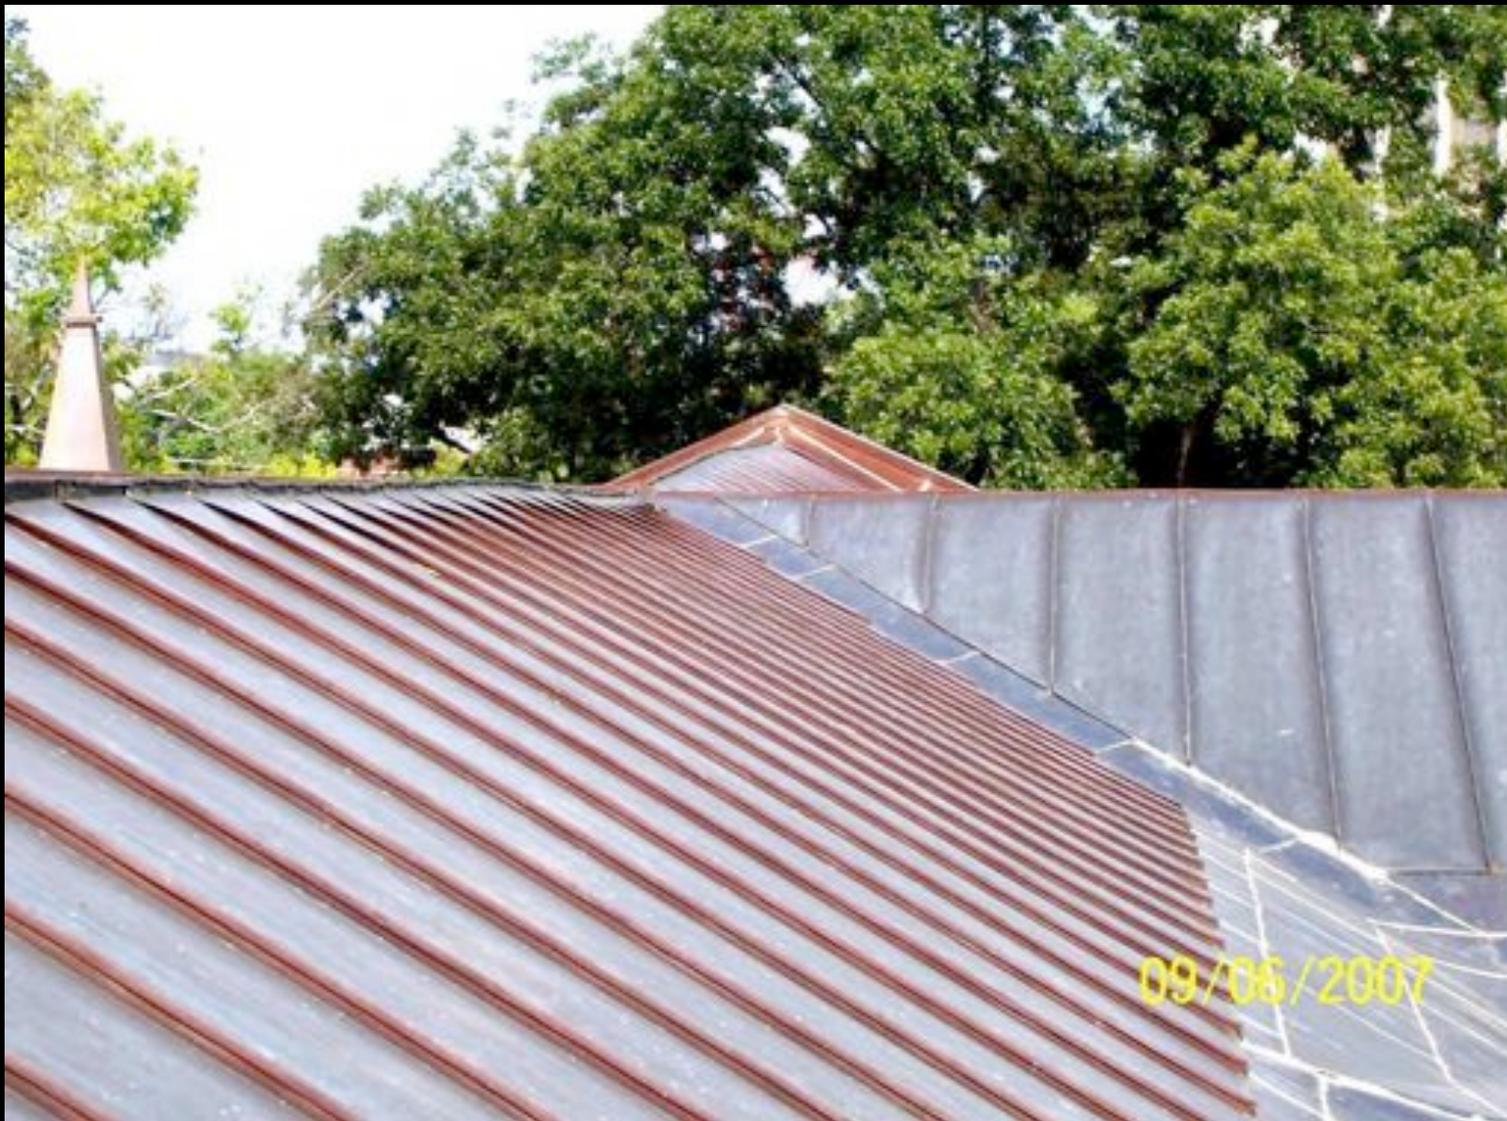
Roof line deformation

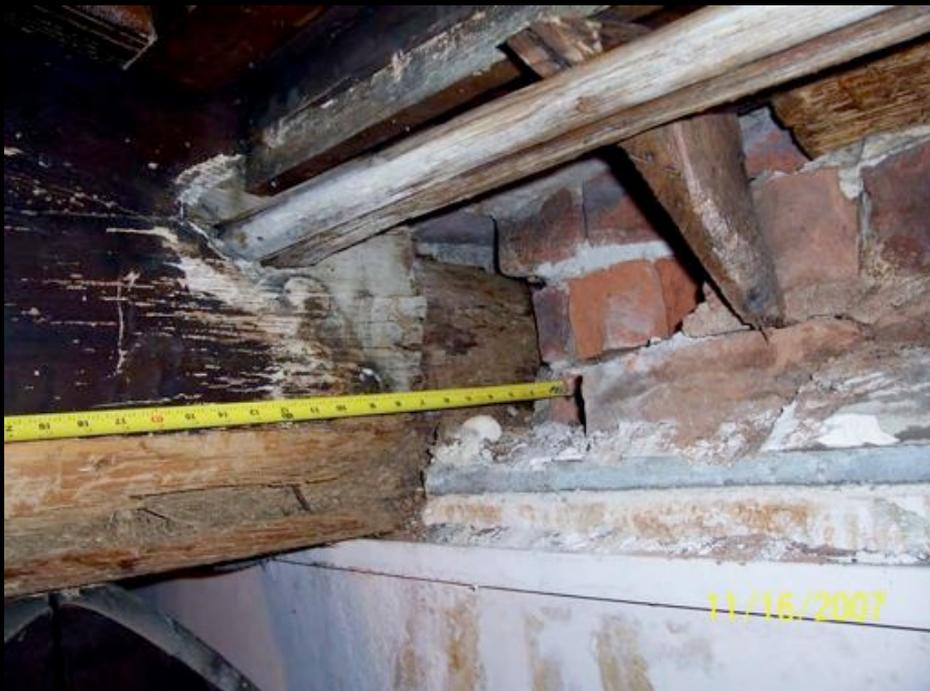
Severe wood deterioration of trusses at masonry pockets

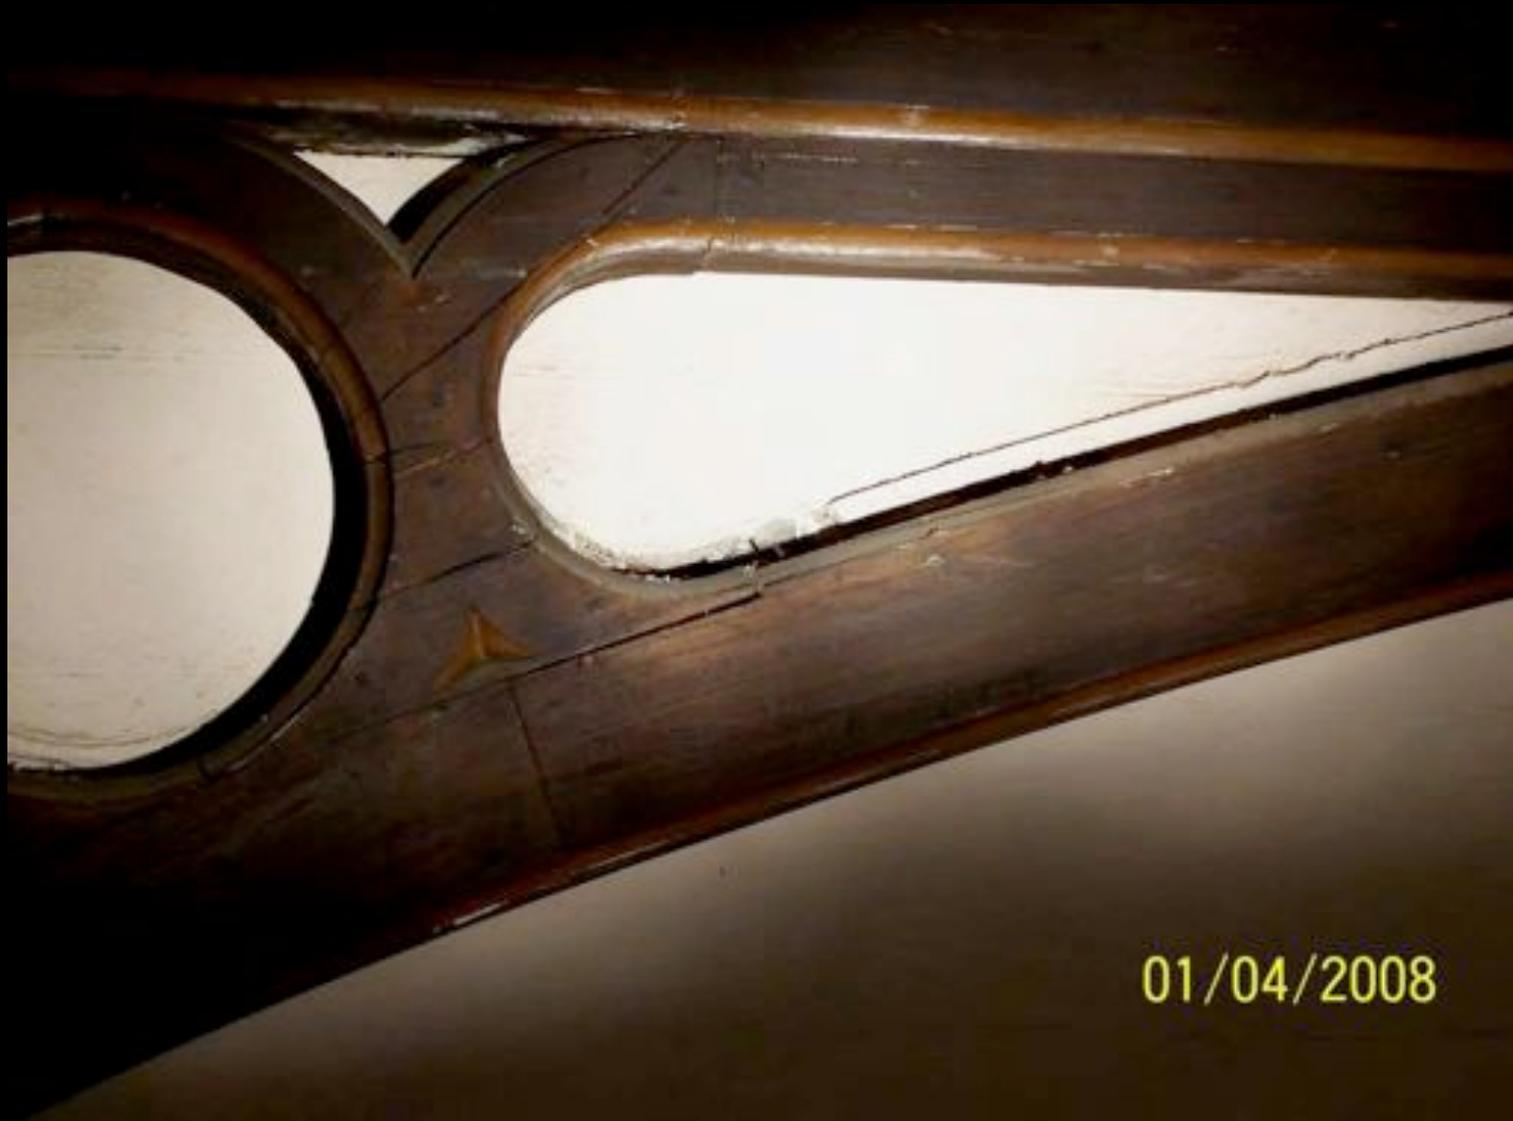
Trusses have dropped significantly

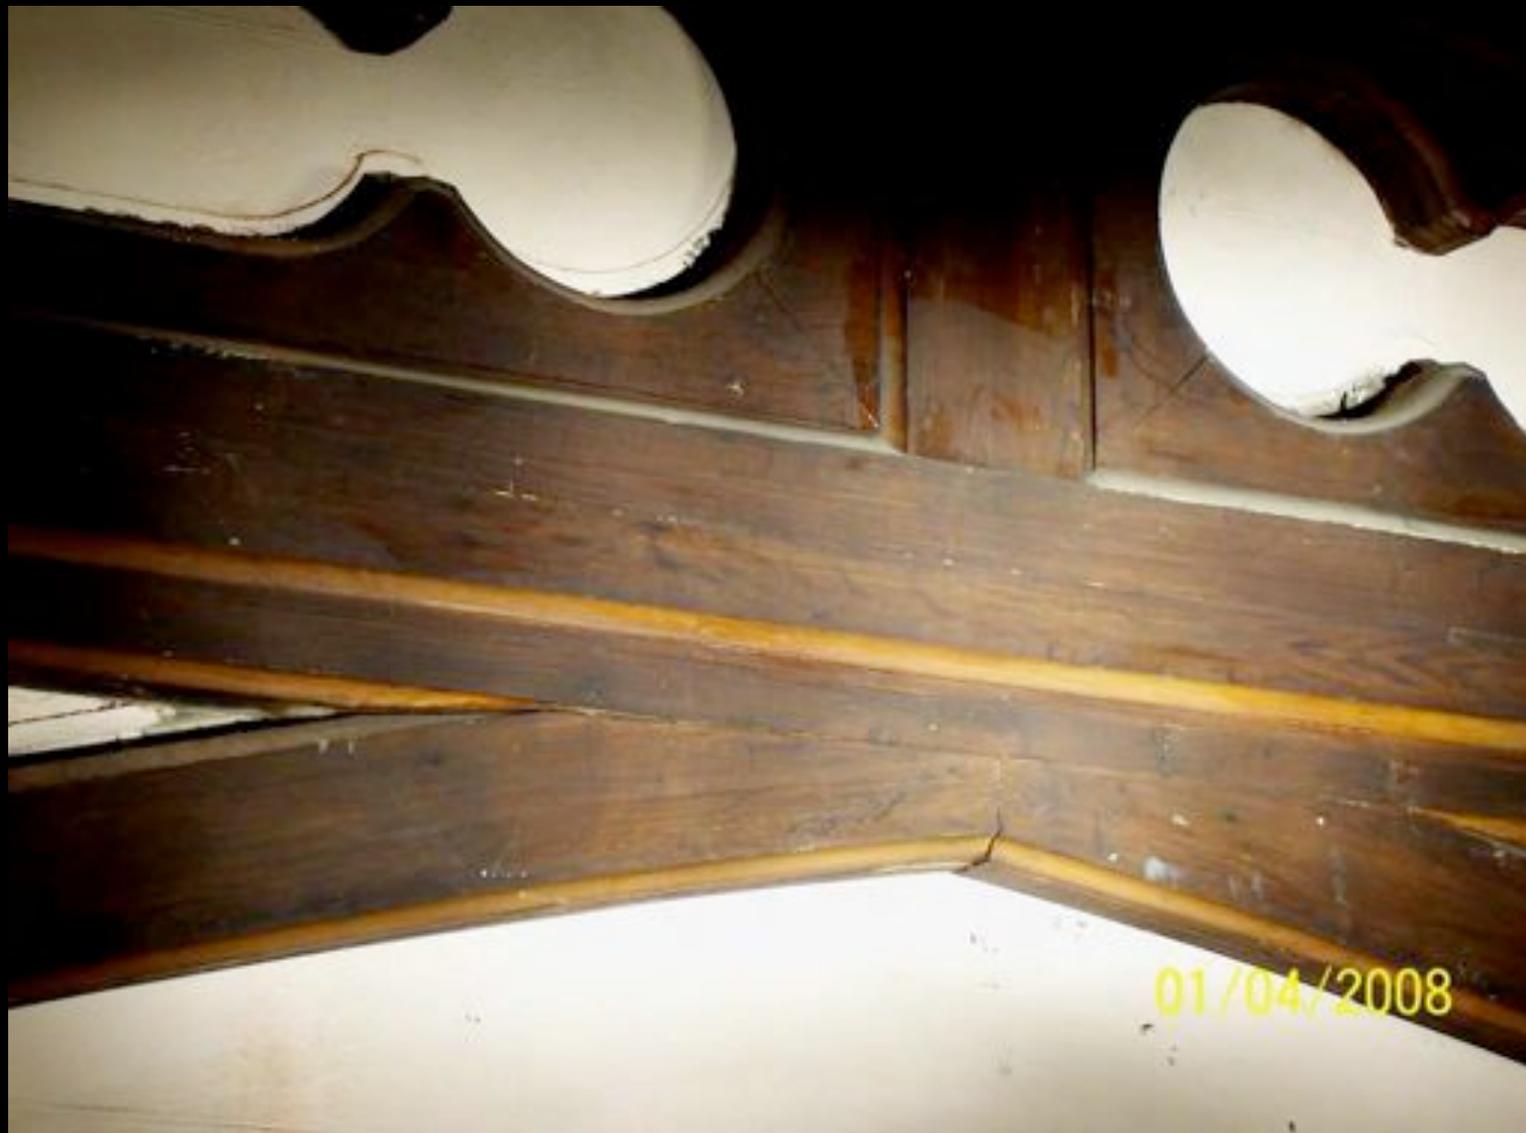
Trusses have dropped significantly

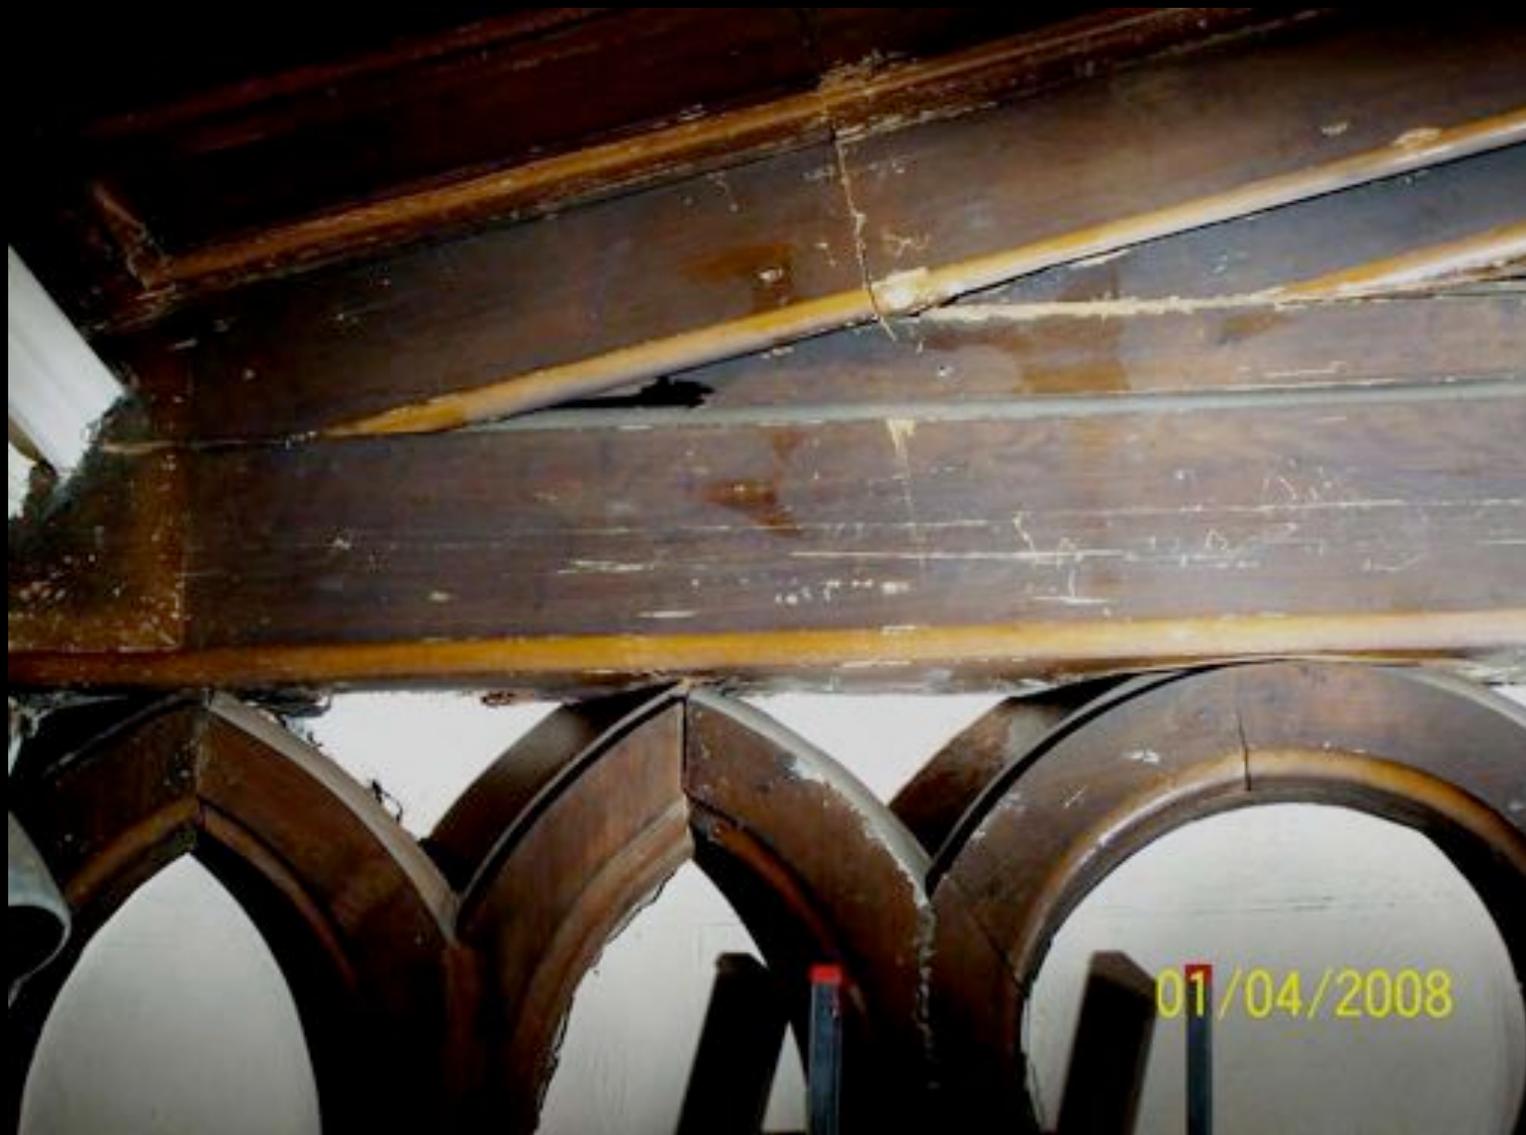
Crushing and splitting of truss members

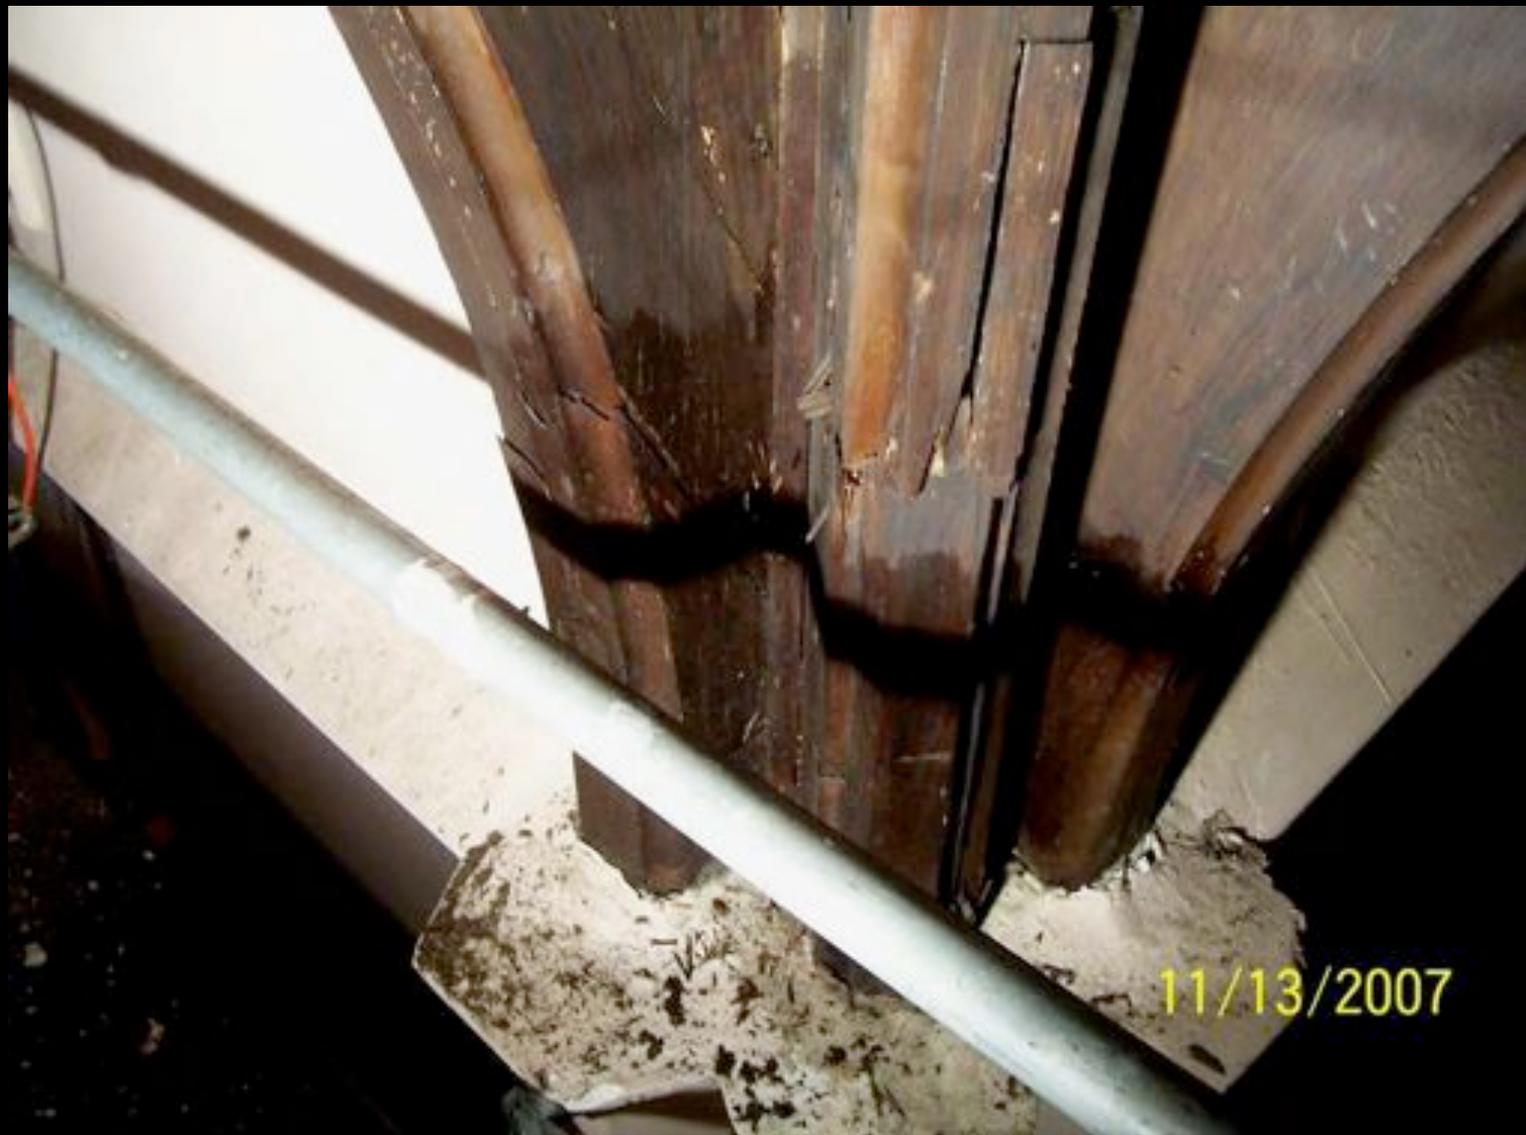
Crushing and splitting of truss members

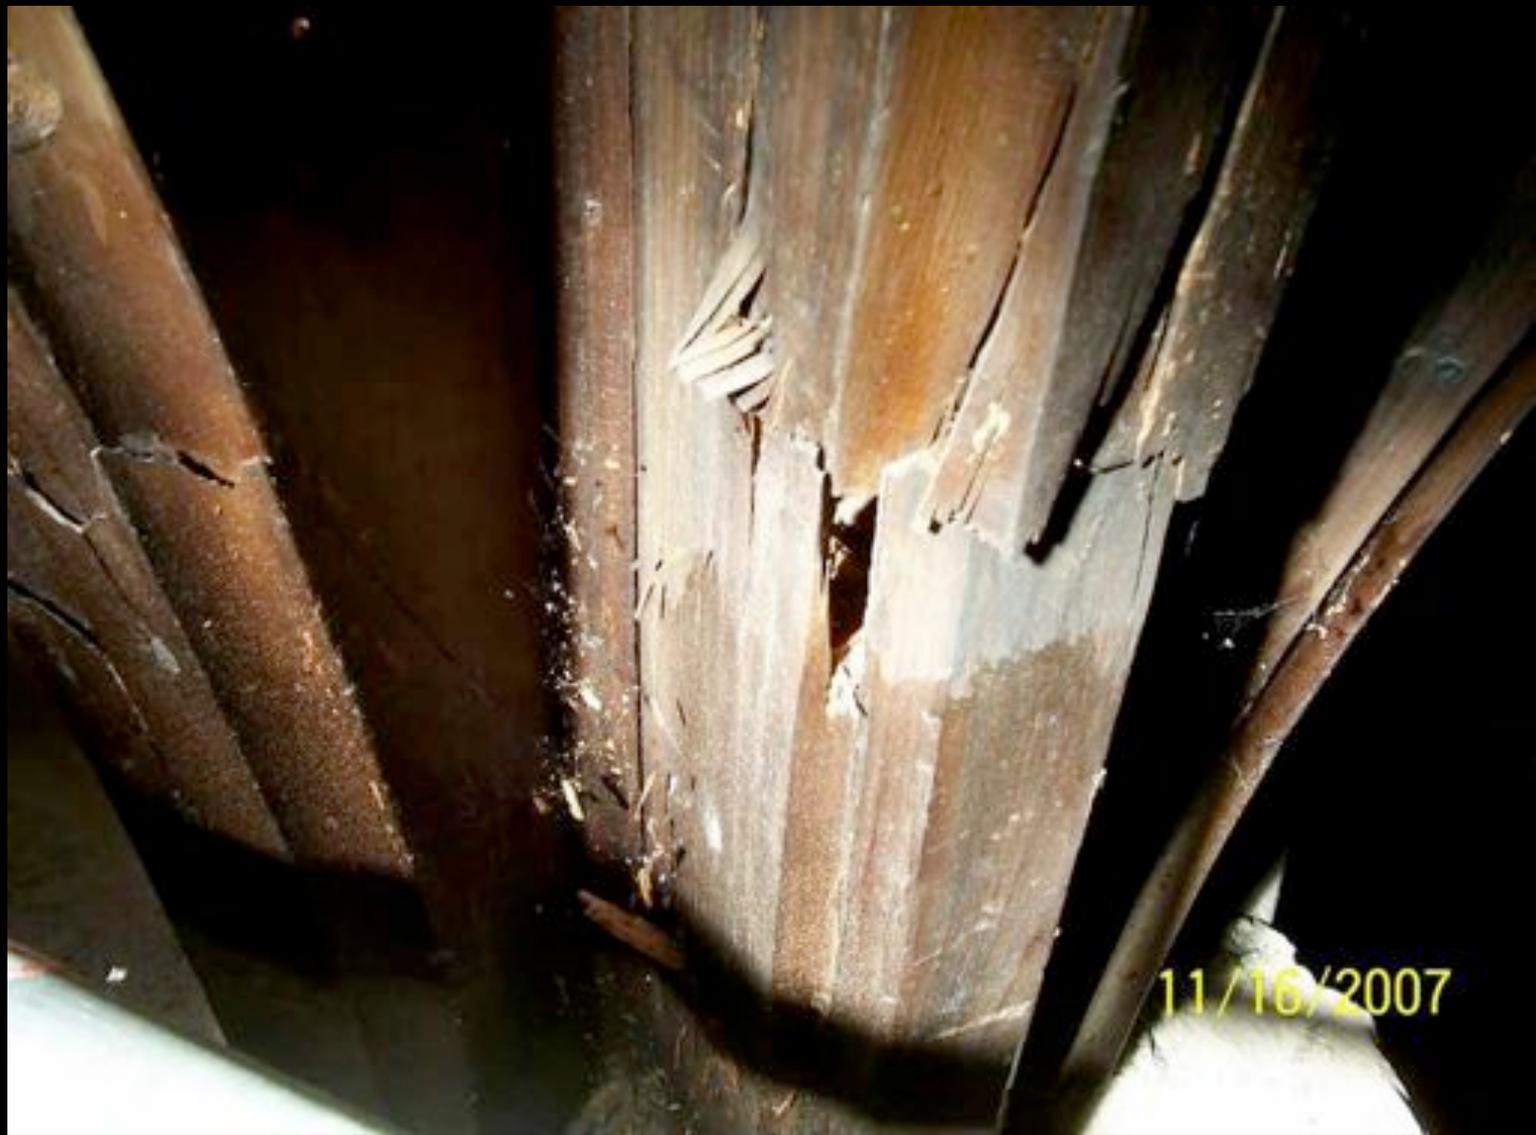
Crushing and splitting of truss members

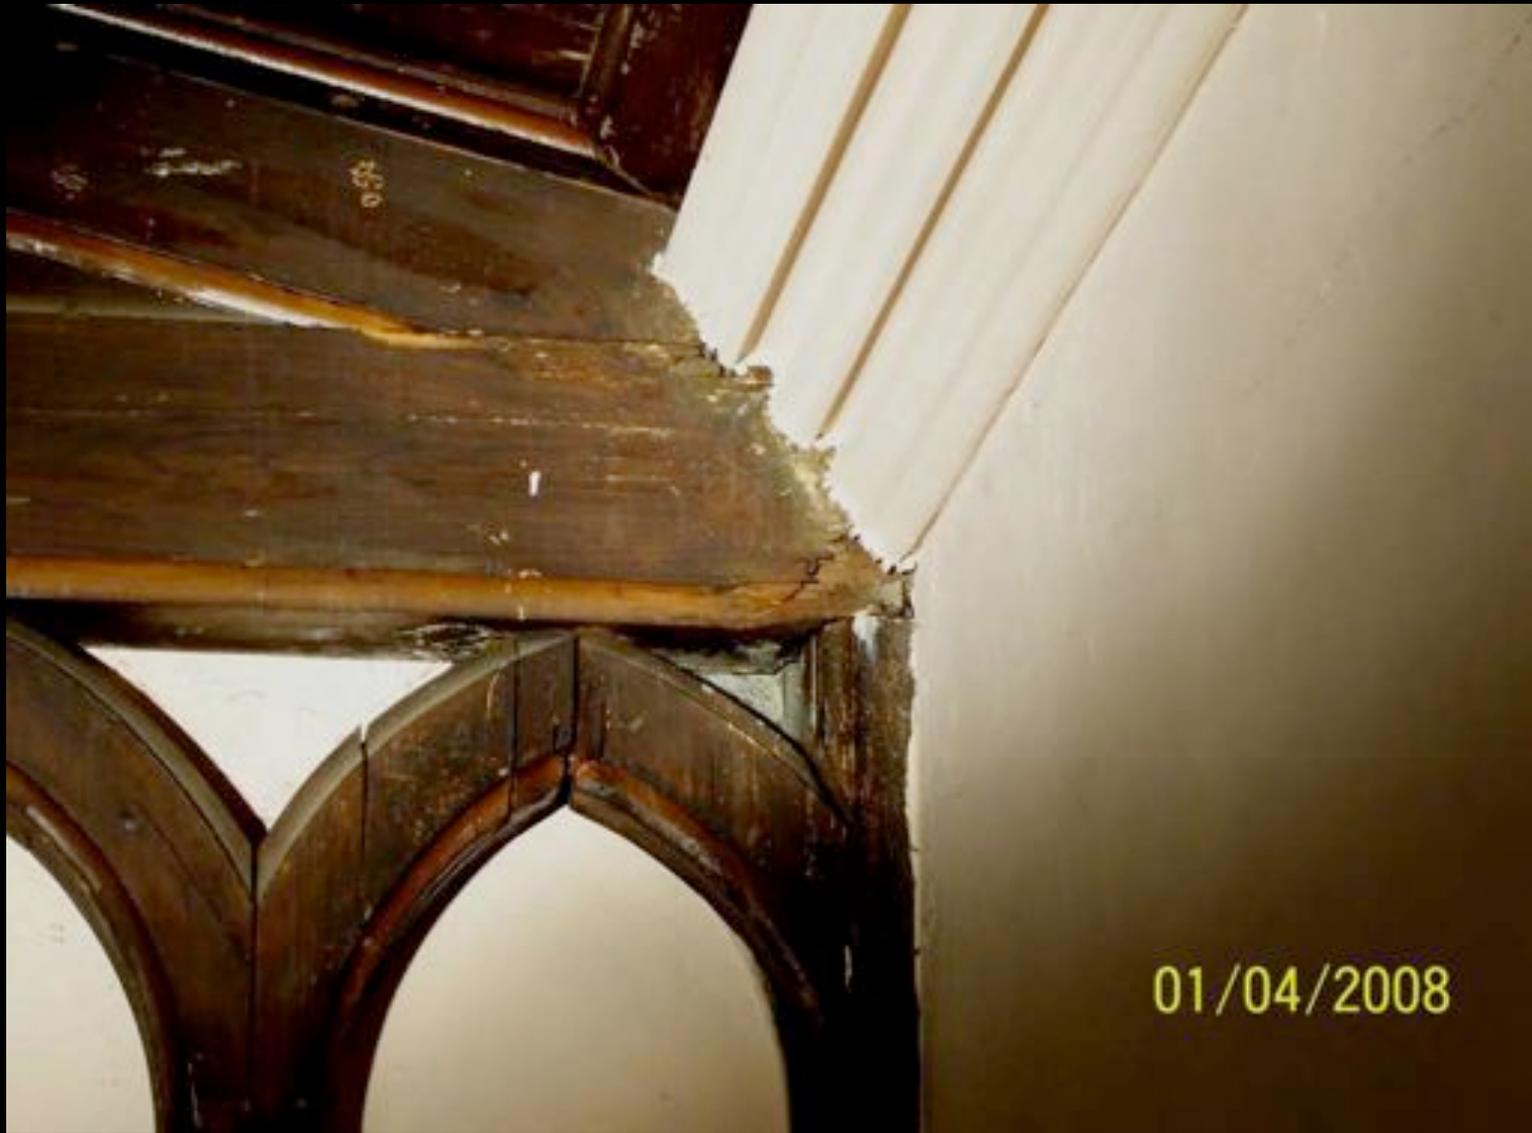
Crushing and splitting of truss members

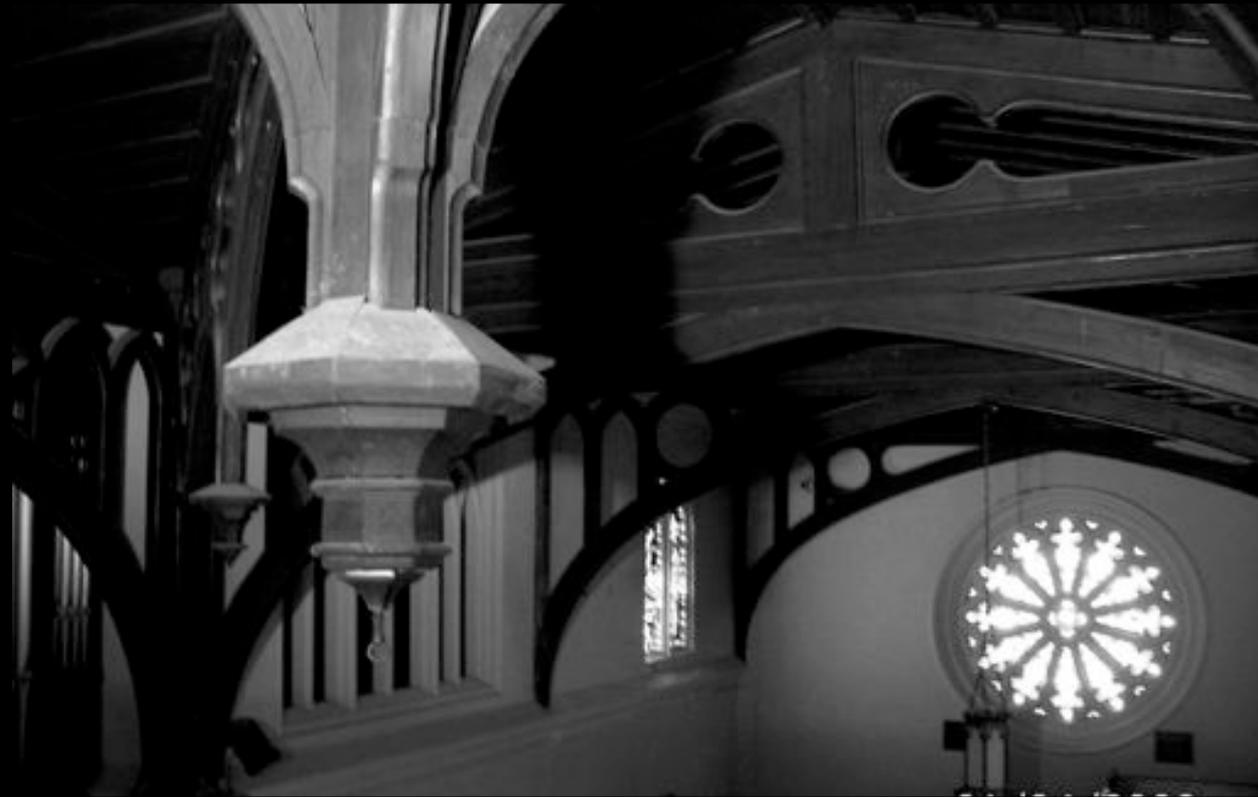
There is significant movement and deterioration of the truss system, including significant load transfer to areas which were not intended to carry any load. This is due to the deterioration and movement of the truss members, not the separation or settling of the masonry walls.

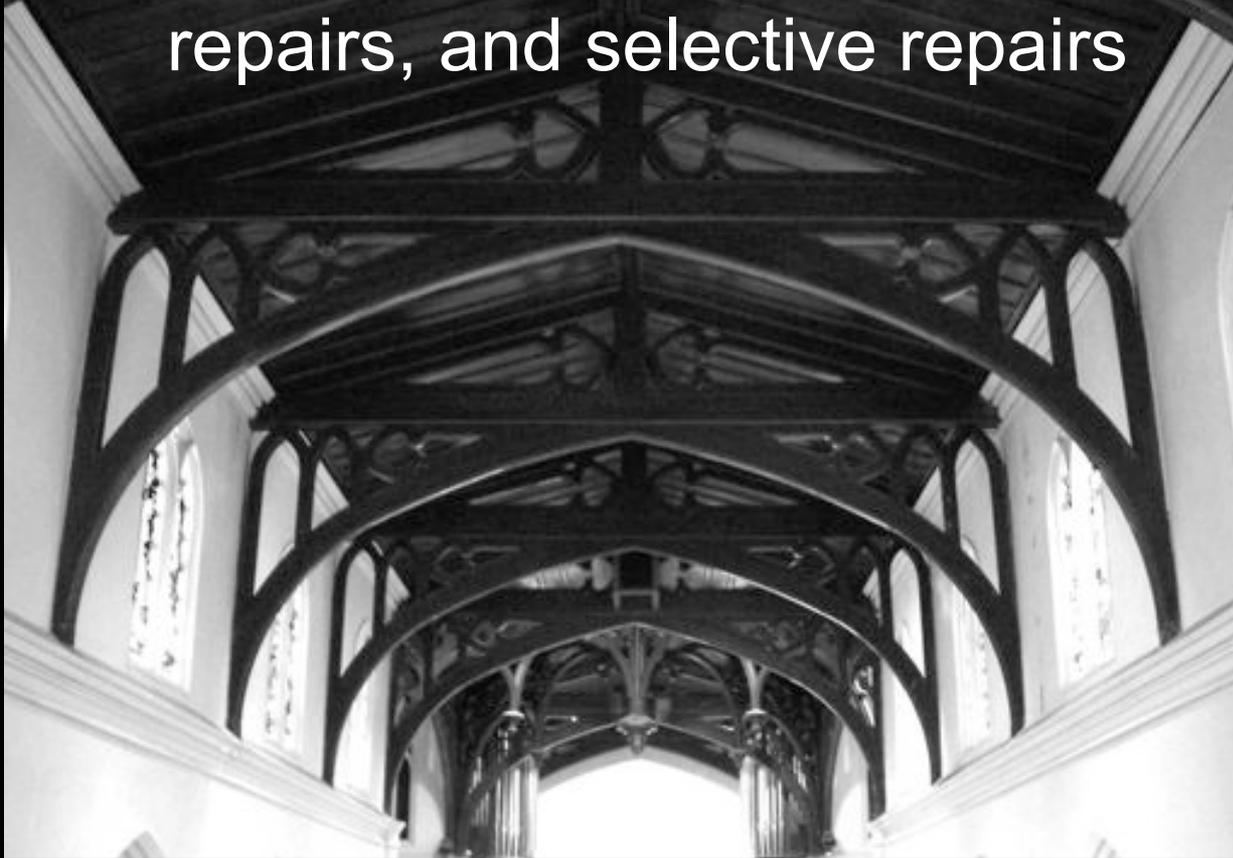
It should be noted that due to varying degrees of deterioration, no two trusses will require the same type or extent of repair.

Interior structural repairs to truss members, including complete replacement, partial replacement, extensive repairs, and selective repairs
