# Trinity Episcopal Church: Preservation Case Study of a Gothic Revival Church

MEADORS CONSERVATION

# [Case Study: Trinity Episcopal Church]

*Abbeville, SC*

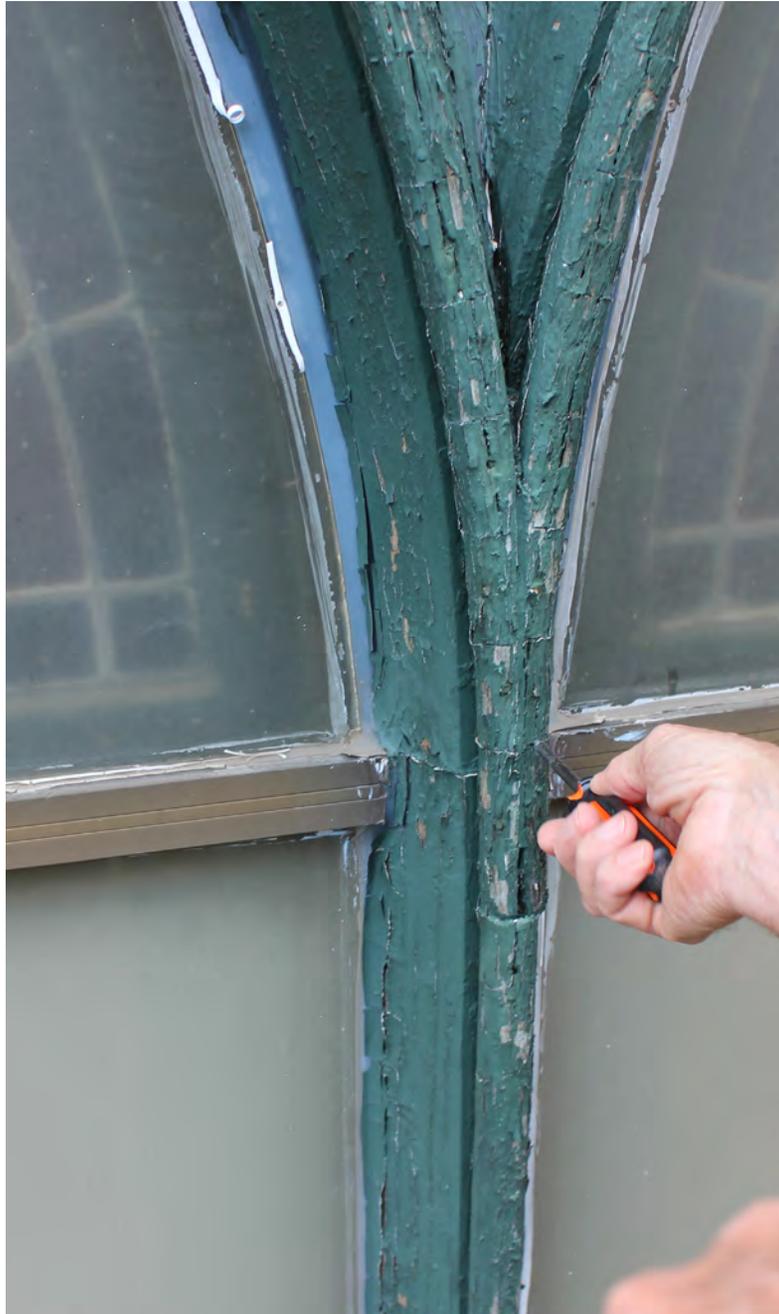
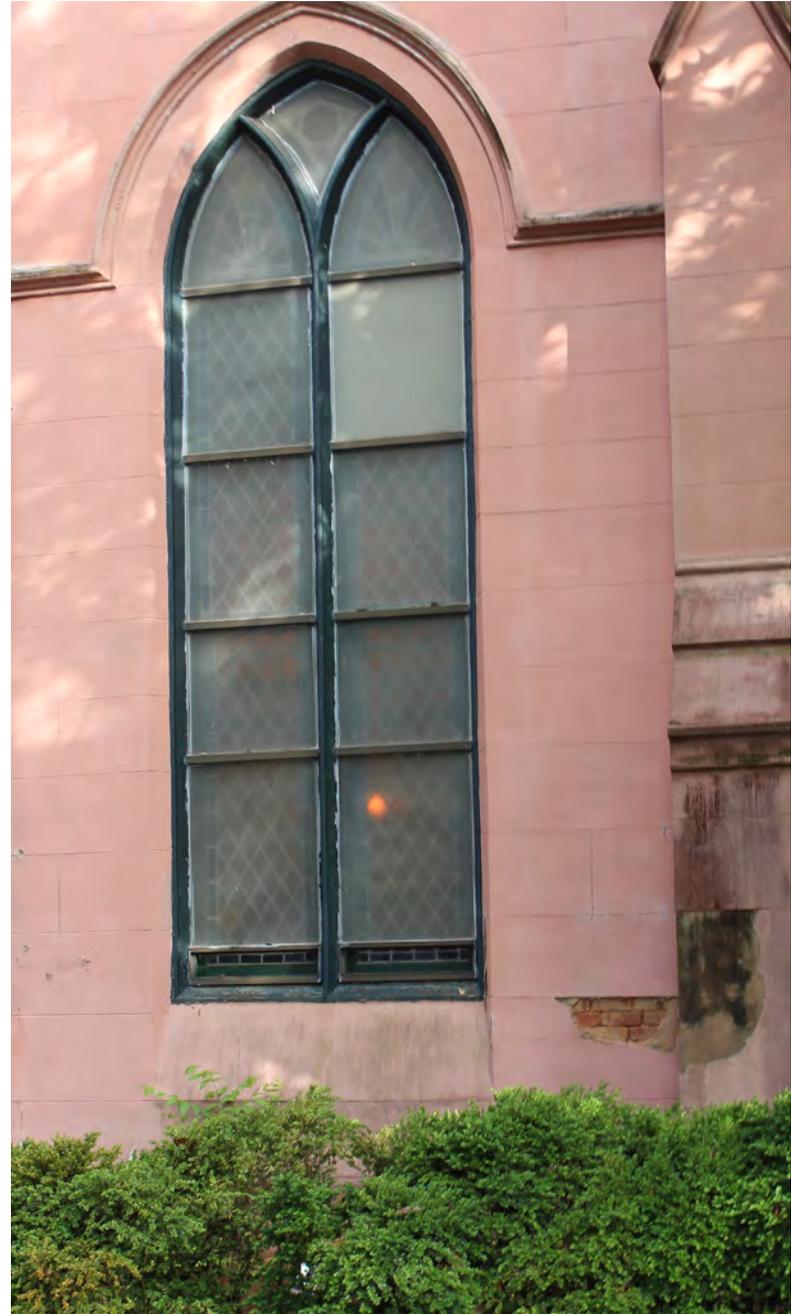
# [Assessing Buildings: Windows]

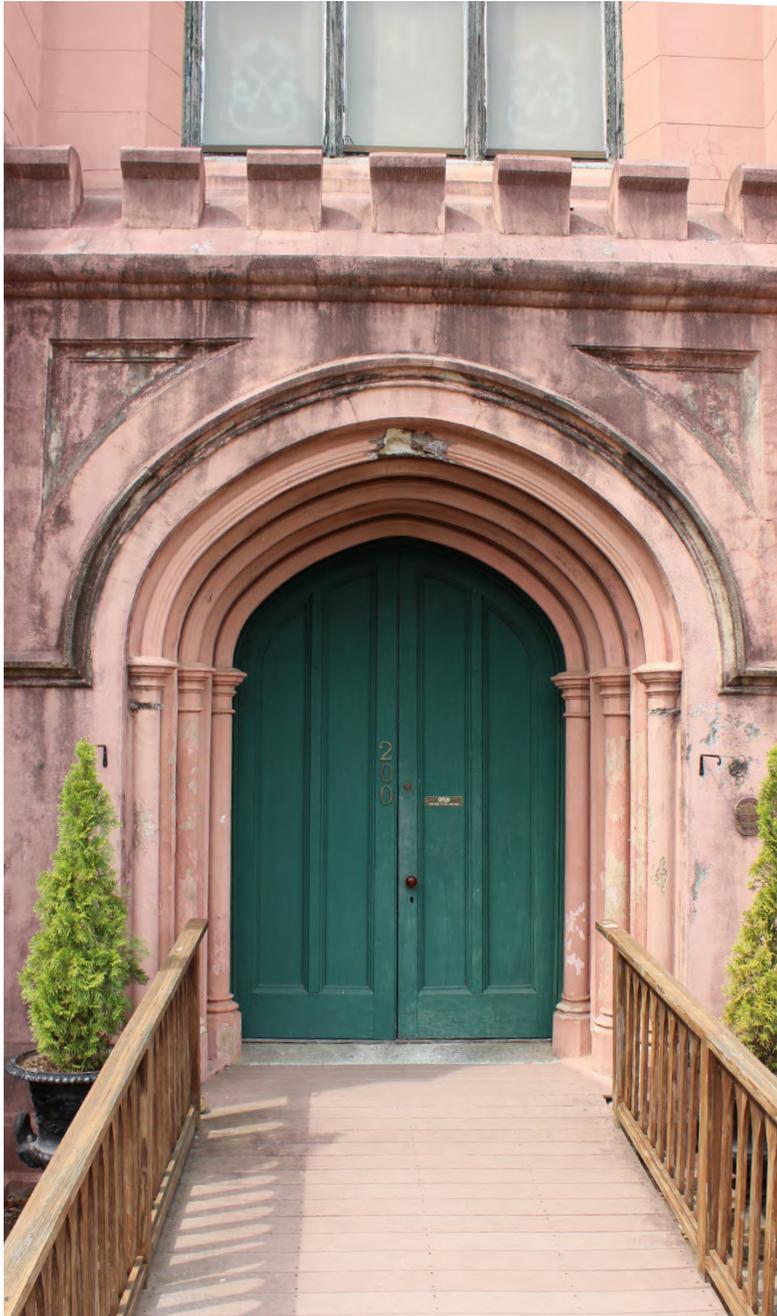
# [Assessing Buildings: Doors]

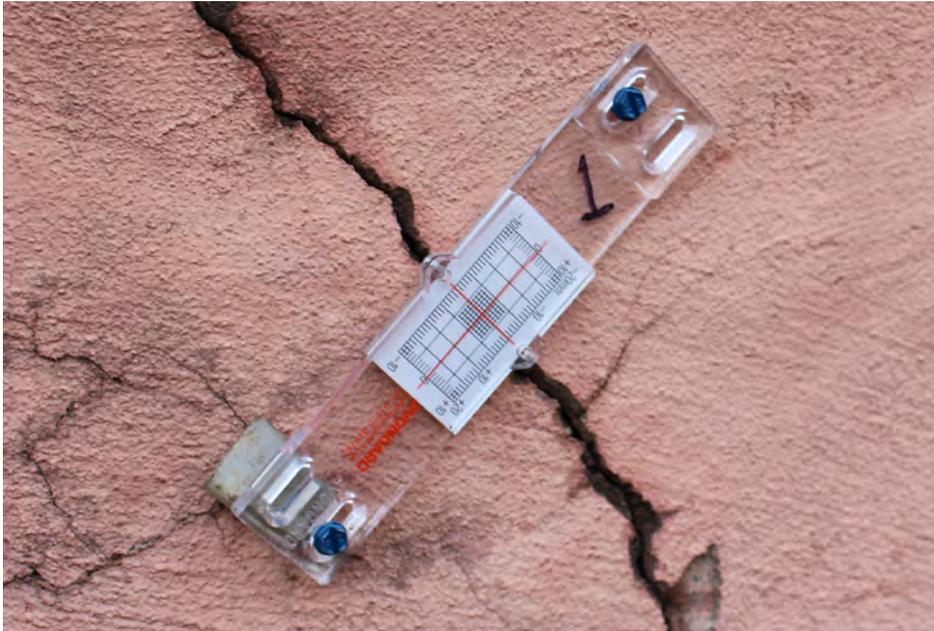
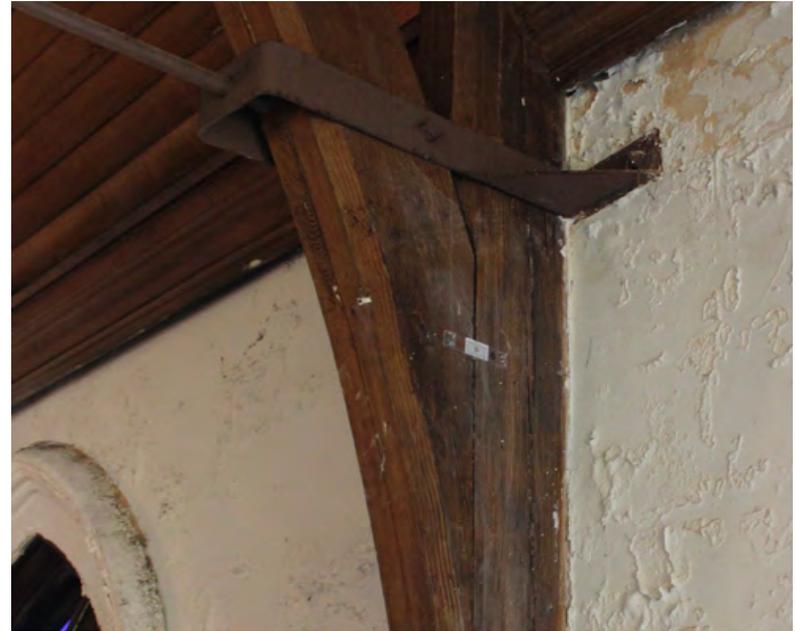
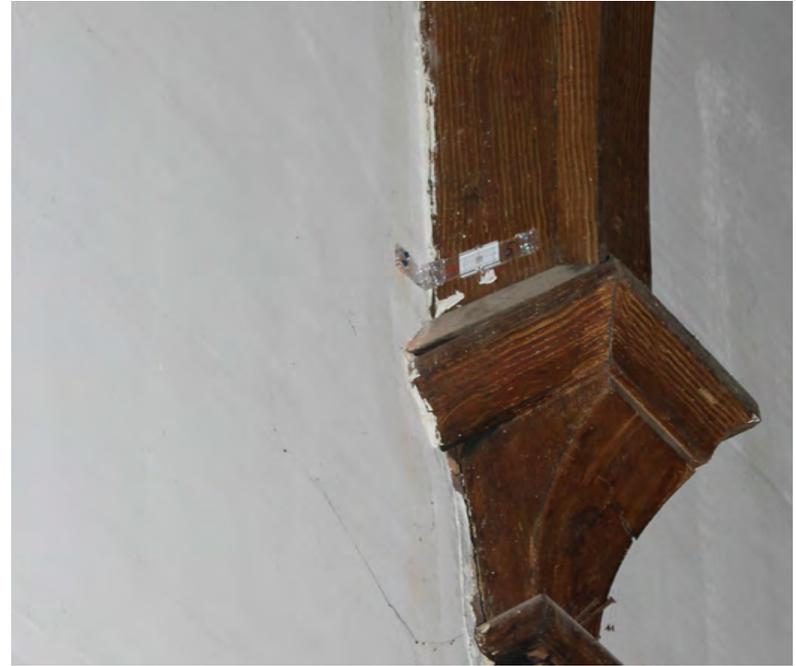
# CRACK MONITORING RECORD

PROJECT Trinity Episcopal Church

LOCATION OF CRACK MONITOR Exterior, East Elevation Below Window #3

Date of Reading  
8/7/2015
